**CERTIFICATE OF APPROPRIATENESS**

**Applicant:** Sarah Hannah, Four Square Design Studio, for Matt and Ashlea Sheridan, owners

**Property:** 803 W Melwood St, Lot 18, Block 205, North Norhill Subdivision. The property includes a historic 911square foot, one-story wood frame single-family residence and a situated on a 6,157 square foot (59.2' x 104') corner lot.

**Proposal:** Demolition – of the existing detached garage

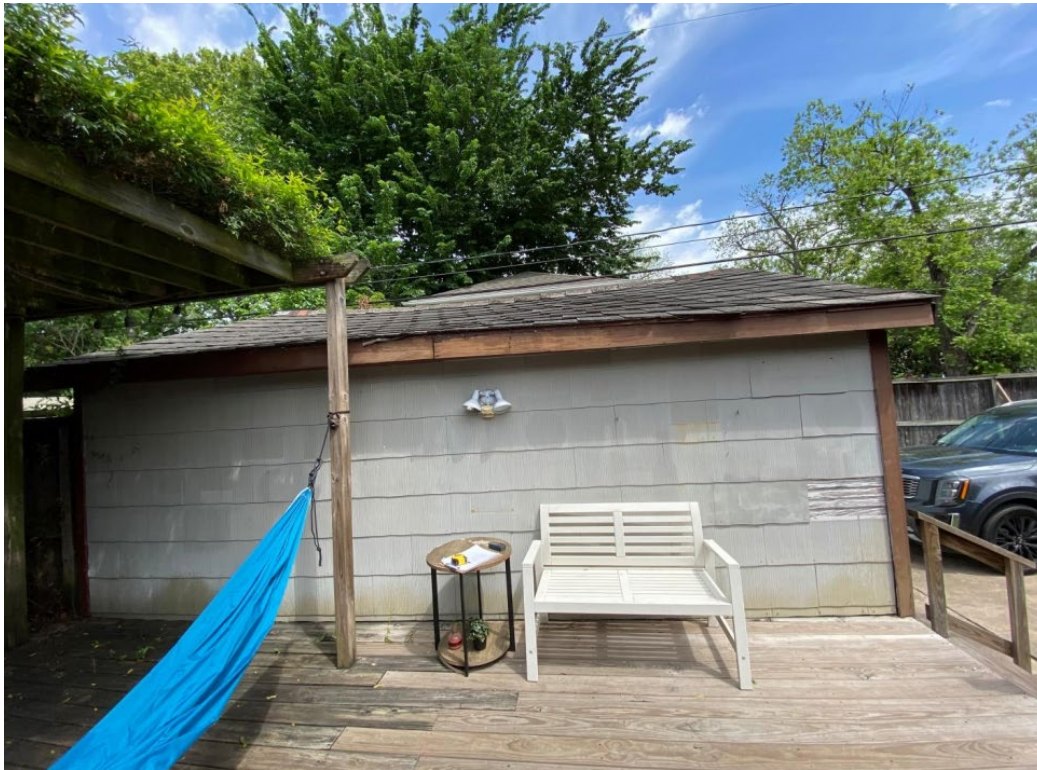
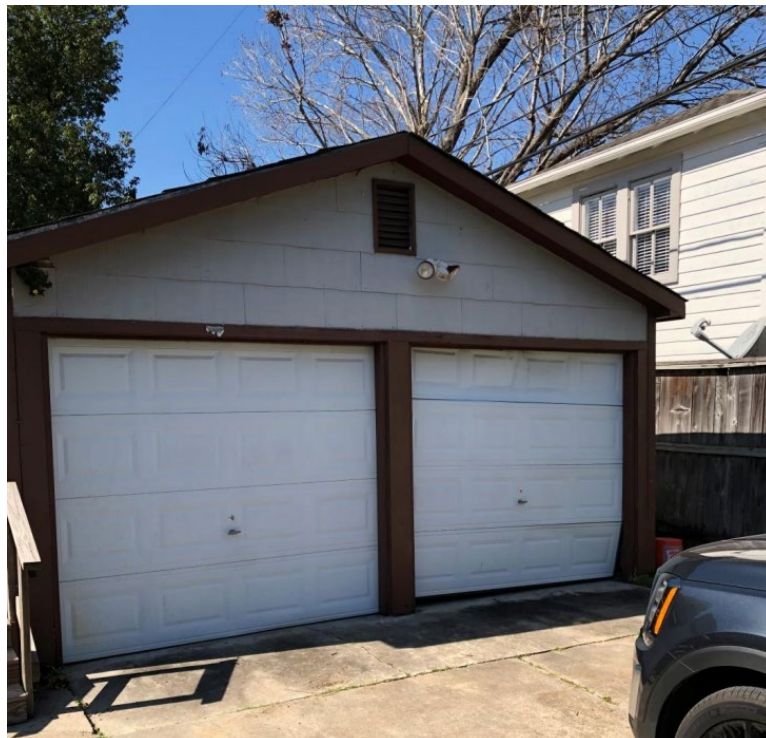
**GARAGE'S PHOTOS**

In addition, the garage as shown on Sanborn and in Tax records isn't original and therefore is noncontributing and has no historic value. In addition to that it's in bad condition and isn't functioning as a garage. Please see mechanical report attached in support of that and supporting pictures.

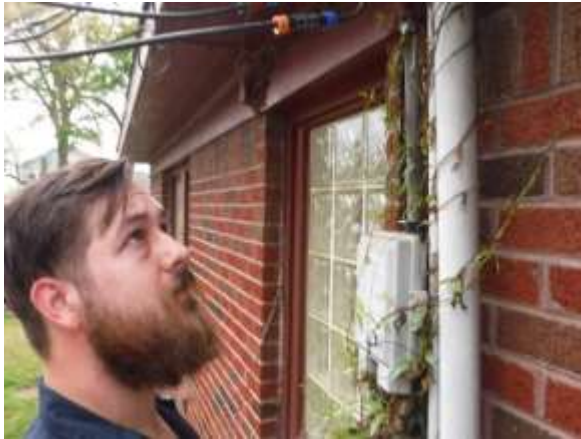
The service entrance conductors were observed to be approximately 6 feet above deck. This is a dangerous condition which could possibly cause serious injury. The current National Electric Code requires service entrance conductors to be a minimum of 10 feet above grade. Have the service raised to meet the current minimum standard.

**Obtain Cost Estimate**

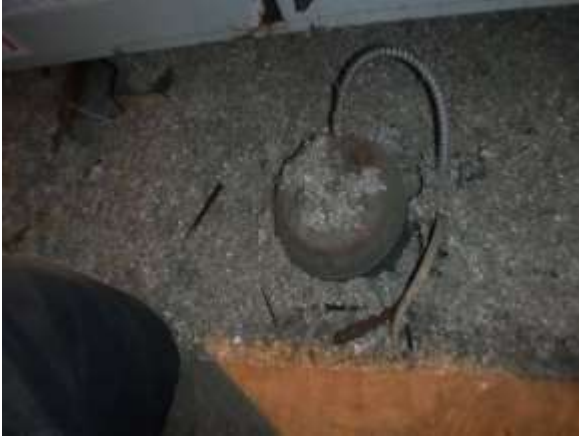
### **Visible Wiring**

Open junction boxes were observed.  
Locations included: attic

**Obtain Cost Estimate**

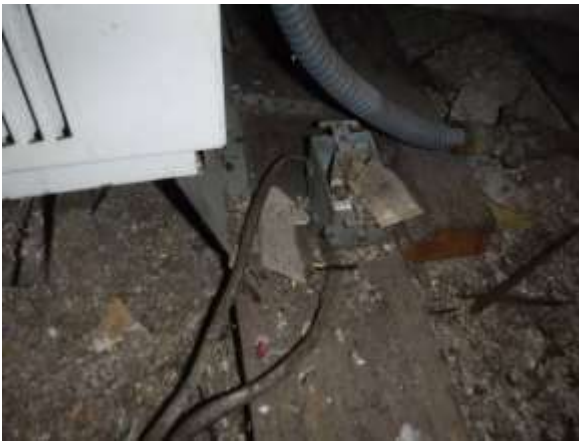
The house was observed to have remnants of knob-and-tube wiring and non-metallic sheathed wiring. The knob-and-tube wiring is an antiquated ungrounded and unbonded system, and many insurance companies will require the wiring to be replaced with non-metallic sheathed wiring that is properly grounded and bonded. Contact an electrician for more information and/or a cost estimate to replace all active or inactive knob-and-tube wiring.

**Obtain Cost Estimate**

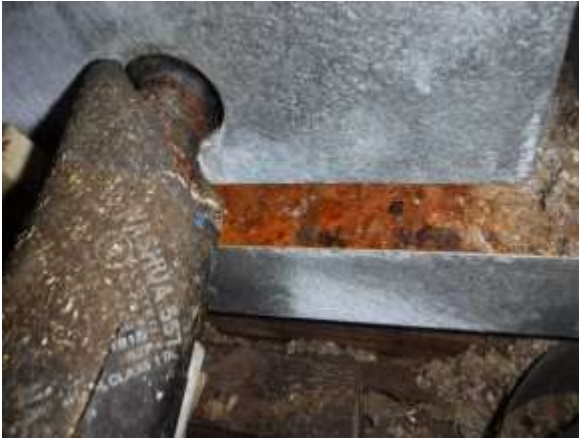
### **Overflow Pans – Rust**

The overflow pan under the evaporator coil had rust in the pan, apparently from water overflowing the condensate drain line into the overflow pan. No water was in the pan at the time of the inspection, but, since we only ran the unit for a few minutes, it is recommended that the drain line be checked by an air conditioning service company. (see photo below)

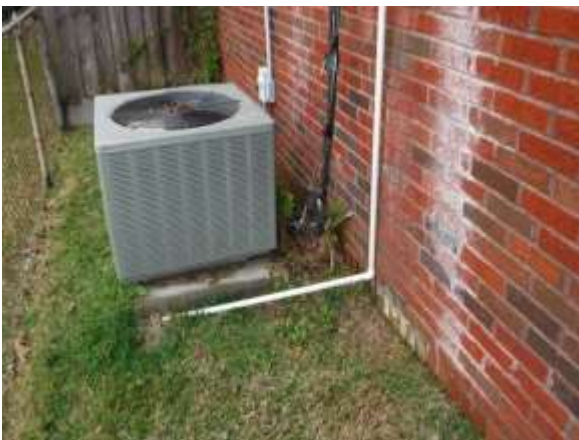
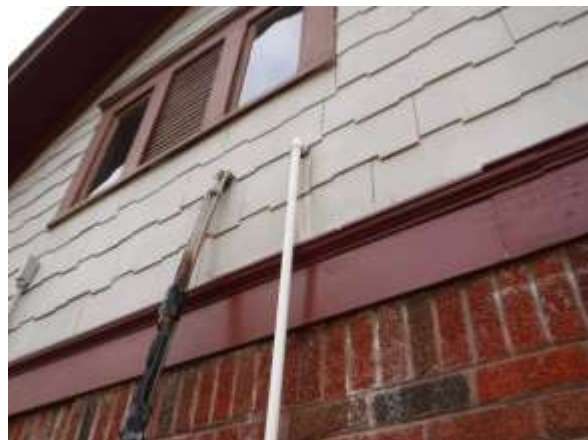
The primary condensate drain line from the air conditioning unit was emptying its water next to the foundation. This can cause the soil in that area to stay saturated and contribute to differential foundation movement. It is recommended that the drain line be routed to a bathroom sink drain line.

**Obtain Cost Estimate.**

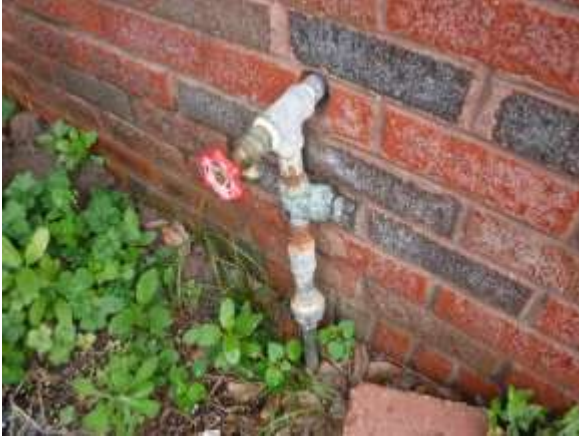
### **Water Service**

The shut-off valve for the main inlet water line was located at the exterior of the house at the front of the house.

The main inlet water line needs to be insulated at the house.

**Obtain Cost Estimate**

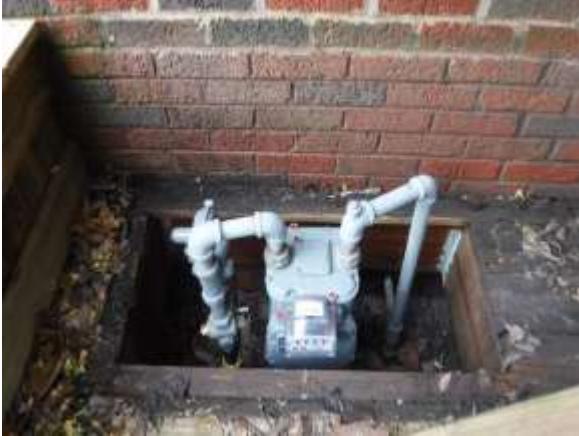
### Gas Lines

The gas meter, with the main shut off valve for the gas to the house, was located at the rear of the house under a bench on the deck.

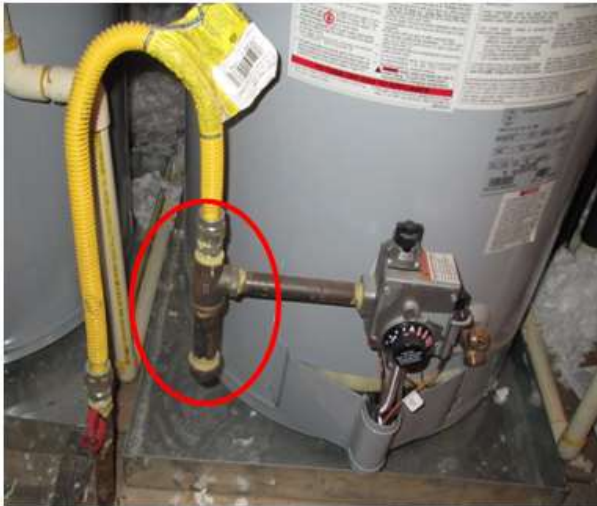
HEI file photo showing sediment trap

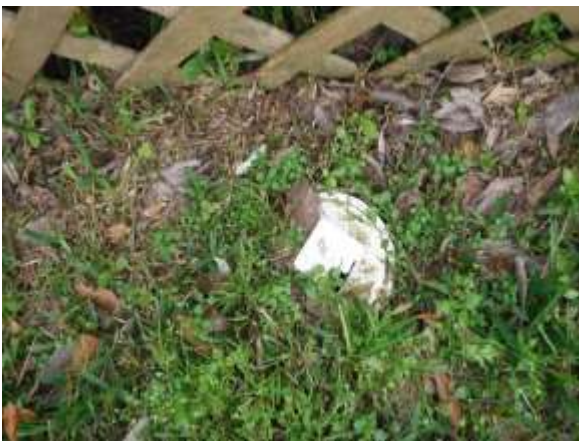
The main sewer PVC clean out was located at the rear of the house. The clean out is needed in the event of a stoppage in the main sewer drain line, and the clean out is where a sewer snake would be installed to remove the clog in the drain line. The cap was observed to be damaged and needs to be replaced. (Information)

**Obtain Cost Estimate**

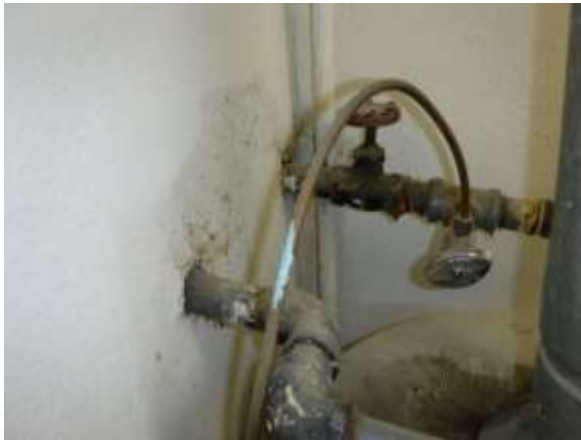
The piping at the top of the water heater was severely corroded at the fittings and is in need of repair.

**Obtain Cost Estimate**

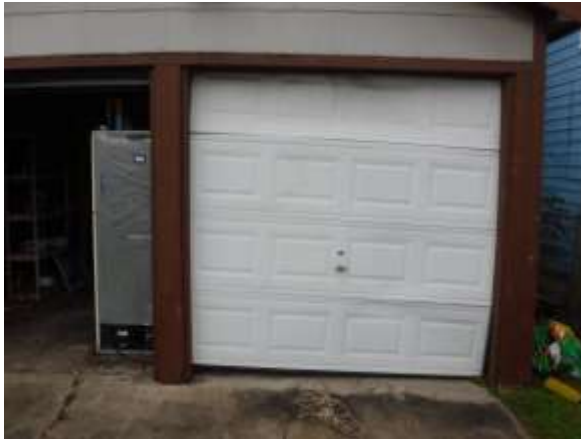
The garage door was severely damaged and was not able to be tested at the time of the inspection. Have a garage door service company make any necessary repairs.

**Obtain Cost Estimate**
