**CERTIFICATE OF APPROPRIATENESS**

**Property:** 1113 Tulane St, Lots 11 & 12, Block 205, Houston Heights Subdivision. The property includes a 1,024 SF one-story wood single family residence with a later two-story addition in the rear on a 8,800 sqft interior lot.

**Proposal:** Demolition –The applicant is proposing to demolish the contributing structure and the later additions due to its deteriorated condition, termite damage and water damage.

## STRUCTURAL REPORT

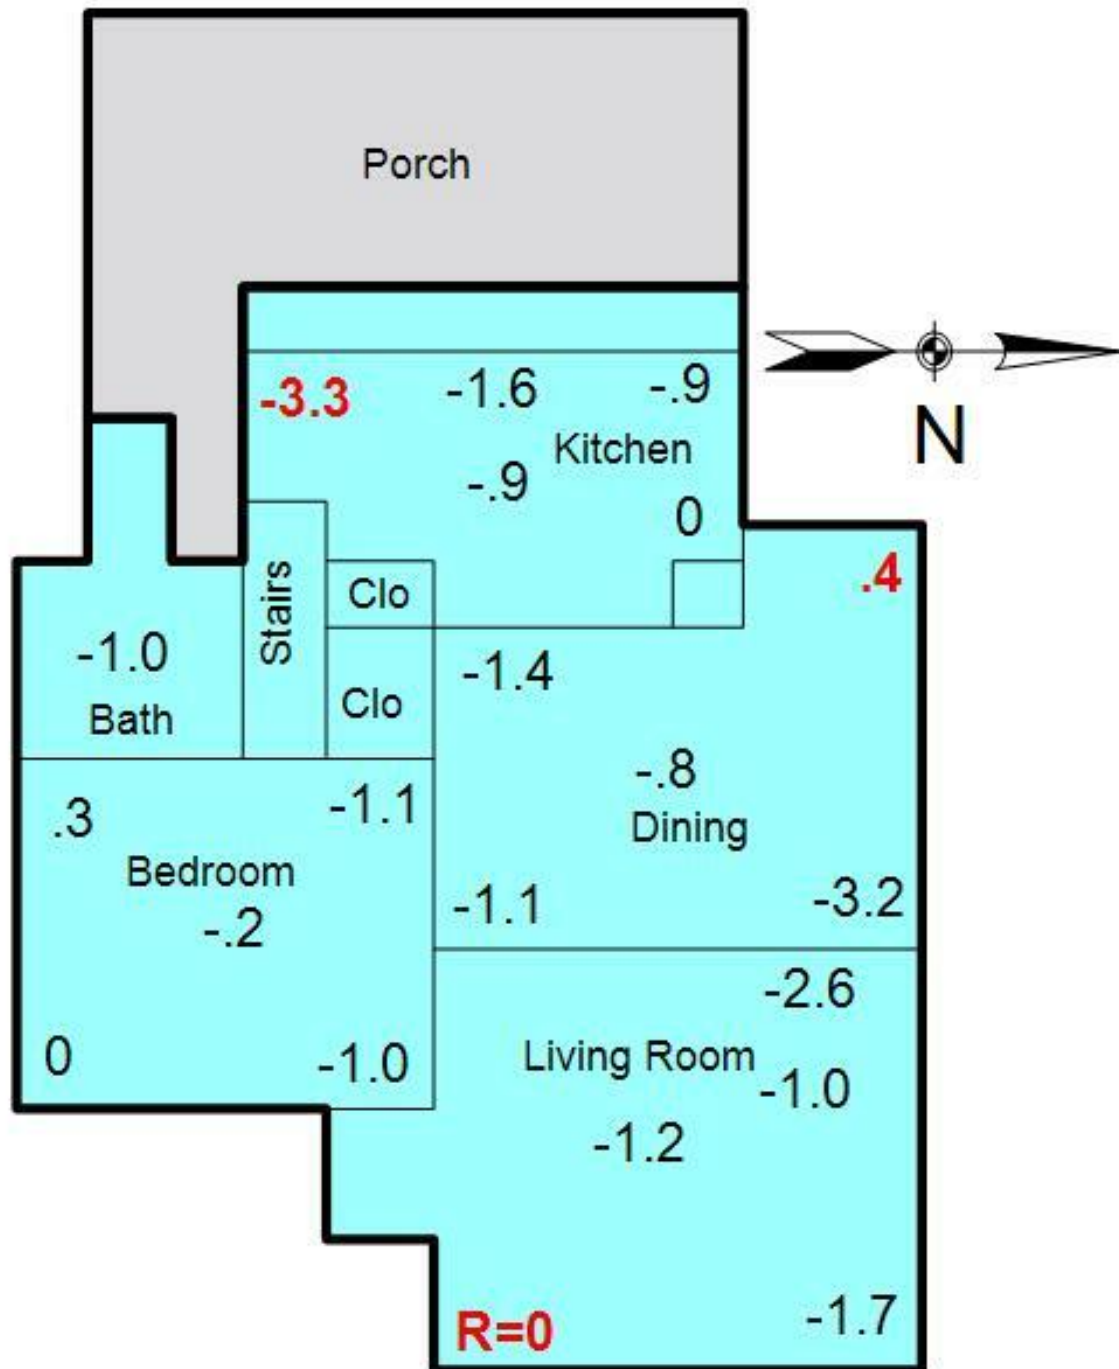
## Elevation Readings 1113 Tulane St.

The floors were checked with an electronic level, and were observed to be sloping a more than normal degree towards the rear of the house and the east side of the house. The difference in elevation between the high point and low point was 3.7 inches. The high point was located at the dining room, and the low point was located at the kitchen. The unlevelness takes place over a horizontal distance of approximately 15-20 feet.

Due to the more than acceptable amount of movement of the foundation of this structure, it is our opinion that releveling of the foundation is needed at this time. It is recommended that at least three foundation repair contractors be contacted in order that they may make their own assessment of the scope and cost of the work needed to bring this foundation back to an acceptable degree of levelness.

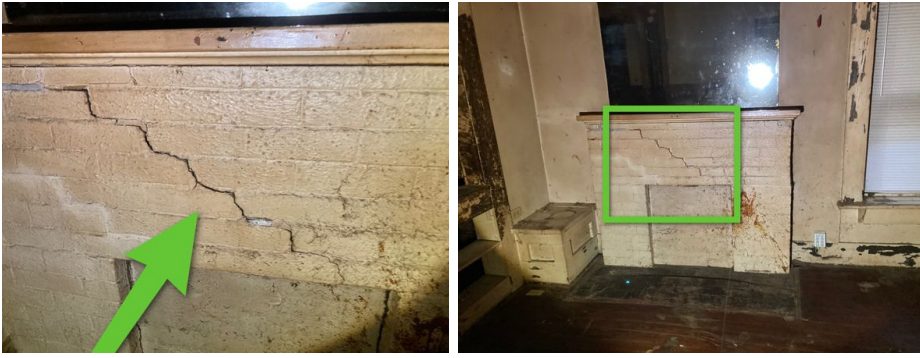
### Differential Movement: Fireplace - Cracks

Cracks were observed in the fireplace at the time of the inspection.

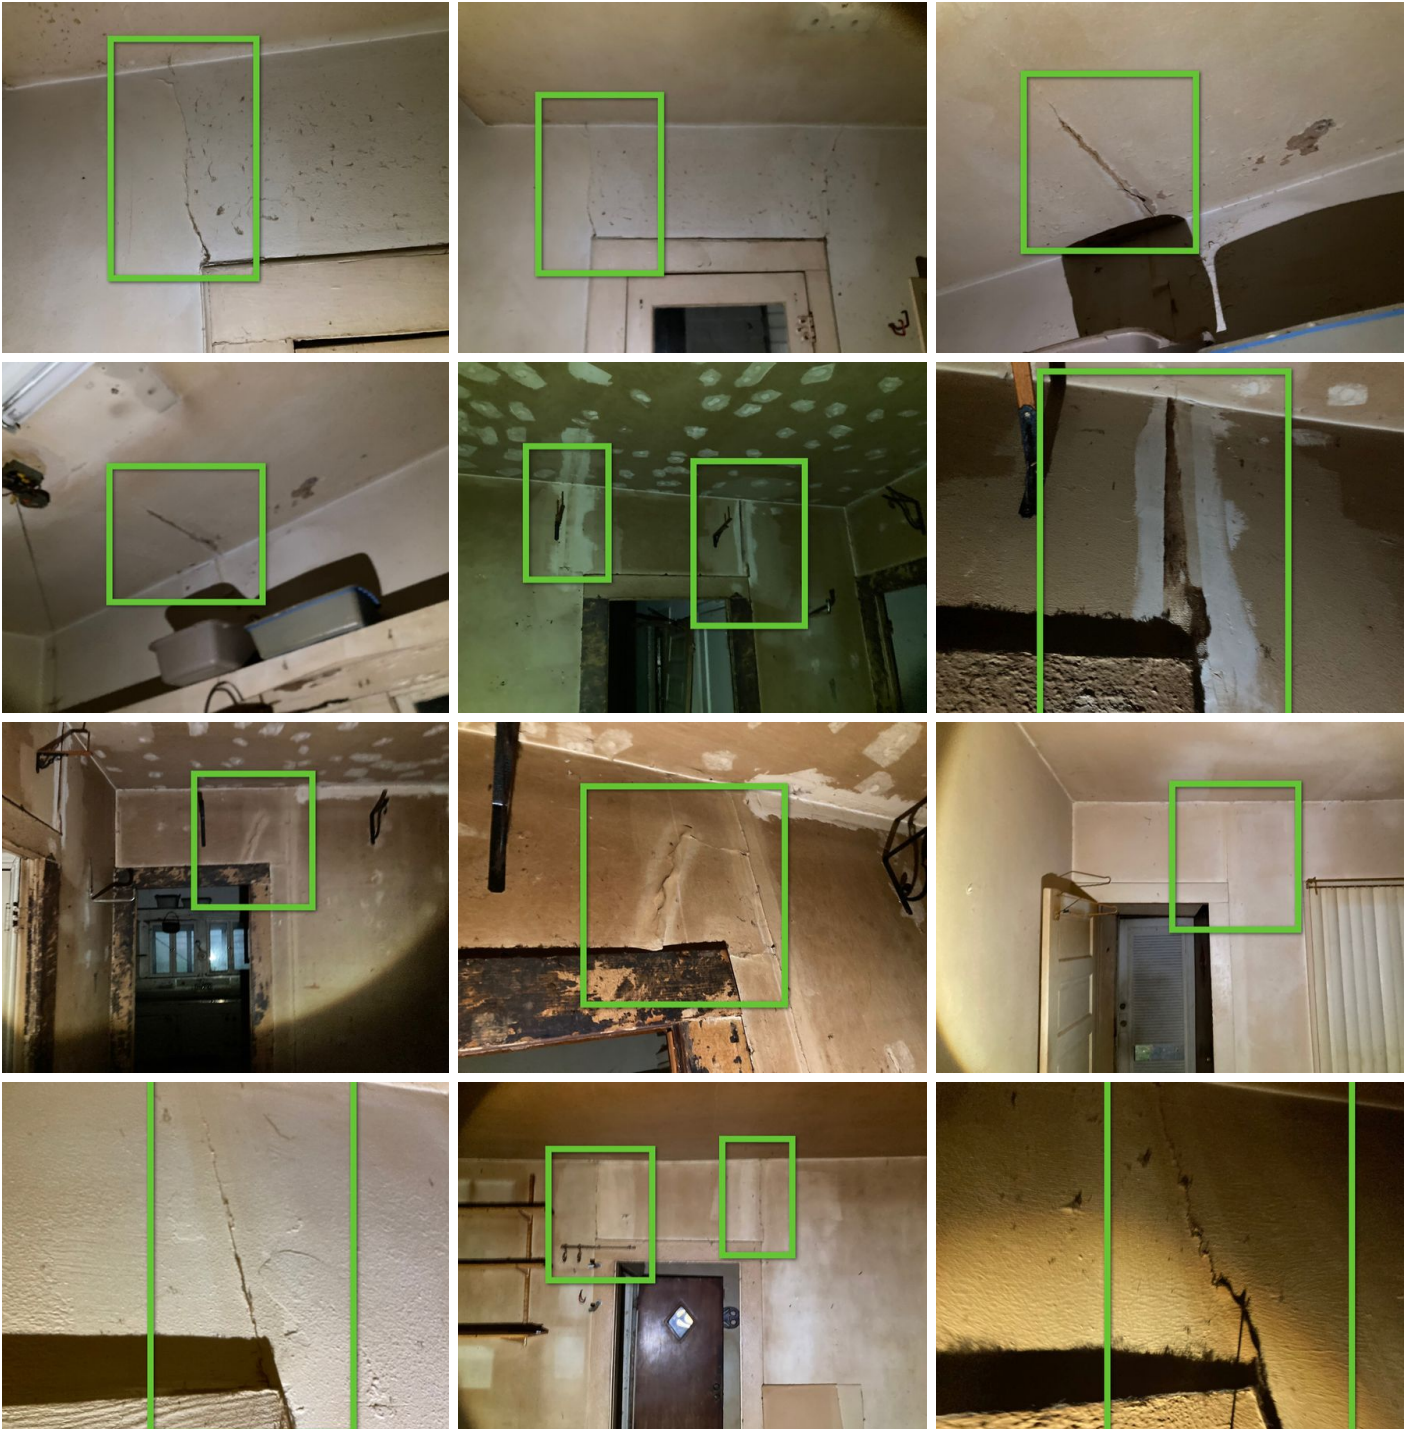
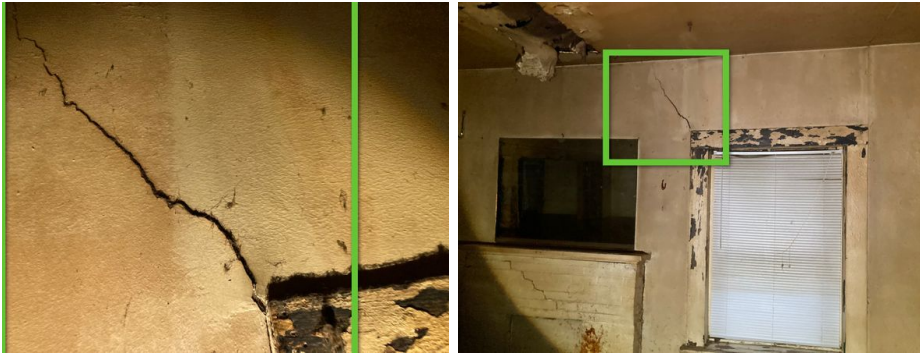
**Differential Movement: Sheetrock Cracks/Patches/Compression ridges**

Sheetrock cracks, patches, and/or compression ridges were observed in the house during the inspection, including at the specified locations.

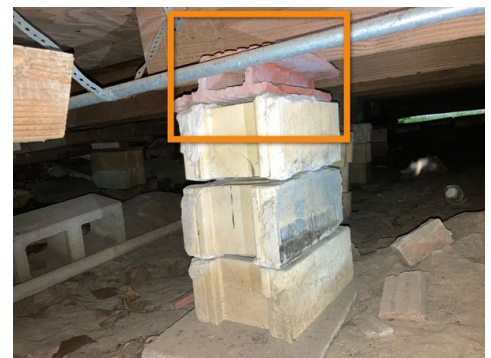
A piece of clack brick was used as a shim. Clay bricks are not suitable for this application and the brick should be replaced.

**Obtain Cost Estimate**

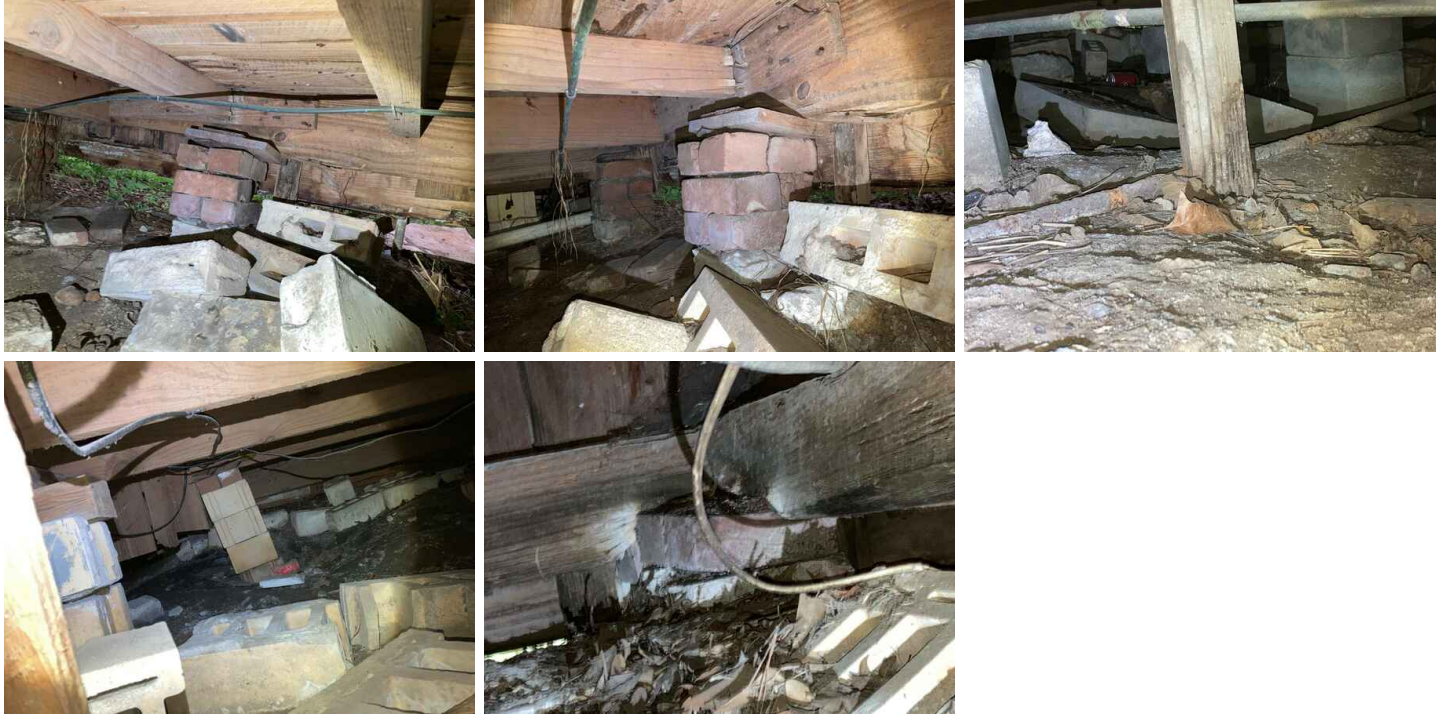
## 4.5.2 Crawlspace

**MISSING PIERS**

Missing piers were observed under the living room fireplace. Also, leaning piers were visible at several location. Some of the brick piers were eroded and in need of repairs. Some areas have wood piers that were rotted. Many repairs are needed at the piers under the house. Contact a foundation contractor to provide a cost estimate.

**Obtain Cost Estimate**

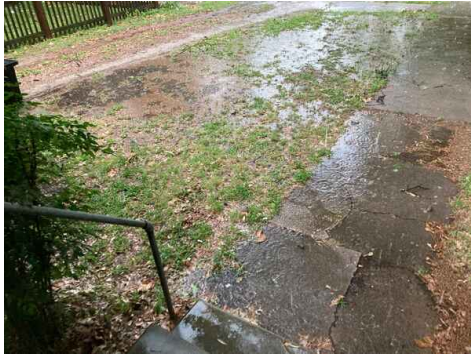
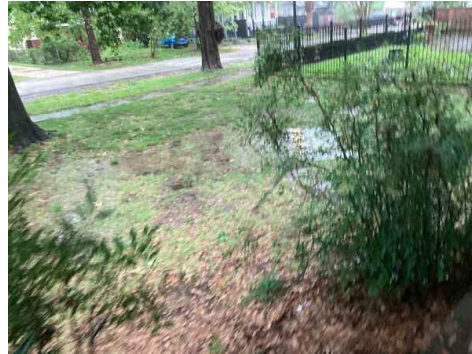
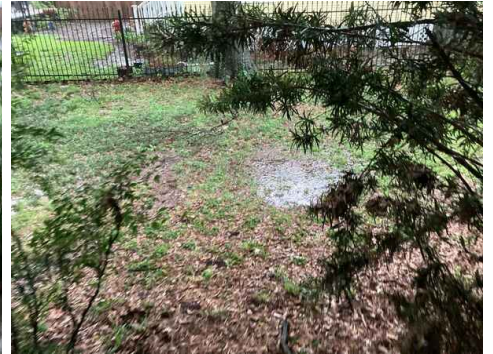
Water was observed to be ponding at some locations on the property. Have a service company specializing in drainage solutions provide a solution and cost estimate to eliminate the poor drainage conditions, as poor drainage can contribute to foundation movement.

**Obtain Cost Estimate**

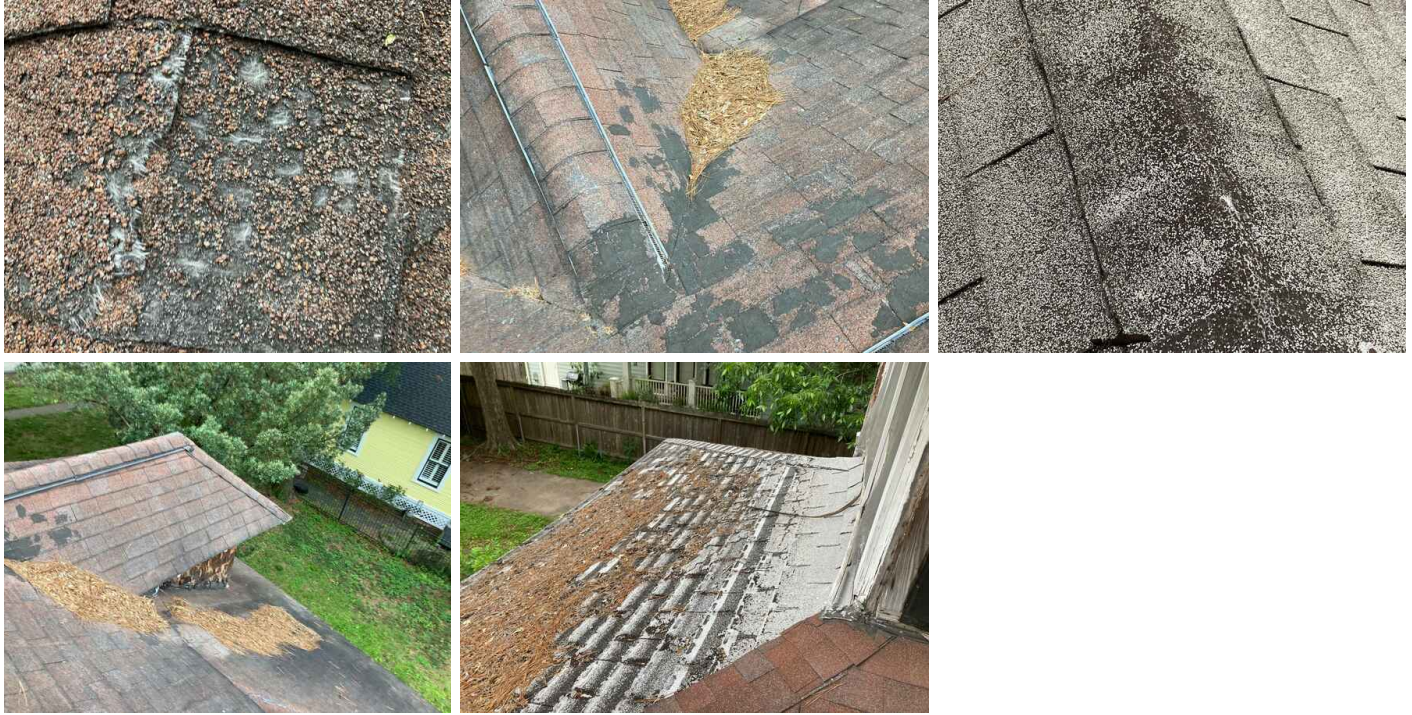
### Wear and Deterioration: Composition - Advanced

Discolored, Brittle, Excessive aggregate loss, Rusted Roof Jack, Cracked, Curling, Deteriorated Ridge Shingles, Patched, Roof decking rotted, Sealants deteriorated, Shingles Damaged

The composition roof surface was showing evidences of advanced deterioration of the roof surface as described above and shown below.

**ROOF NOT SERVICEABLE - REPLACE COMPOSITION**

After observing the age of the roof, the deteriorated condition of the majority of the shingles, and the evidences of roof leaks, it is my opinion that the roof is at the end of its normal, serviceable life, and replacement of the roof is needed at this time. It is recommended that a roofing contractor be contacted for a cost estimate to install a new roof.

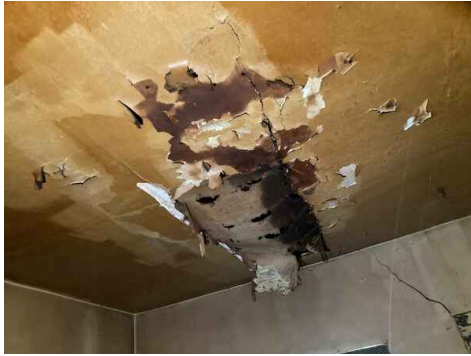
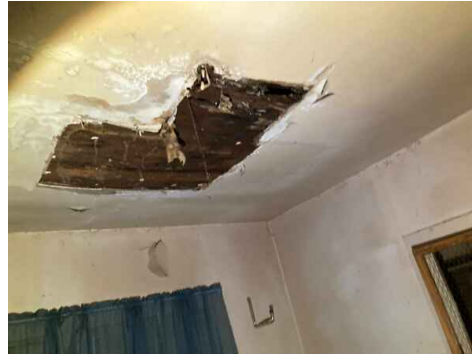
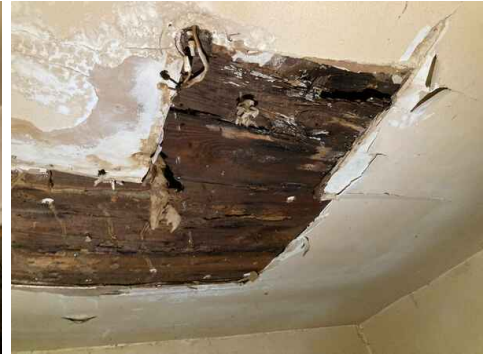
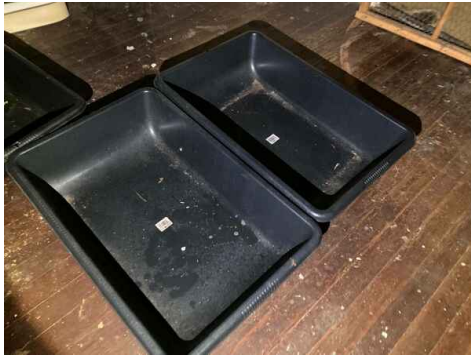
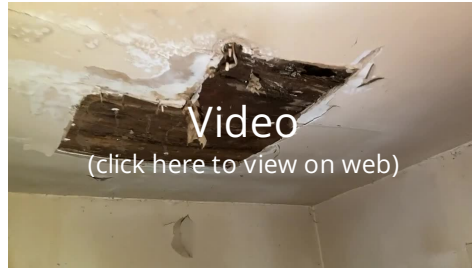
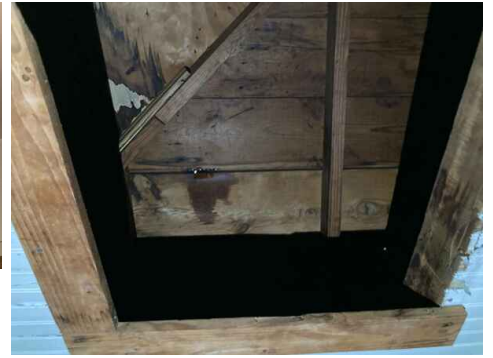
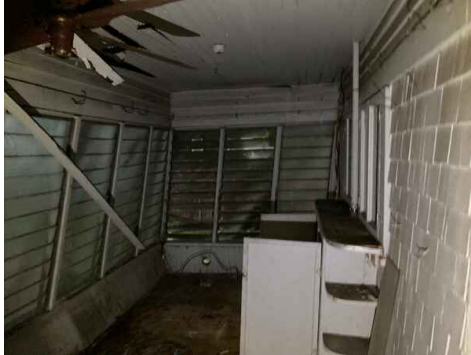
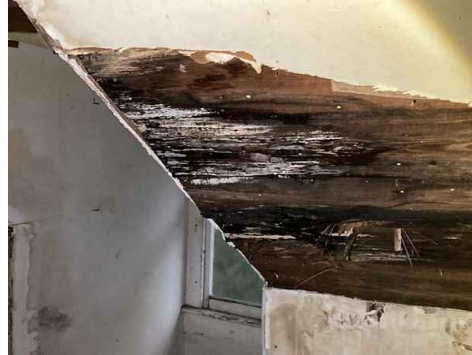
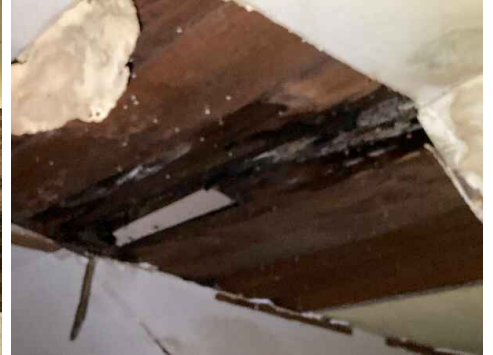
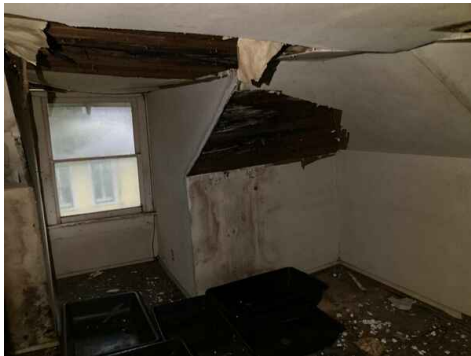
5.9.1 Roof Leaks

**SEVERAL LEAKS**

It was raining during the inspection and the roof was leaking severely at the back porch, bedroom and the second floor. It is pointed out that some areas were not safe to access due to the water damage on the framing due to the leaks.

**Obtain Cost Estimate**

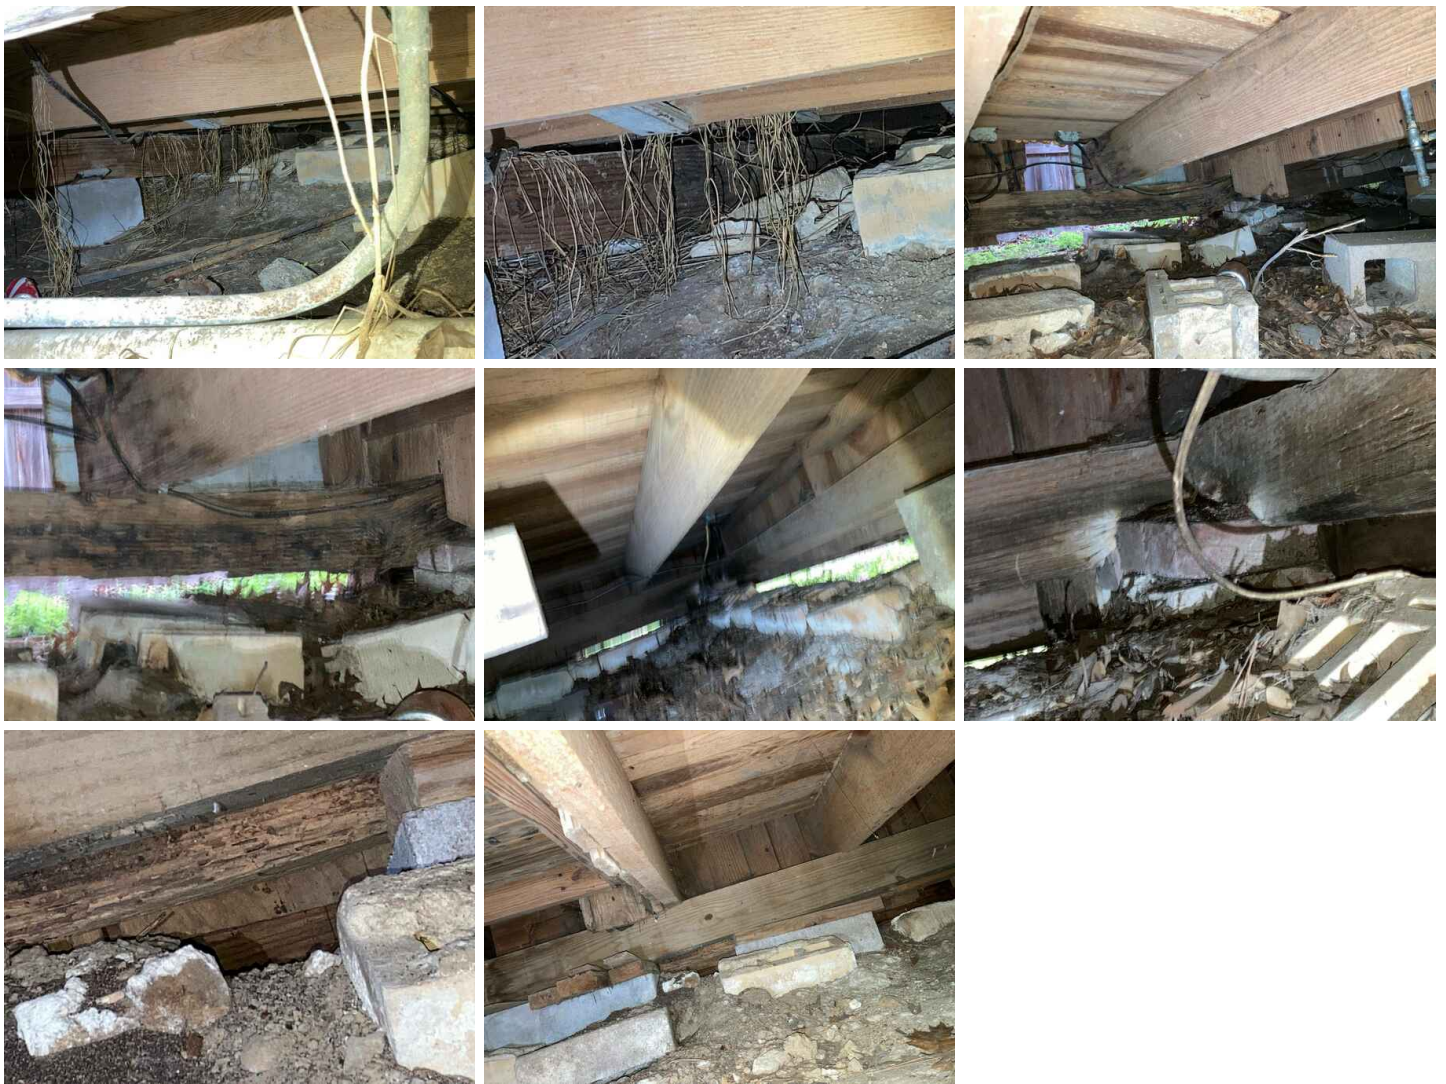
**FRAMING DAMAGED**

We observed framing members that were damaged and need to be replaced.

**Obtain Cost Estimate**

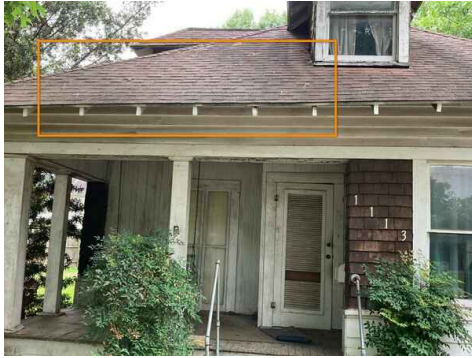
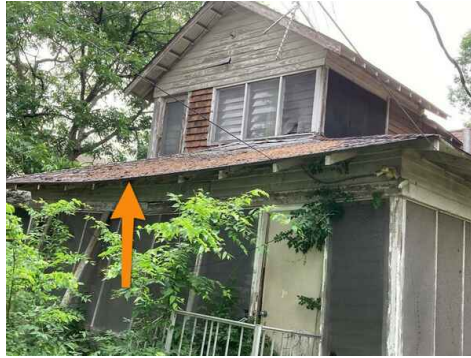
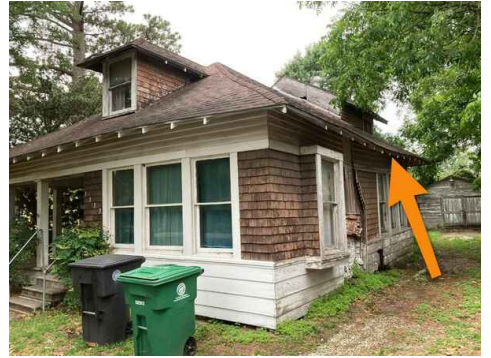
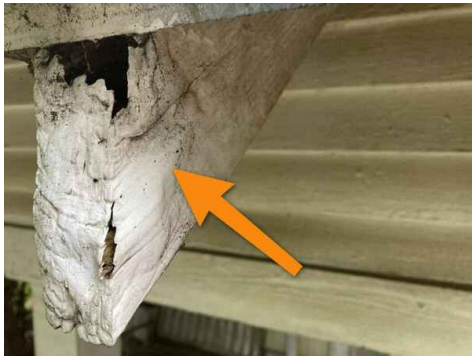
FRONT PORCH, REAR PORCH, NORTH SIDE OF THE HOUSE NEAR THE CHIMNEY.

The roof framing was deflecting at several locations. The majority of the deflected areas have rotted rafters, and damage from wood destroying insects.

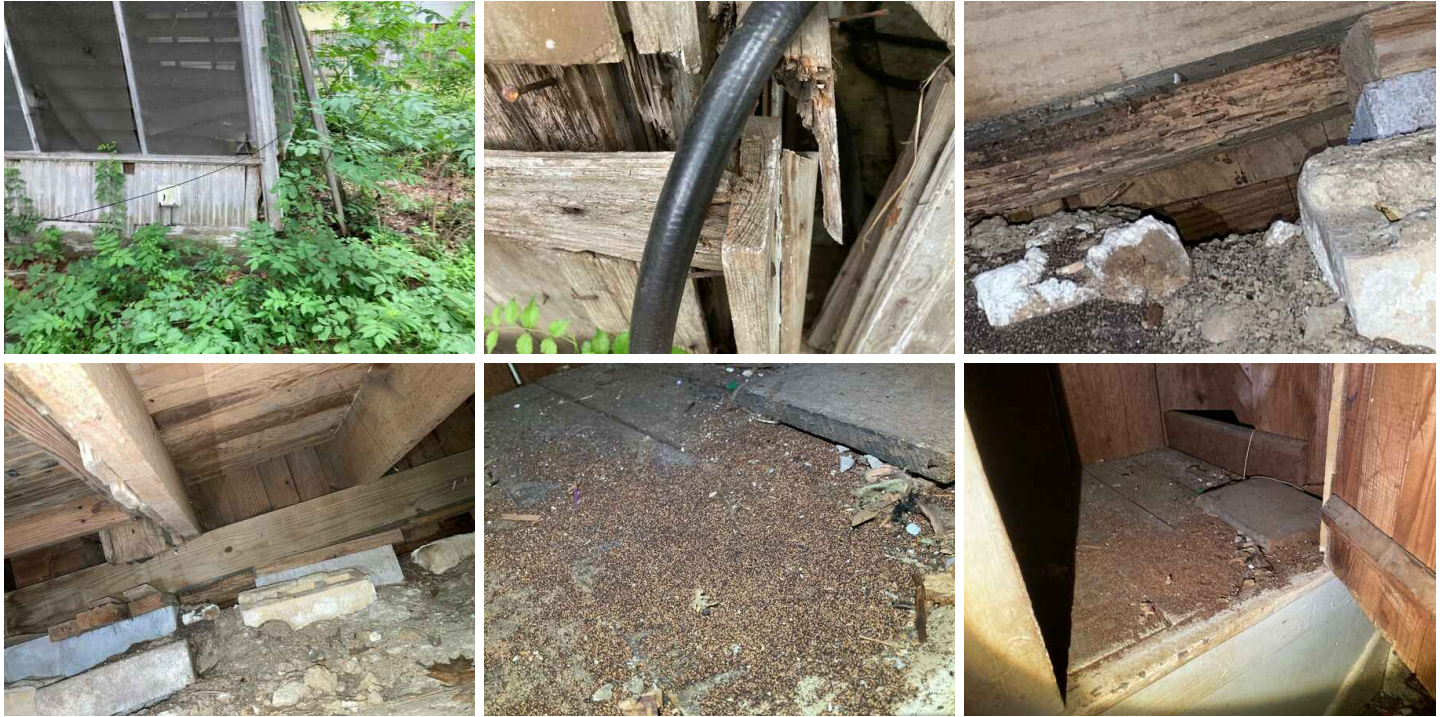
## 6.19.1 Wood Destroying Insect Damage

**CRAWLSPACE - REPAIR**

We observed damage from wood destroying insects to the framing members under the house at the crawlspace, exterior walls, and some of the roof rafters. The degree of the damage was significant enough to need repairs to the damaged framing members. Have a contractor provide a cost estimate to make all needed repairs.

**Obtain Cost Estimate**

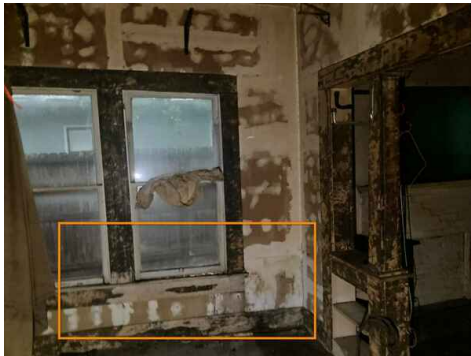
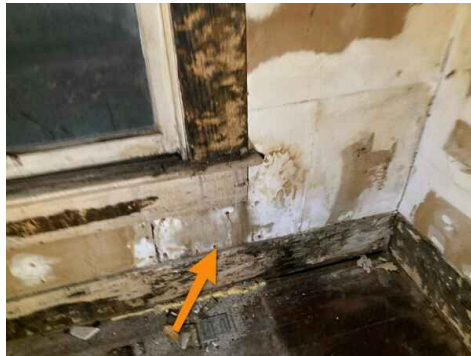
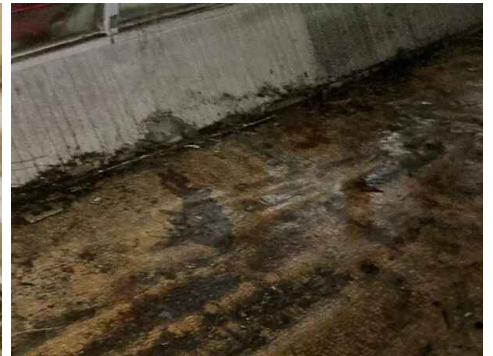
Back porch rear wall and floor

#### **WATER STAINS/WATER DAMAGE**

Evidences of water penetration to the interior of the structure were observed, including water stains/water damaged materials. Further investigation is recommended with service companies to determine the source(s) of the water penetration along with any secondary damages, and also to provide a cost estimate for any needed repairs.

**Obtain Cost Estimate**

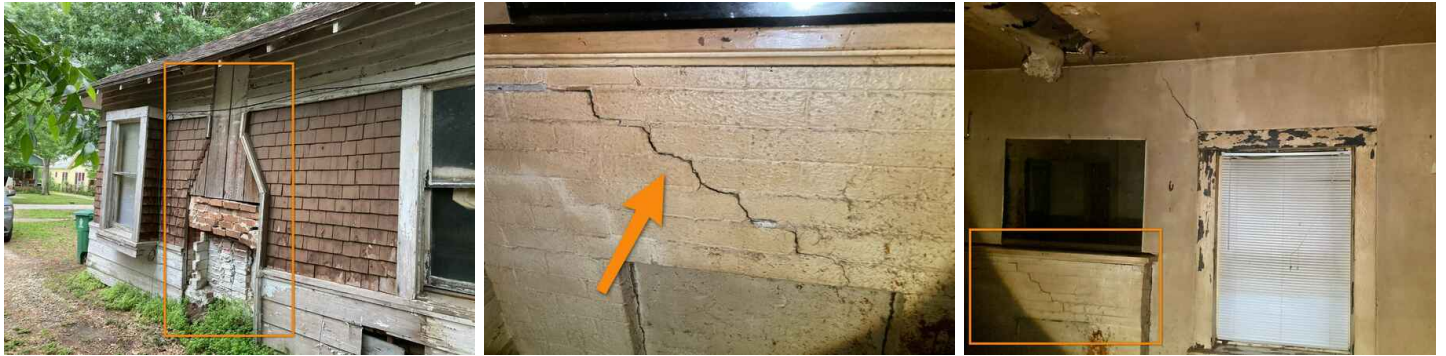
##### **MOCK FIREPLACE NO FLUE PIPE**

The fireplace was a mock fireplace. The fireplace was completely damaged. Further investigation with a contractor is recommended to provide a cost estimate to replace the fireplace.

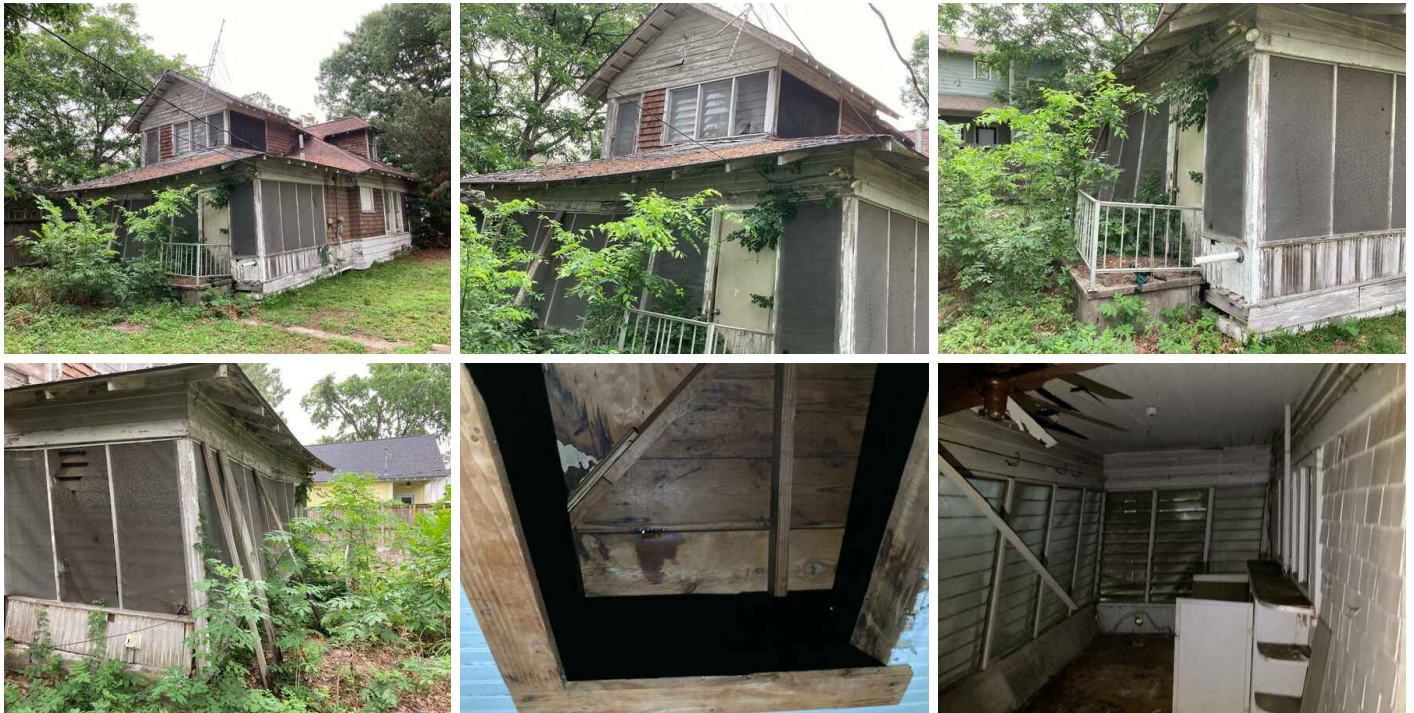
#### Attic Viewed From: Attic not Accessible-Obstructions

The attic back porch attic was not safe to access due to the rear porch falling apart. Due to the current condition the back porch attic was not entered.

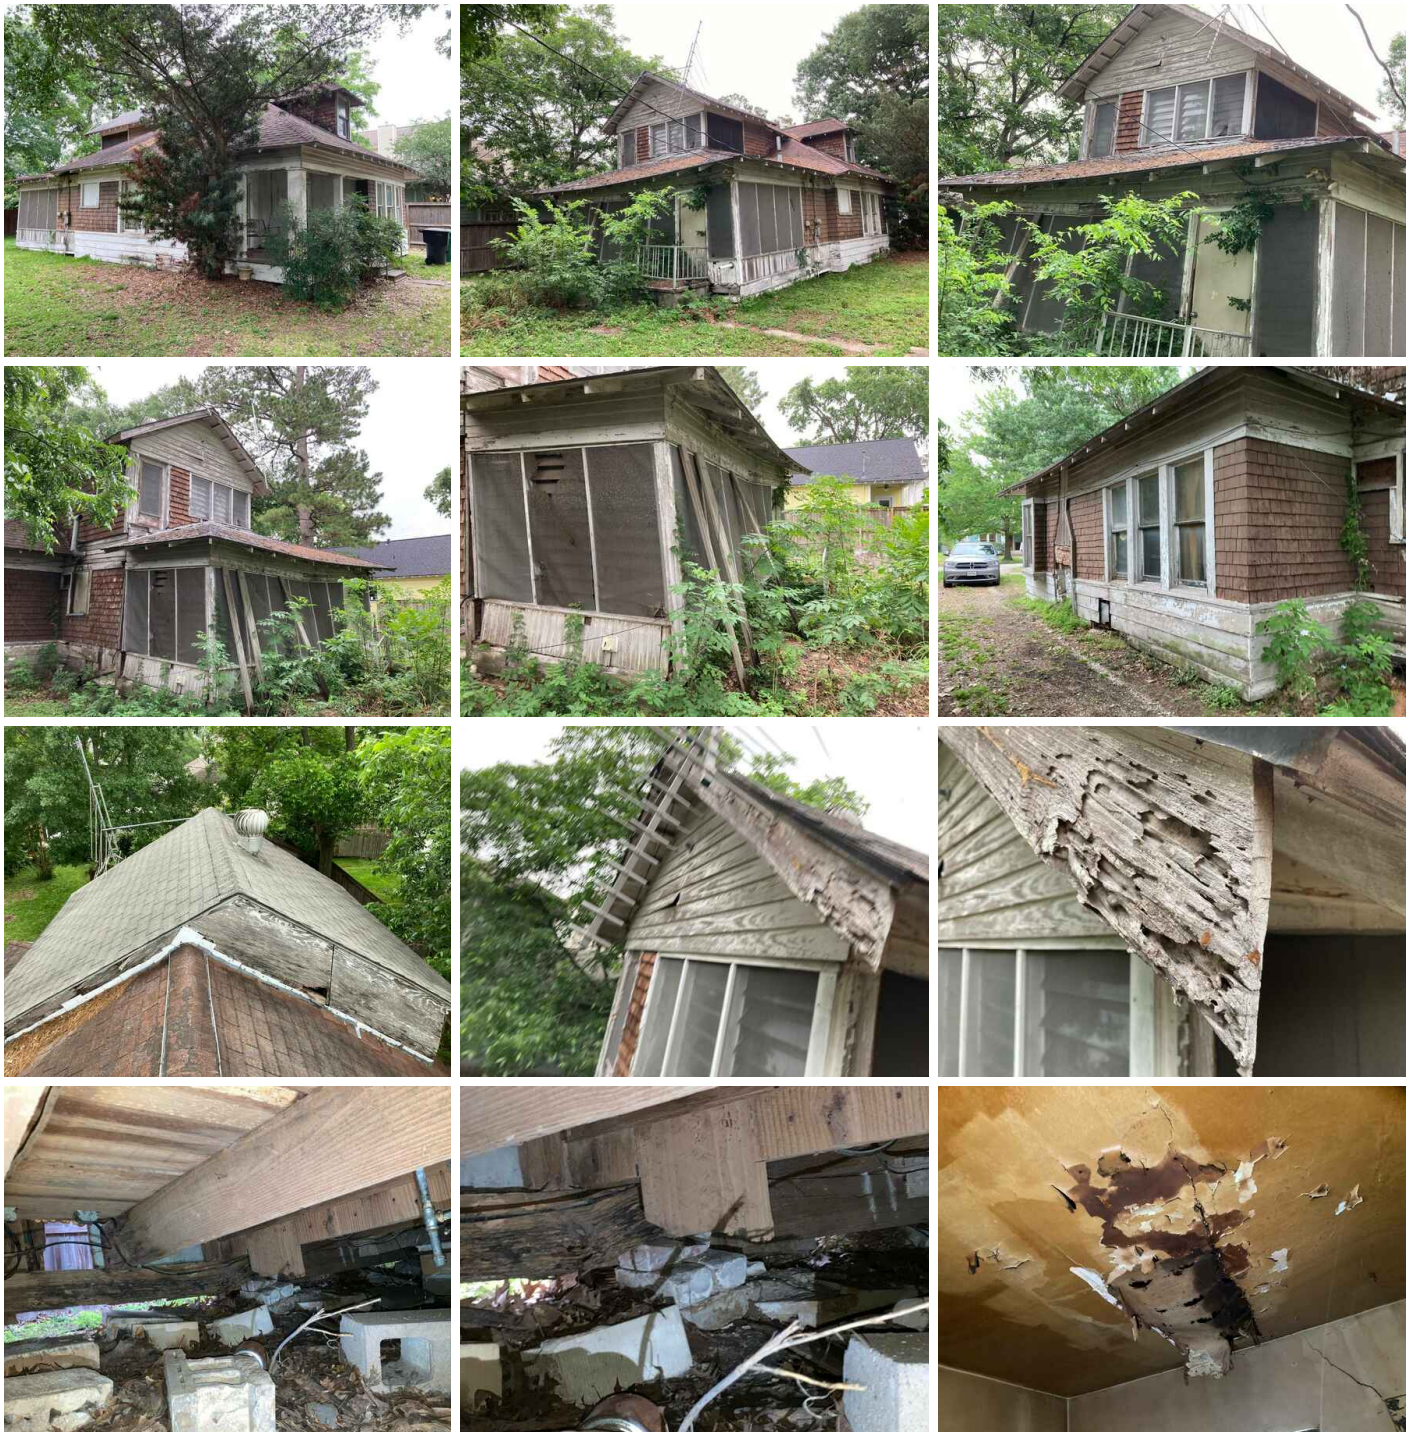
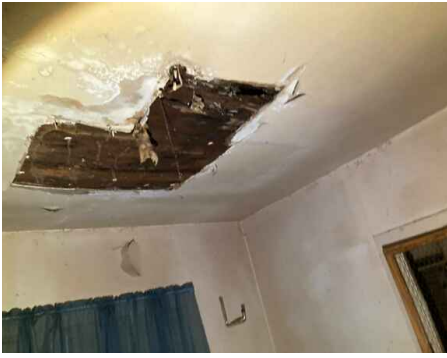
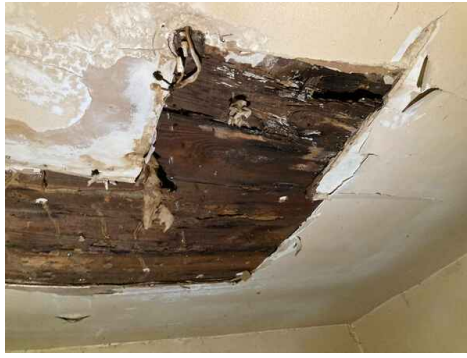
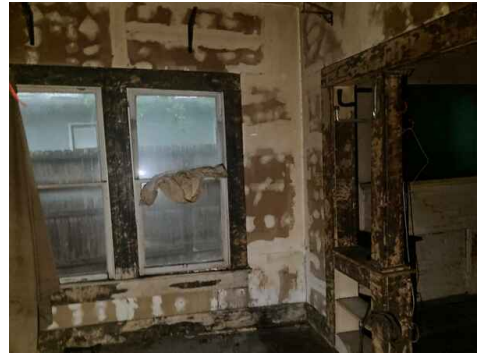
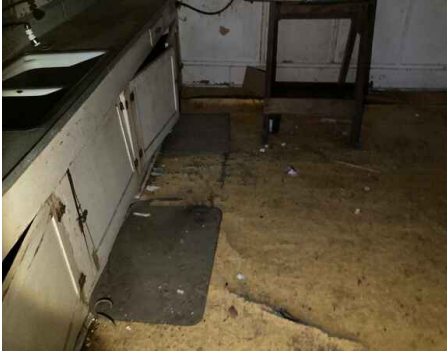
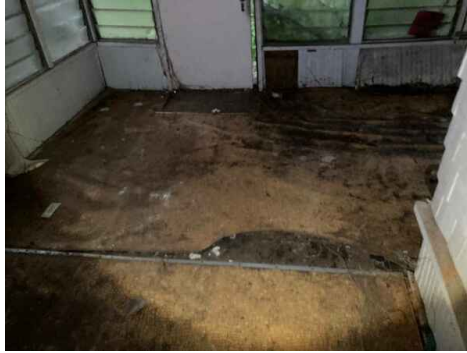
### House general evaluation

The house was in very poor condition, and, in our opinion, was in essentially tear down condition, with severe damage on beams under the house, water damage due to severe roof leaks, the walls being racked out of plumb, sagging framing members, rotted framing members, damage from wood destroying insects, and rotted roof deck. It is pointed out that the house it is not safe to inhabit in its current condition.
