CERTIFICATE OF APPROPRIATENESS

Property: 4104 Greeley St. Lot 5, Block 14, Lockhart Conner & Barziza

Proposal: Alteration – Work begun without a permit or a COA

Ram Residential Designs

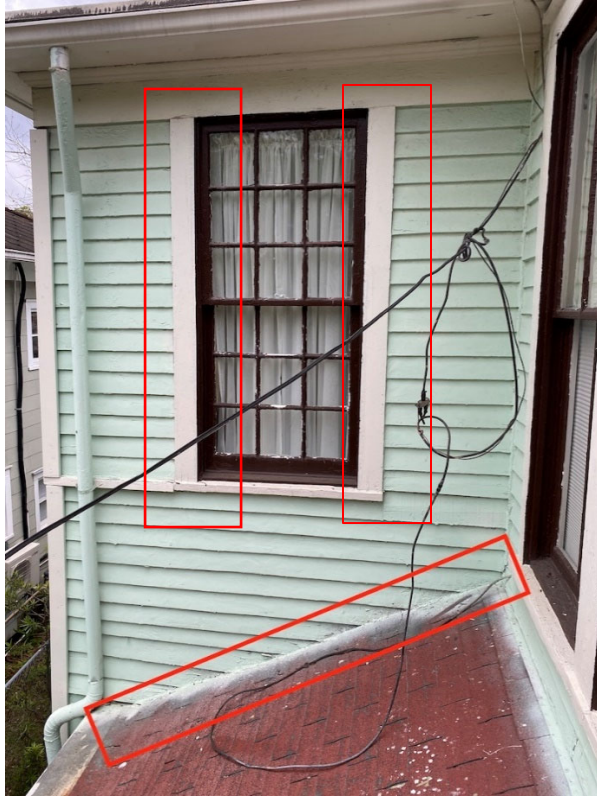
Front Elevation (left side)

The wood siding by the porch roof has been compromised by water damage due to the missing flashing. There is evidence of extensive mold build-up.

The area around the window trim and sill has extensive rotten wood due to water damage.

As we attempted to remove the siding, to maintain the integrity of the original wood, the nails were splitting the siding.

The good pieces of original wood will be kept in safe storage to splice back into the front elevation.

We proposed to splice in (Cedar Bevel Siding 5/8"x6"x16' or approved material) in the remaining areas.

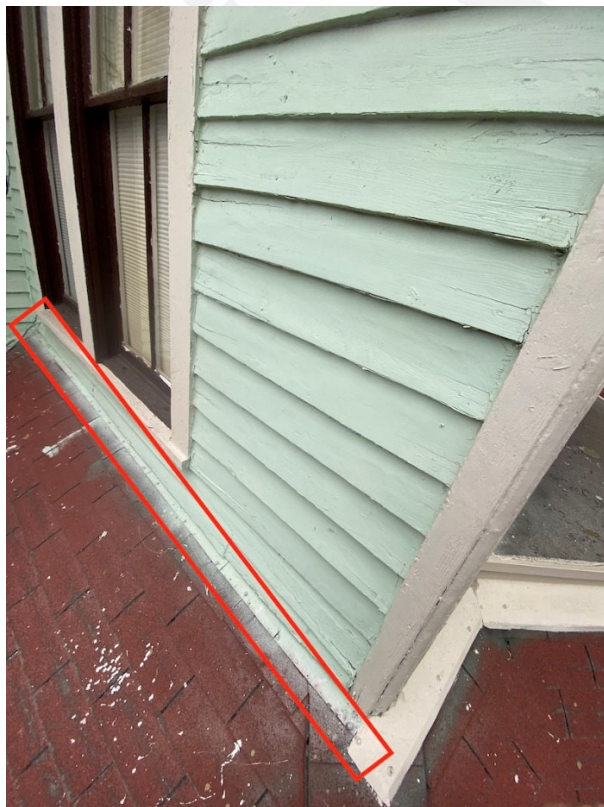
Left Elevation (front porch side)

The wood siding by the porch roof has been compromised by water damage due to the missing flashing. There is evidence of extensive mold build-up.

The area around the window trim and sill has extensive rotten wood due to water damage. Note the splitting by the nails.

As we attempted to remove the siding, to maintain the integrity of the original wood, the nails were splitting the siding.

The good pieces of original wood will be kept in safe storage to splice back into the front elevation.

We proposed to splice in (Cedar Bevel Siding 5/8"x6"x16' or approved material) in the remaining areas.

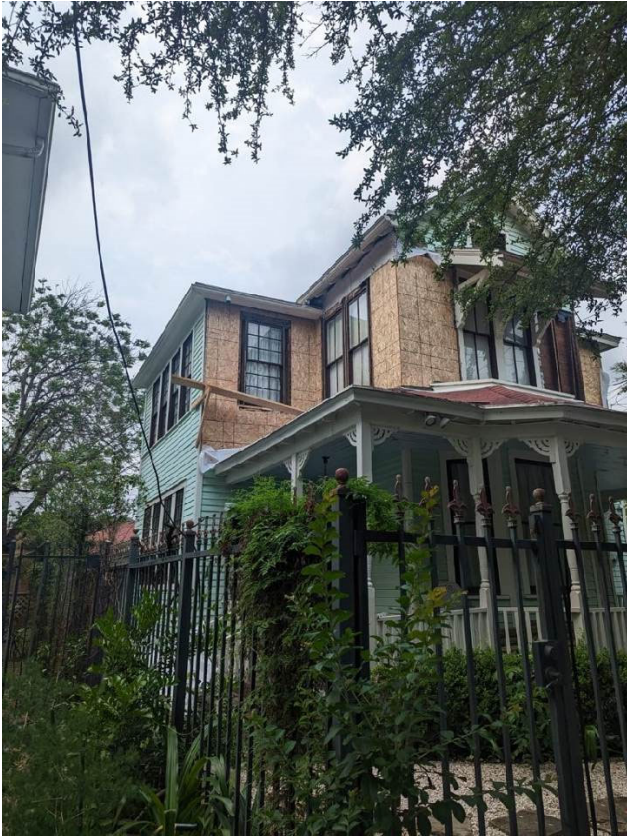
Front Elevation (left side)

As we attempted to remove the siding, to maintain the integrity of the original wood, the nails were splitting the siding.

The plywood shown in the image is to protect the home from the rain.

We proposed to use the wall section detail (Insulative Sheathing Detail) provided by the Preservation staff to finish the wall and maintain the air gap originally provided in these homes.

The good pieces of original wood will be kept in safe storage to splice back into the front elevation.

We proposed to splice in (Cedar Bevel Siding 5/8" x 6" x 16' or approved material) in the remaining areas.

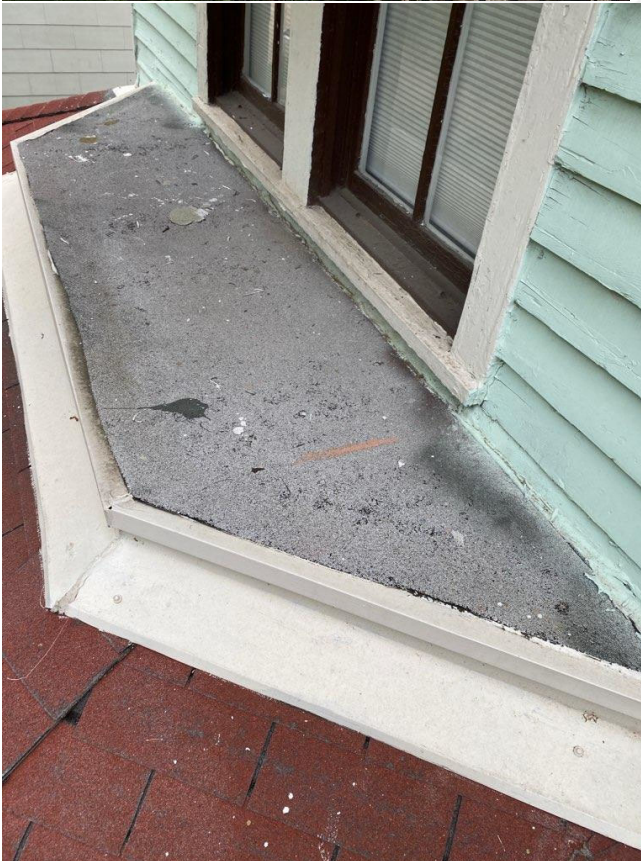
Front Elevation

The wood siding by the porch flat roof has been compromised by water damage due to the missing flashing. There is evidence of extensive mold build-up.

The area around the window trim and sill has extensive rotten wood due to water damage. Note the splitting by the nails.

As we attempted to remove the siding, to maintain the integrity of the original wood, the nails were splitting the siding in half.

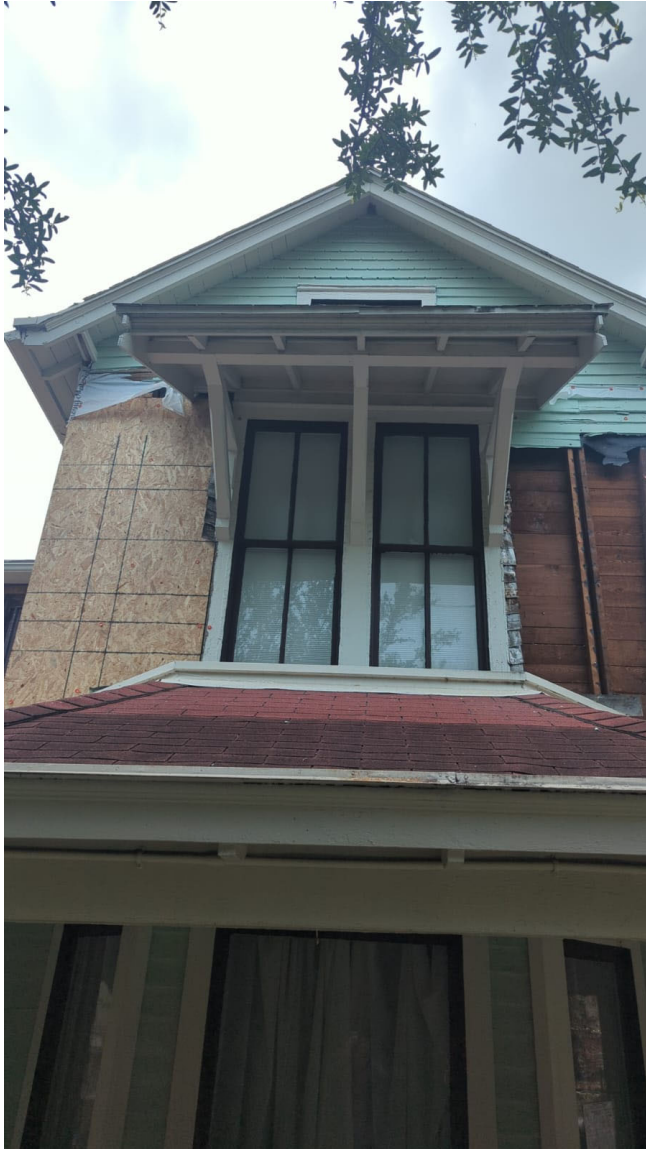
Front Elevation (left side)

As we attempted to remove the siding, to maintain the integrity of the original wood, the nails were splitting the siding.

The plywood shown in the image is to protect the home from the rain.

We proposed to use the wall section detail (Insulative Sheathing Detail) provided by the Preservation staff to finish the wall and maintain the air gap originally provided in these homes.

The good pieces of original wood will be kept in safe storage to splice back into the front elevation.

We proposed to splice in (Cedar Bevel Siding 5/8"x6"x16' or approved material) in the remaining areas.

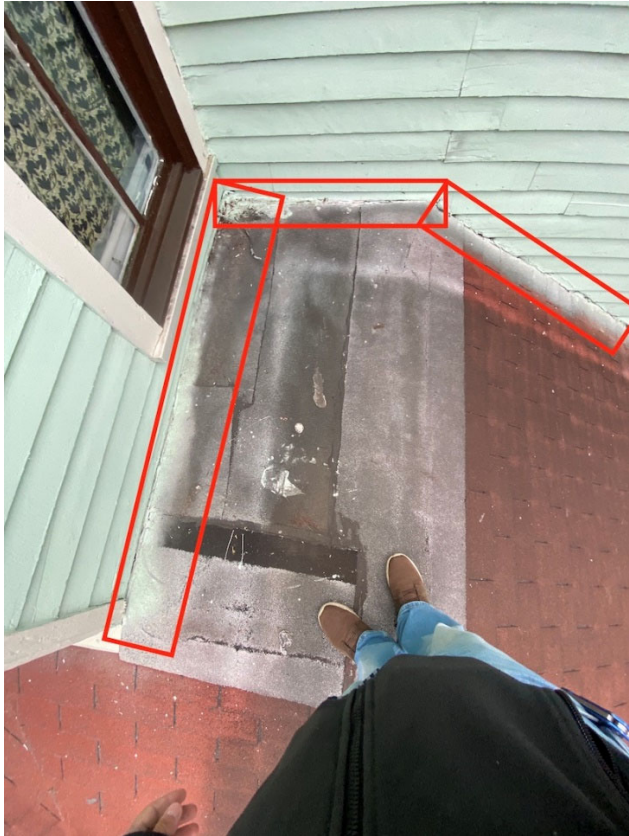
Front Elevation (right side)

The wood siding by the porch flat roof has been compromised by water damage due to the missing flashing. There is evidence of extensive mold build-up.

The area around the window trim and sill has extensive rotten wood due to water damage.

As we attempted to remove the siding, to maintain the integrity of the original wood, the nails were splitting the siding.

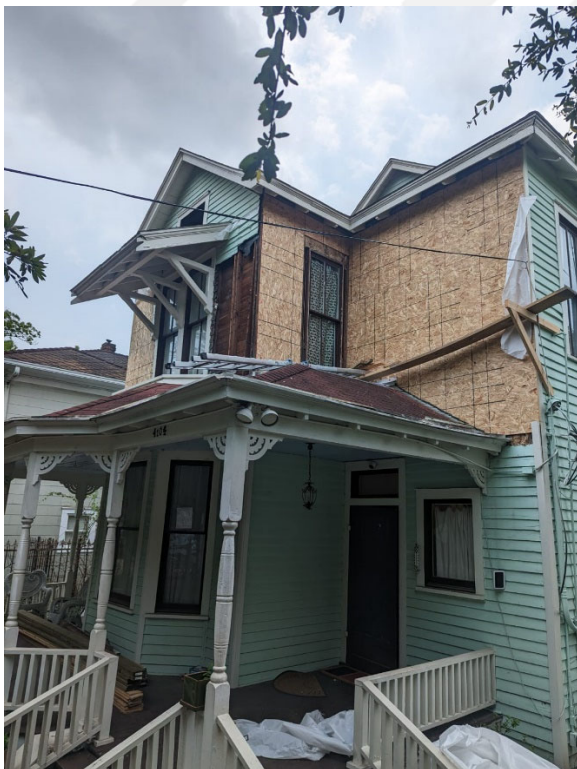
Front Elevation (left side)

As we attempted to remove the siding, to maintain the integrity of the original wood, the nails were splitting the siding.

The plywood shown in the image is to protect the home from the rain.

We proposed to use the wall section detail (Insulative Sheathing Detail) provided by the Preservation staff to finish the wall and maintain the air gap originally provided in these homes.

The good pieces of original wood will be kept in safe storage to splice back into the front elevation.

We proposed to splice in (Cedar Bevel Siding 5/8"x6"x16' or approved material) in the remaining areas.

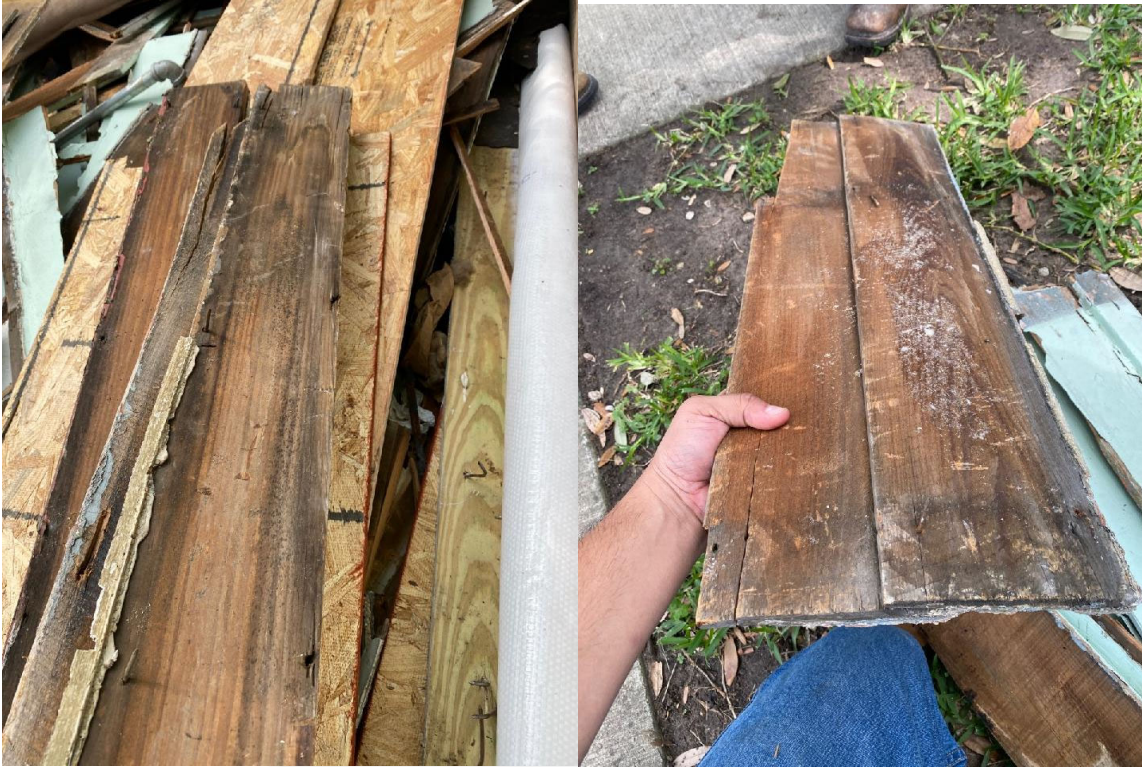
As we attempted to remove the siding, to maintain the integrity of the original wood, the nails were splitting the siding.

The good pieces of original wood will be kept in safe storage to splice back into the front elevation.

We proposed to splice in (Cedar Bevel Siding 5/8"x6"x16' or approved material) in the remaining areas.

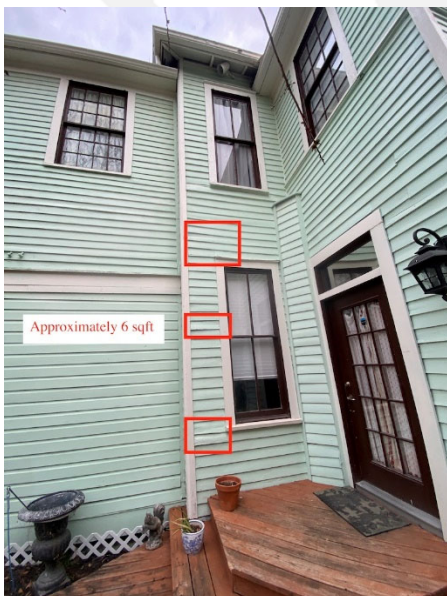
Left Elevation (rear)

The wood siding in the specified area has been compromised by water damage.

The area around the window trim and sill has extensive rotten wood due to water damage.

We proposed to remove non-original wood and replace (splice where required) with (Cedar Bevel Siding 5/8"x6"x16' or approved material).

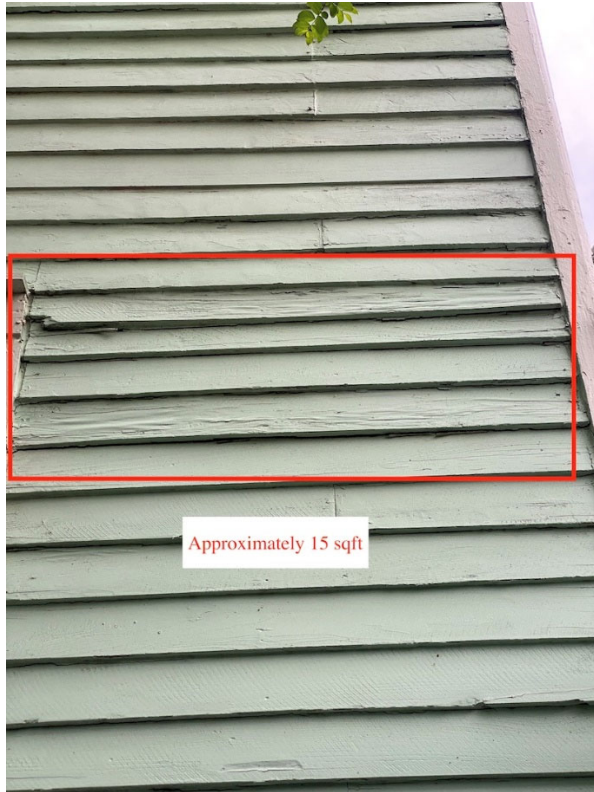
The wood siding in the specified area has been compromised by water damage.

The area around the window trim and sill has extensive rotten wood due to water damage.

We proposed to remove rotten wood and replace (splice where required) with (Cedar Bevel Siding 5/8"x6"x16' or approved material)

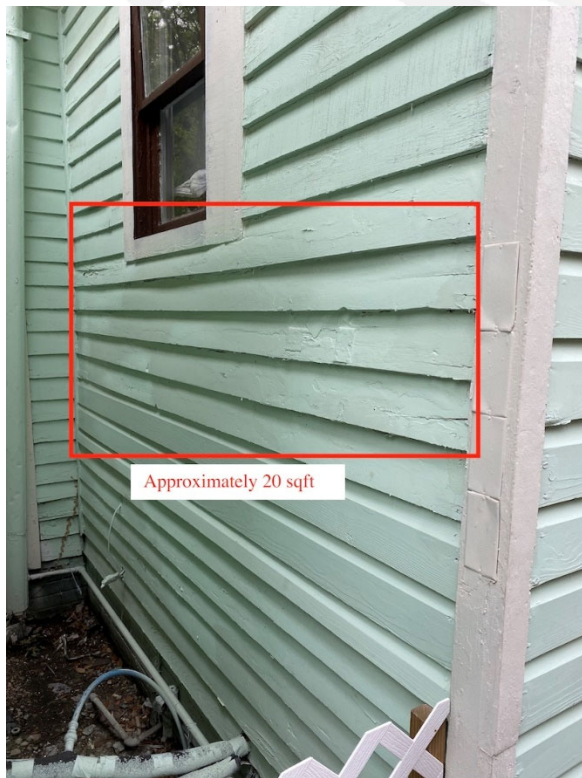
Rear Elevation

The wood siding in the specified area has been compromised by water damage.

The area around the window trim and sill has extensive rotten wood due to water damage.

We proposed to remove non-original wood and replace (splice where required) with (Cedar Bevel Siding 5/8"x6"x16' or approved material)

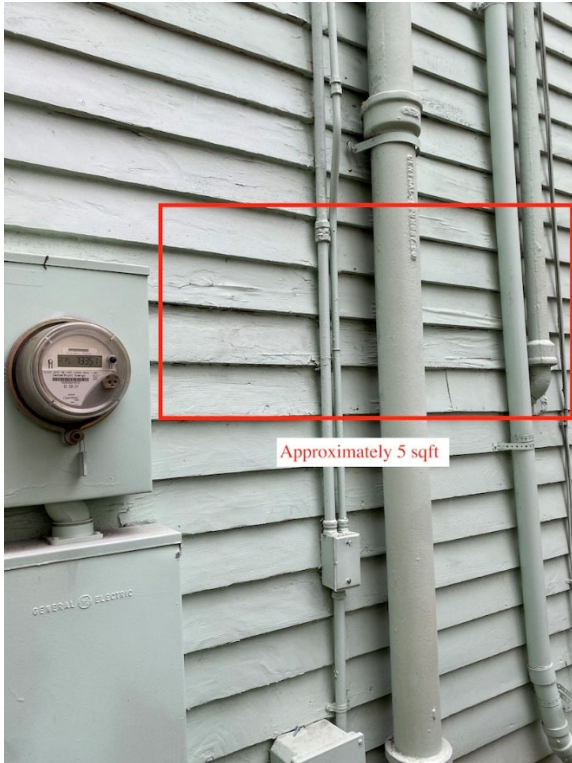
Rear Elevation (left side)

The wood siding in the specified area has been compromised by water damage.

We proposed to remove wood siding and replace (splice where required) with (Cedar Bevel Siding 5/8"x6"x16' or approved material)

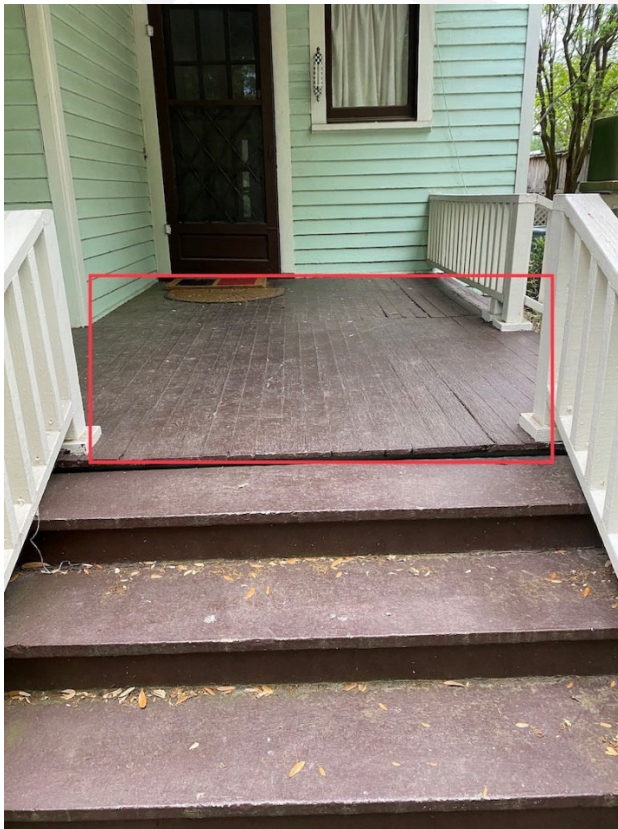
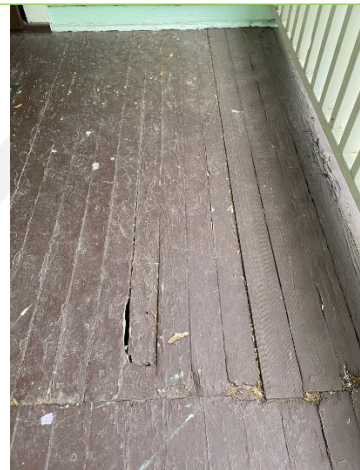
Front Porch

The wood siding in the specified area has been compromised by water damage.

We proposed to remove rotten wood deck and replace (treated pine with same dimensions) to match existing.

We proposed to repair any rotten framing as

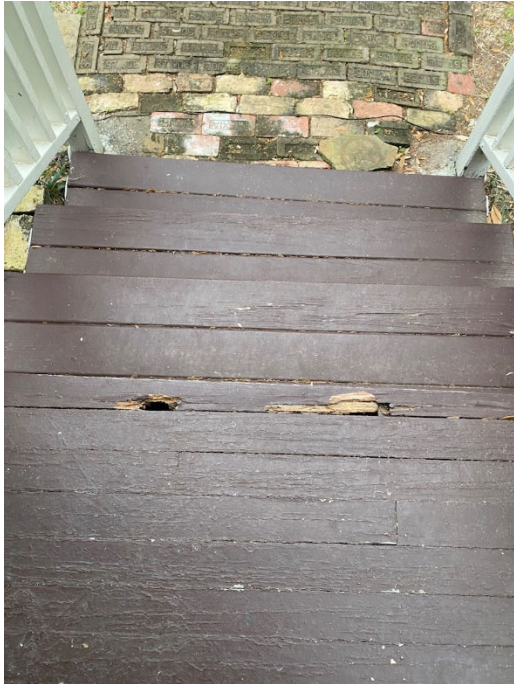
Front Porch Steps

The wood siding in the specified area has been compromised by water damage.

We proposed to remove rotten wood steps and replace, to match existing.

We proposed to repair any rotten framing as required.

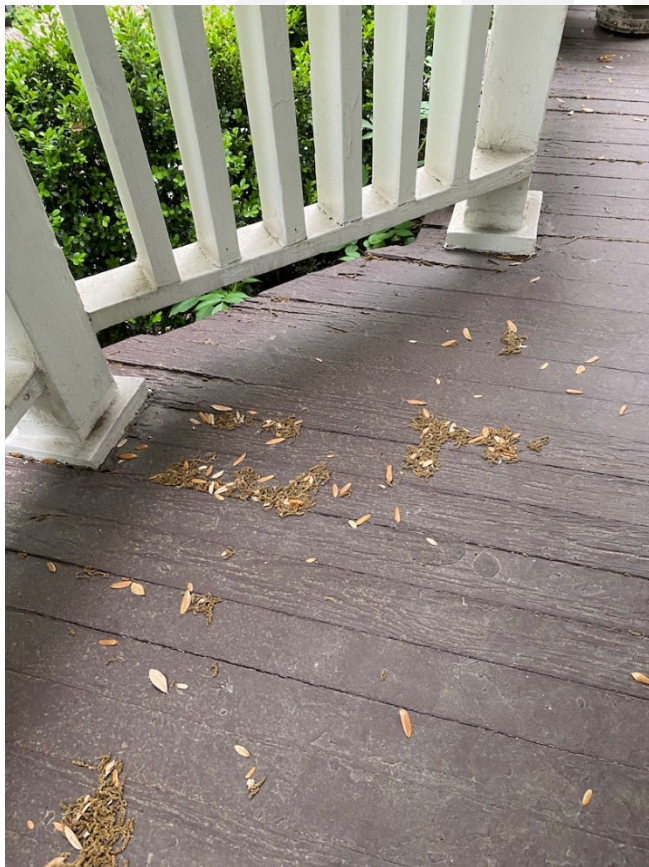
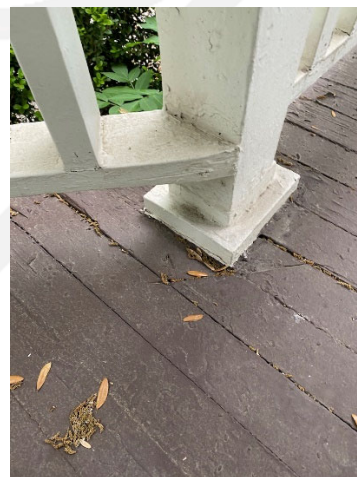
Front Porch Deck & Rail

The wood deck and rails in the specified area have been compromised by water damage.

We proposed to remove rotten decking, railing and replace to match existing.

We proposed to repair any rotten framing as required.

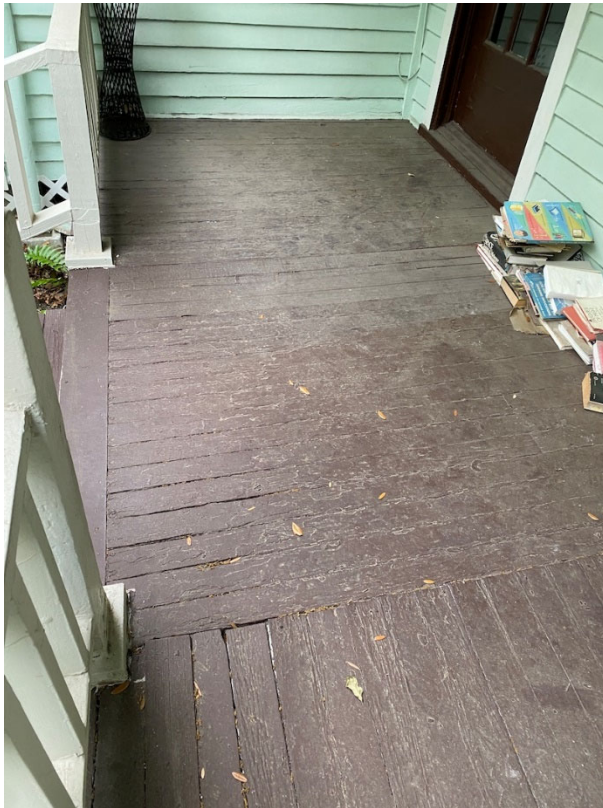
Front Porch Deck & Rail

The wood deck and rails in the specified area have been compromised by water damage.

We proposed to remove rotten decking, railing and replace to match existing.

We proposed to repair any rotten framing as required.

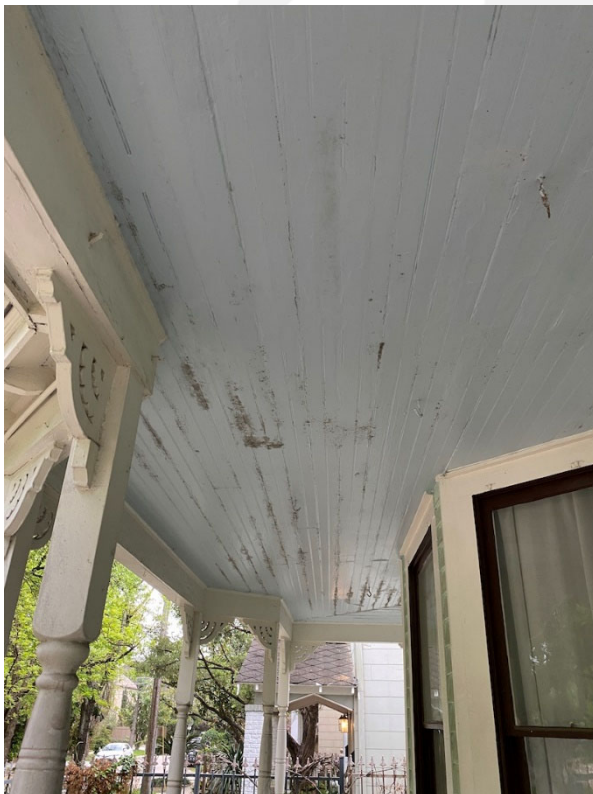
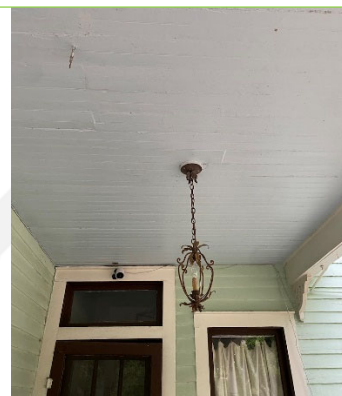
Front Porch Ceiling

The wood ceiling and in the specified area have been compromised by water damage and shows evidence to molding.

We proposed to remove material and replace to match existing.

We proposed to repair any rotten framing as required.

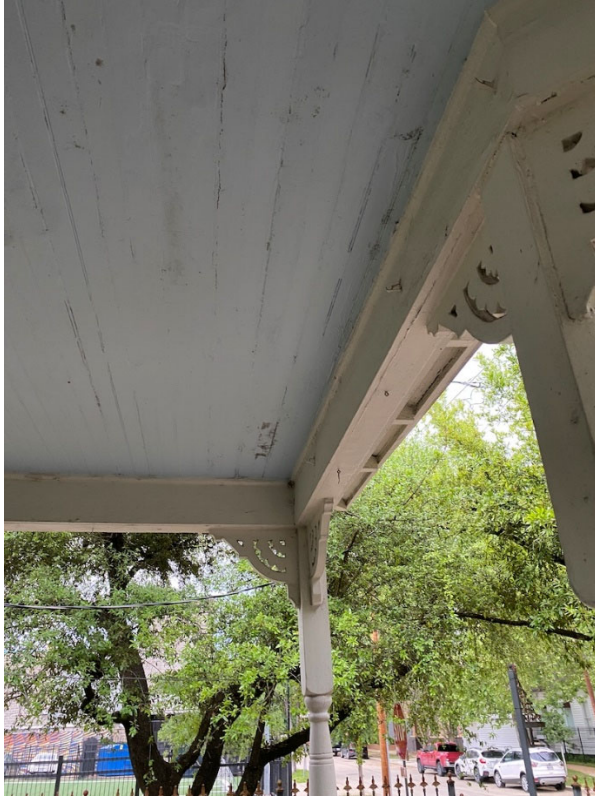
Front Porch Ceiling

The wood ceiling and in the specified area has been compromised by water damage and shows evidence of molding.

We proposed to remove material and replace to match existing.

We proposed to repair any rotten framing as required.
