# CERTIFICATE OF APPROPRIATENESS

ITEM XXX  
HPO File #: HP2026\_0206

914 Main St  
Landmark:

RE: North Elevation Façade Repair Program – Supplemental Letter (Completed Stabilization Inspections)  
Commerce Towers  
914 Main Street  
Houston, Texas 77002  
K&H Project No. 11393.5001R

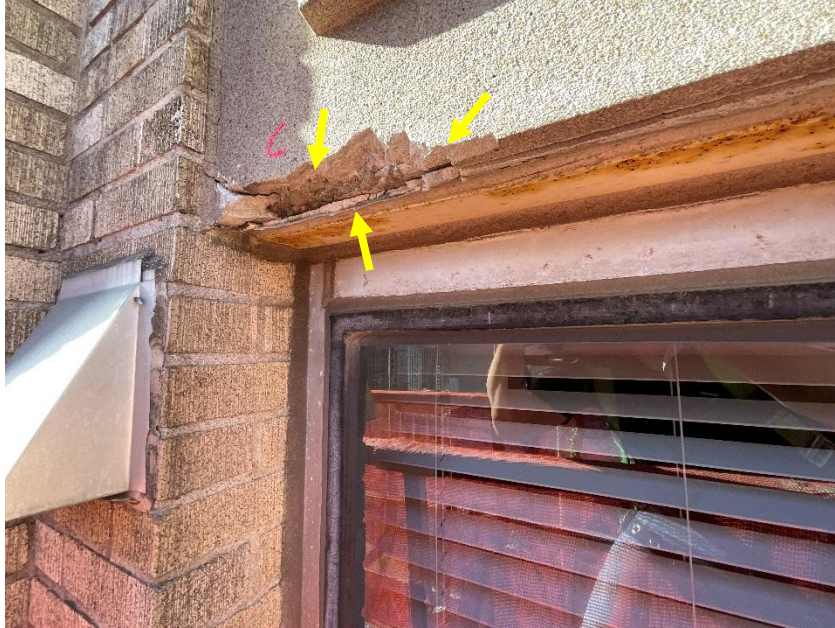
1. Isolated spalls primarily located at the lower/first course of cast stone units, the units which bear on the steel shelf angle, were observed (Photo Nos. 1 – 2). This is consistent with the findings from the prior reports. The lower/first course of cast stones contain significantly more deterioration compared to the second course because of the corrosion at the shelf angle and lateral ties.

- a. Consistent with prior findings, the 12<sup>th</sup> floor spandrels contained significant deterioration at both the north and east elevations at nearly every spandrel location.

**Photo No. 1.** View of spalled cast stone spandrel units.

1. **Option 1:** At 100% of the cast stone spandrels, replace the lower three (3) cast stone units across the base of the spandrel and rehabilitate the shelf angle. The two (2) upper cast stone spandrel units will be pinned, stabilized, repaired as necessary, and remain in place. The shelf angle will be cleaned and painted with a rust inhibitive coating and new flashing system installed.

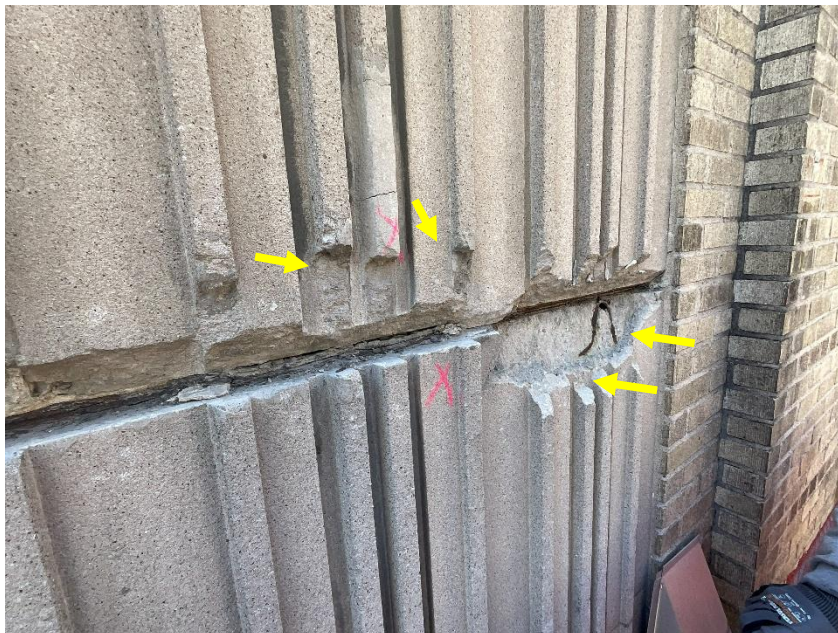
**Photo No. 2.** View of spalled cast stone unit with exposed reinforcing steel.

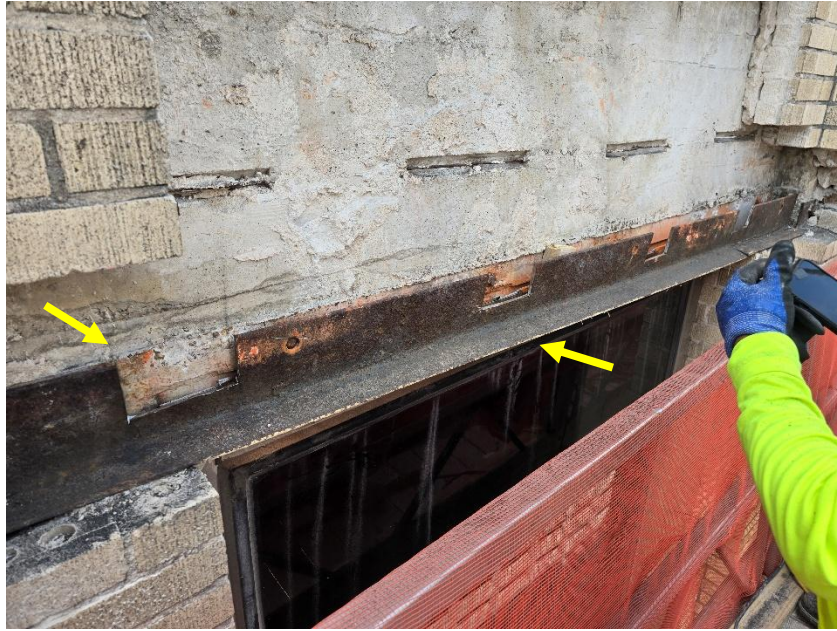
2. The existing anchors were found to be in good condition and spaced at eighteen inches (18") on center, in accordance with the original drawings. The concrete beam which supports the shelf angle was also found to be in good condition, with no significant signs of deterioration or spalling (Photo No. 3).

3. For the spandrel trial repairs, the original intent was to replace the existing steel shelf angle; however, removal of the existing shelf angle proved to be difficult, as the shelf angle was found to have concealed welds to the secondary support angle behind the primary shelf angle. The primary shelf angle supports the cast stone spandrel units and the secondary angle supports the window head anchorage. Because these welds were hidden behind the vertical leg of the primary shelf angle, it was extremely difficult and time consuming for Western to remove. To remove these welds, Western had to cut out slots in the shelf angle without damaging the secondary support angle behind (Photo Nos. 3 – 4).

**Photo No. 3.** View of primary shelf angle removal in progress at cast stone spandrel. Slots in the vertical leg were cut to access the concealed weld at the vertical leg of the secondary angle behind. The concrete beam behind the shelf angle was found to be in good condition.

4. Given that our structural analysis found the existing shelf angles to be adequate, our recommendation is to leave as many in place as possible, unless there is substantial deflection or section loss. Because the shelf angles will remain in place, the goal will be to provide substantial protection to the existing steel to minimize the potential for future corrosion.

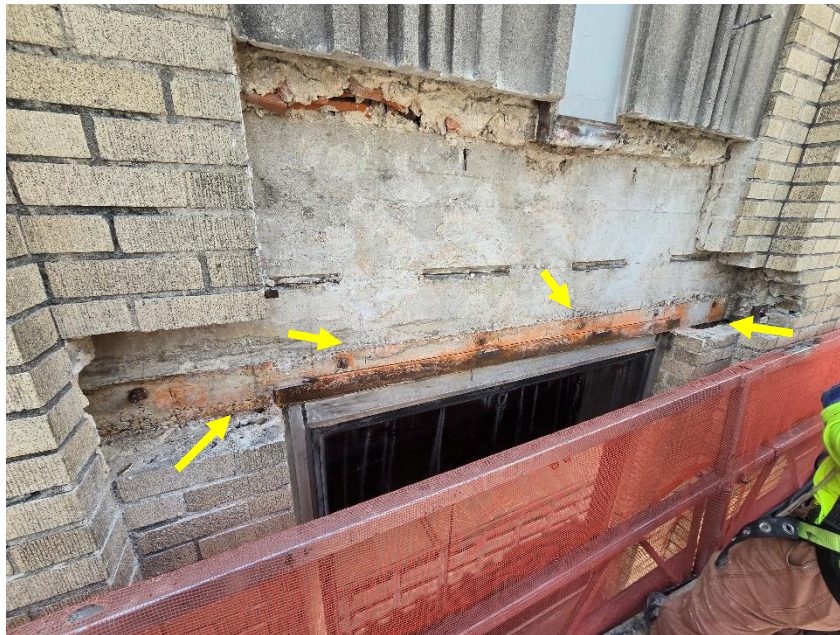
**Photo No. 4.** View of removed shelf angle at cast stone spandrel with cut anchors and exposed secondary angle at the window head.

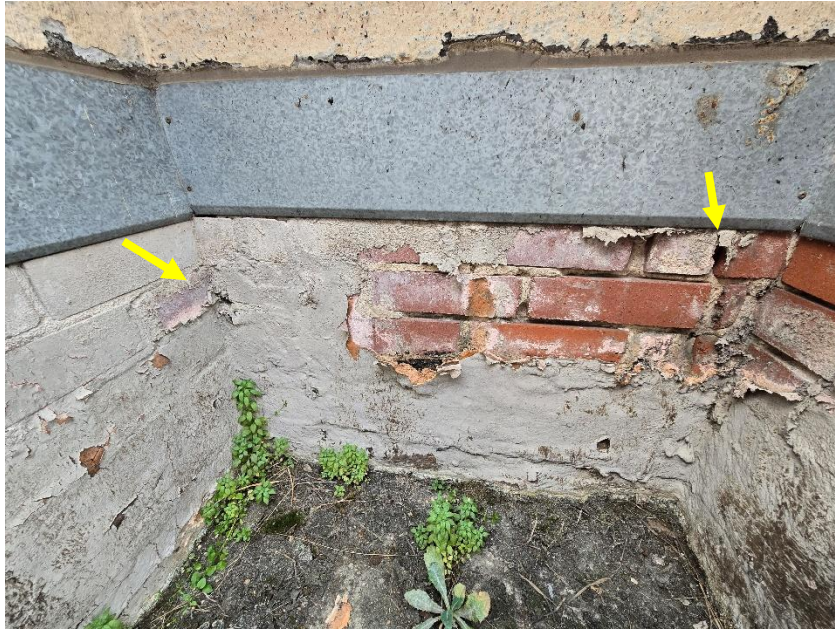
1. The parapet wall across the north facade of the building contained significant deterioration to the inboard/roof-facing masonry wythe, with extensively washed-out mortar joints (Photo Nos. 5 – 6). The outboard/street-facing limestone copings and piers of the parapet wall appeared to be in better condition comparatively, but did have weathered and open mortar joints as well as isolated outwardly displaced limestone units.
2. One (1) inspection opening was performed at the inboard masonry wythe to better understand the condition of the masonry wythes behind the outer wythe. We found that the inboard/roof-facing brick masonry wythe is the only brick wythe before the limestone units. Additionally, although the mortar joints are heavily eroded, the remaining mortar was solid and well bonded.

**Photo No. 5.** View of inboard side of the masonry parapet with eroded mortar joints and peeling coating.

3. Because of these findings, in lieu of rebuilding the parapet walls, the inboard masonry wythe should be repointed 100% with isolated rebuilding of the parapet, as necessary. Isolated displaced limestone units should be removed and reset. This will result in significant cost savings.

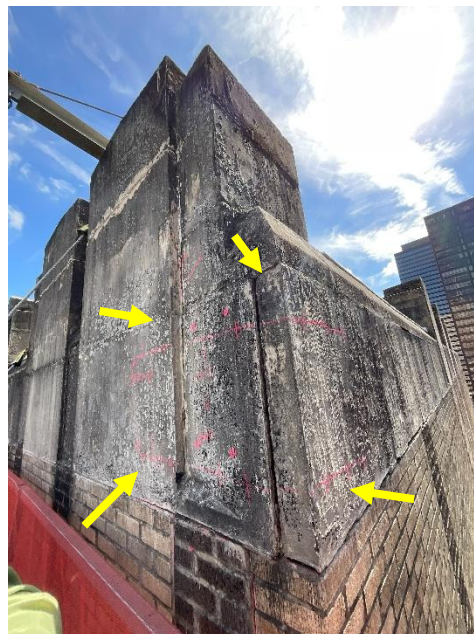
**Photo No. 6.** View of parapet limestone units designated for stabilization. Isolated rebuild at this section is recommended during a repair program.

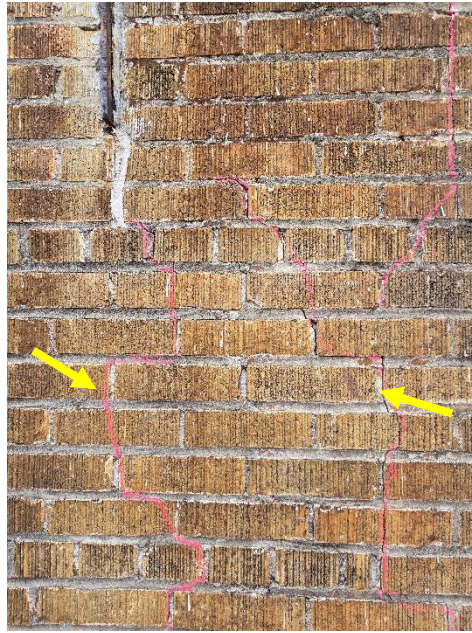
1. Isolated spalled brick and cracked brick masonry units were observed typically at the masonry piers immediately adjacent to the shelf angles, embedded steel elements, or window sills (Photo Nos. 7 – 8). Spalled and loose brick were removed and sealed. Individual spalled/cracked brick should be replaced and larger areas or spalled/cracked masonry are recommended to be rebuilt.

**Photo No. 7.** View of step cracks in brick masonry designated to be sealed. The cracking appears to stem from the embedded steel near the upper left corner of the image.

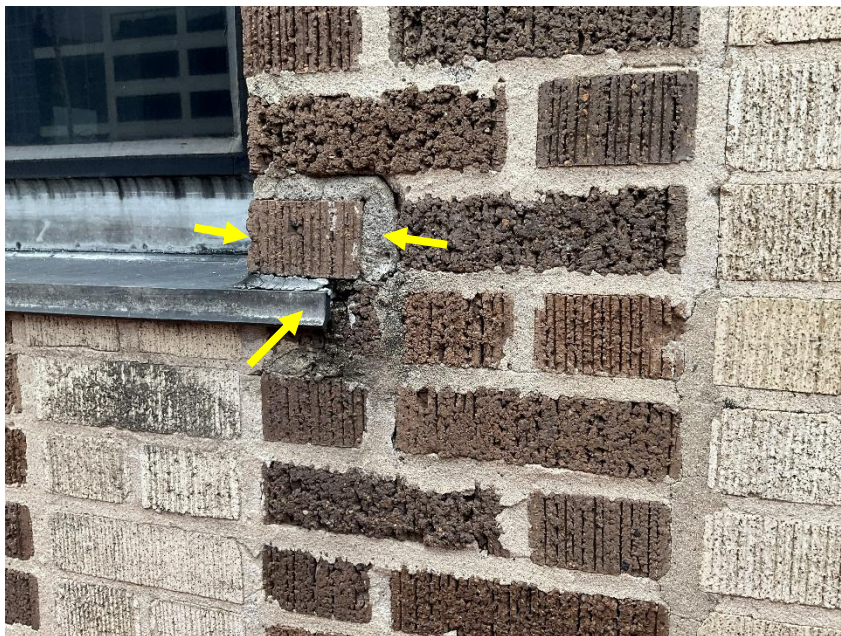
**Photo No. 8.** View of loose brick masonry at the window sill.

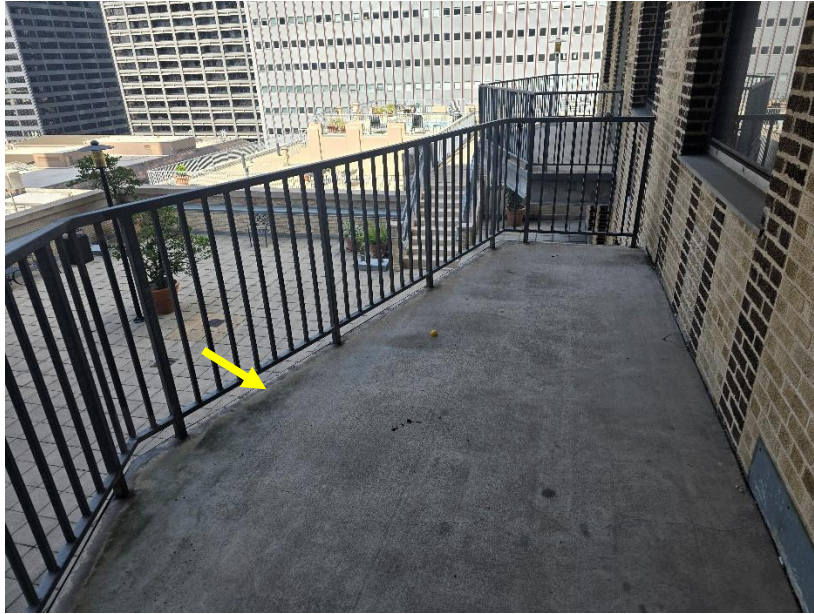
1. The balconies consist of bare concrete on corrugated metal decking with galvanized railings and steel framing elements. Unsealed transitions were observed at the perimeters of the railing post embeds, transition at the concrete balcony slab and perimeter steel angle, and steel frame wall penetrations. These unsealed transitions may allow water to penetrate the balcony slab and the brick masonry walls, causing corrosion of the steel and deterioration to adjacent elements (Photo Nos. 9 –12). These joints are recommended to be sealed throughout and a pedestrian traffic bearing membrane installed at each balcony top surface.

**Photo No. 9.** View of bare concrete balcony topside.

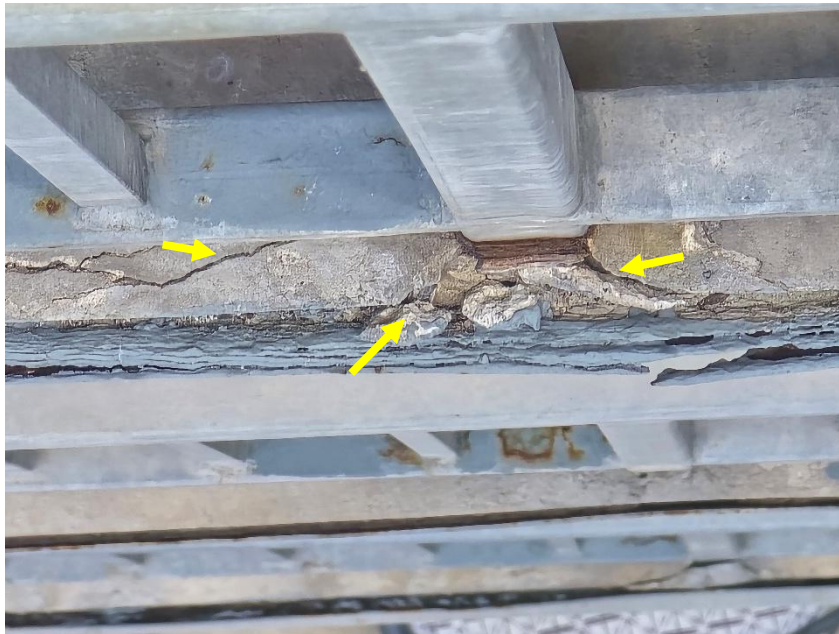
**Photo No. 10.** View looking down at the cracked and spalled concrete near a balcony post embed. The perimeter steel angle is also corroded.

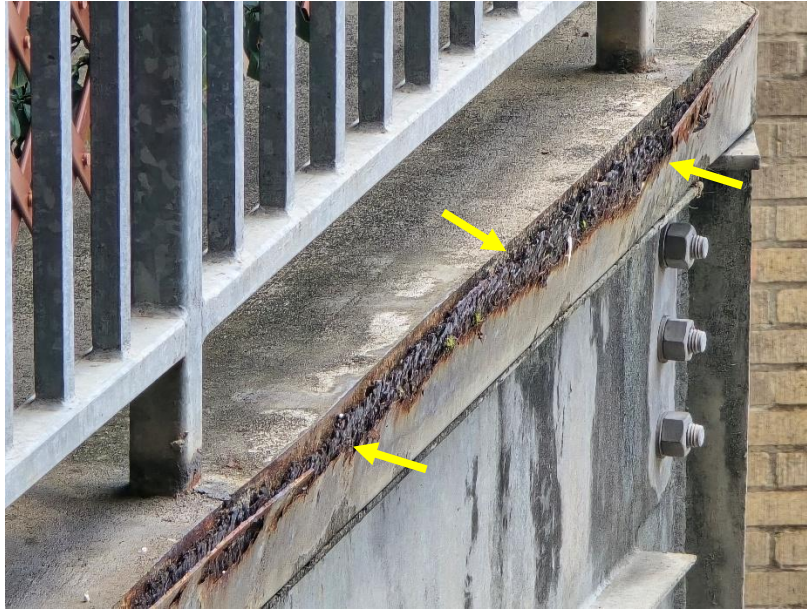
**Photo No. 11.** View of corroded steel angle at balcony slab edge. Moisture is likely getting trapped between the concrete and the steel.

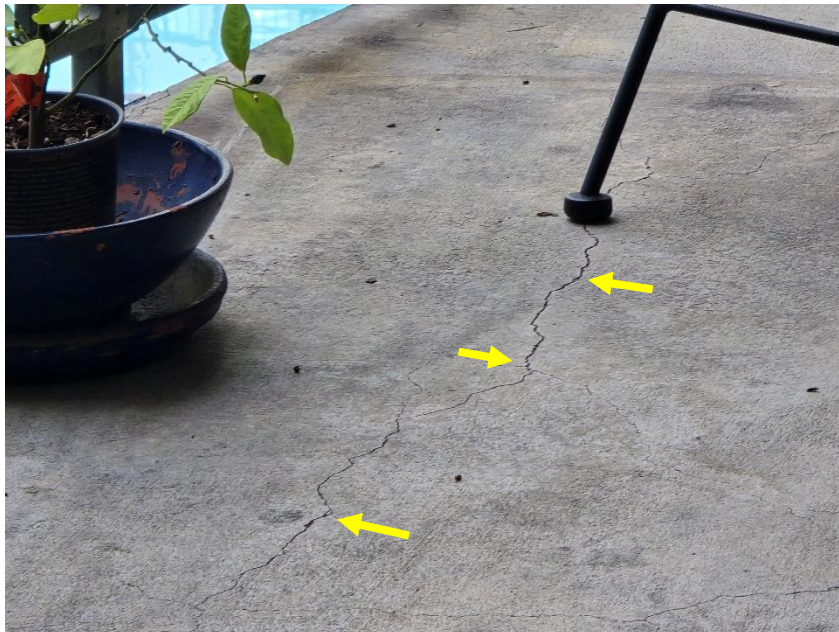
**Photo No. 12.** View of concrete balcony slab crack.
