HPO File No. 2022_0263

ITEM B6 1115 E 14th St Norhill

CERTIFICATE OF APPROPRIATENESS

Proposal: Alteration: Windows

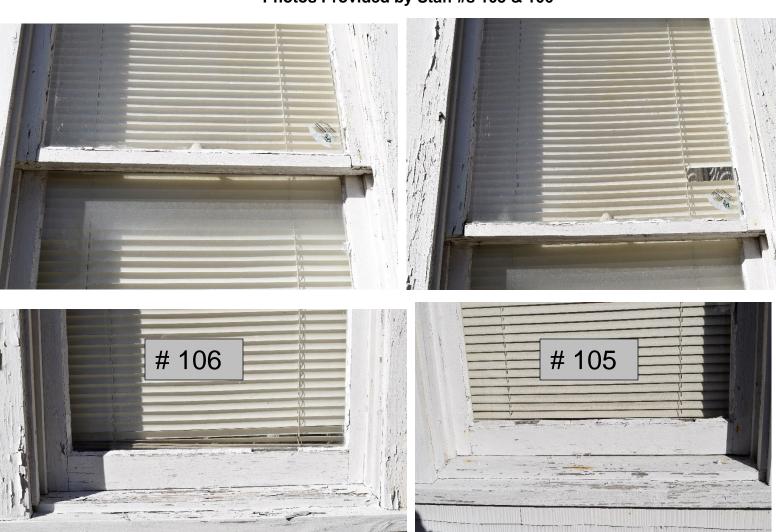
Photos Provided by Staff #s 105 & 106

Windows 105-106 are in repairable condition

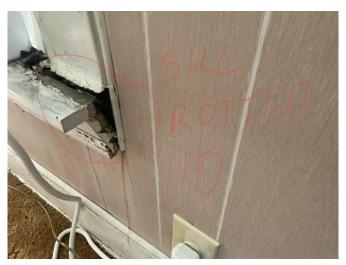
110

Ordinance does not cover interior repair work

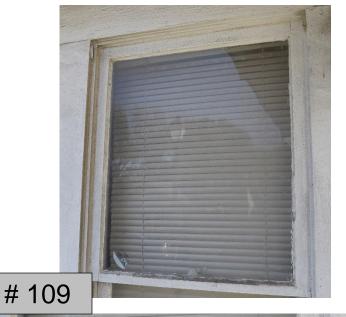
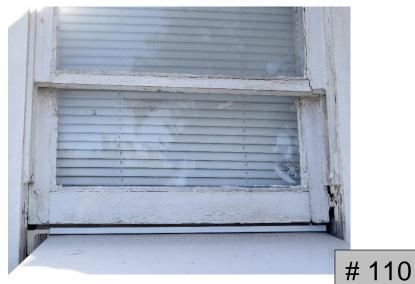
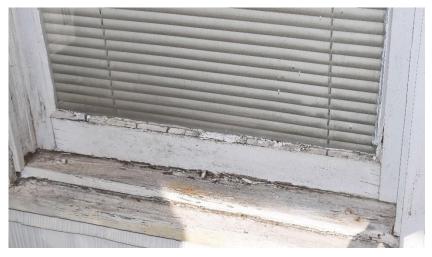
Photos Provided by Staff #s 109 & 110

Windows
109-110
are in
repairable
condition

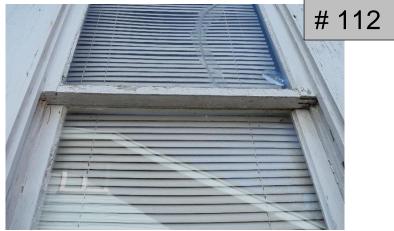
Photos Provided by Staff #s 111 & 112

Windows 111 & 112 are in repairable condition

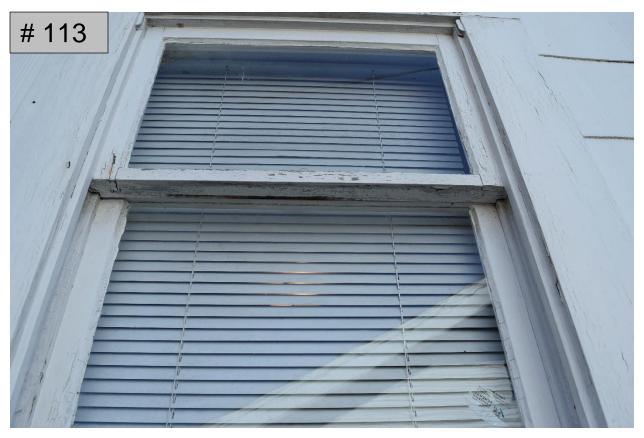
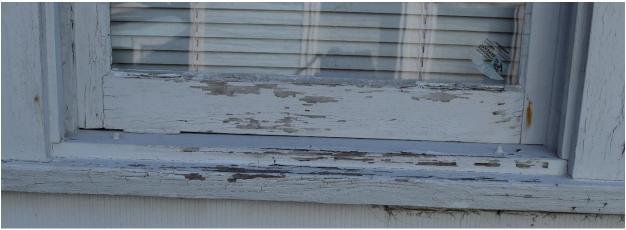
Photos Provided by Staff #113

Window 113 is in repairable condition
