**CERTIFICATE OF APPROPRIATENESS**

**Property:** 1115 E 14<sup>th</sup> Street, Lot 17, Block 117, Norhill Neighborhood Subdivision.  
The property includes a historic 1,140 square foot, one-story wood single-family residence situated on a 5,000 square foot (50' x 100') interior lot.

**Proposal:** Alteration: Windows

- Replace all 15 original, wood windows on structure
- Replace with 1-over-1, double-hung, inset & recessed, Fibrex windows

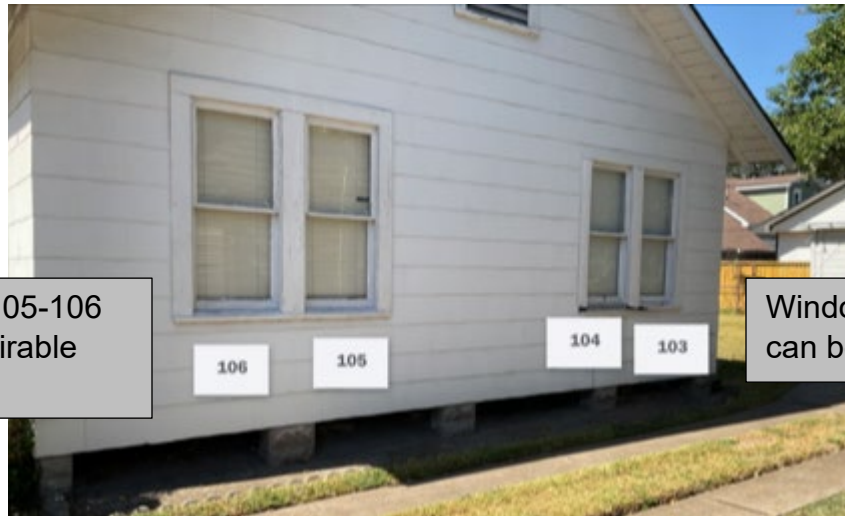
Windows 105-106 are in repairable condition

Windows 103-104 can be replaced

**Recommendation:** Approval with conditions: Okay to replace windows numbered 101-104 and 114-115 (those on the rear of the structure and the two windows on the NE rear corner of structure). Retain all other original windows.

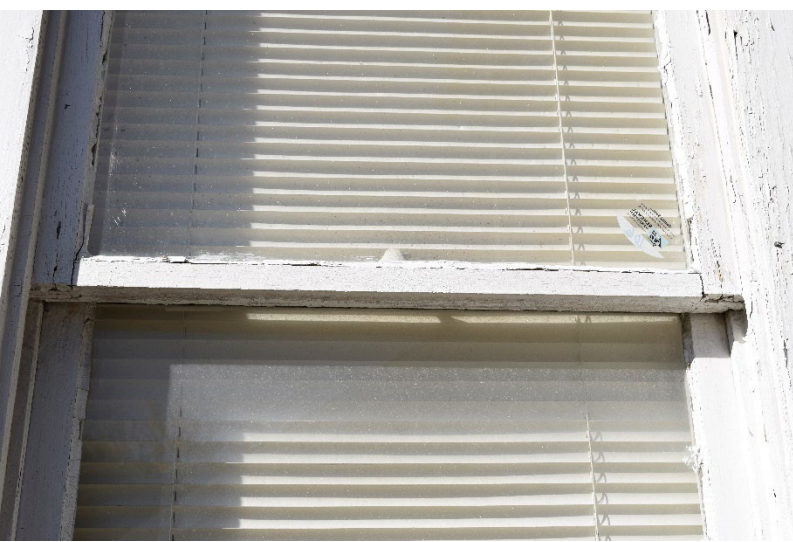
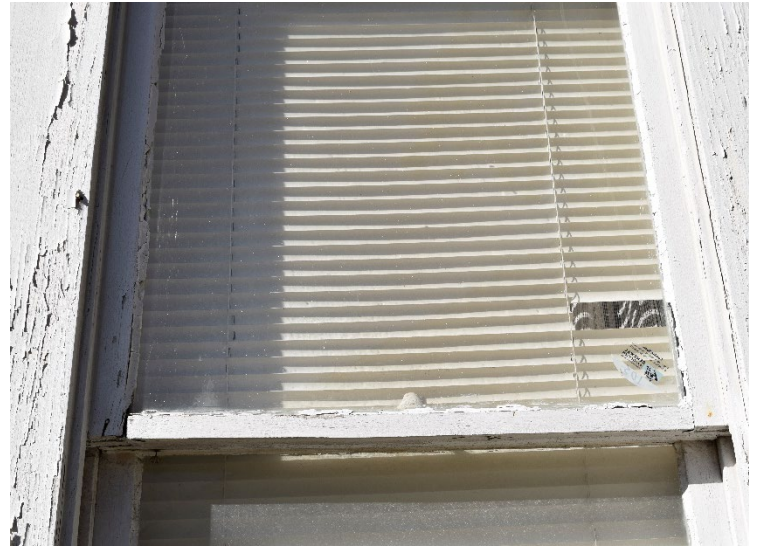
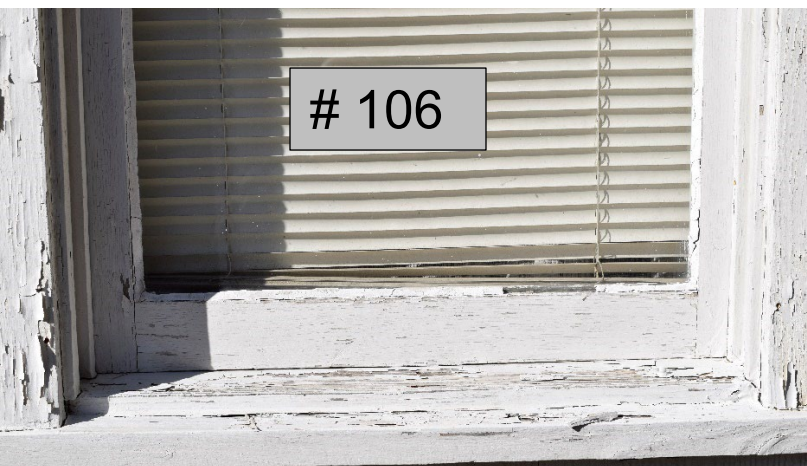
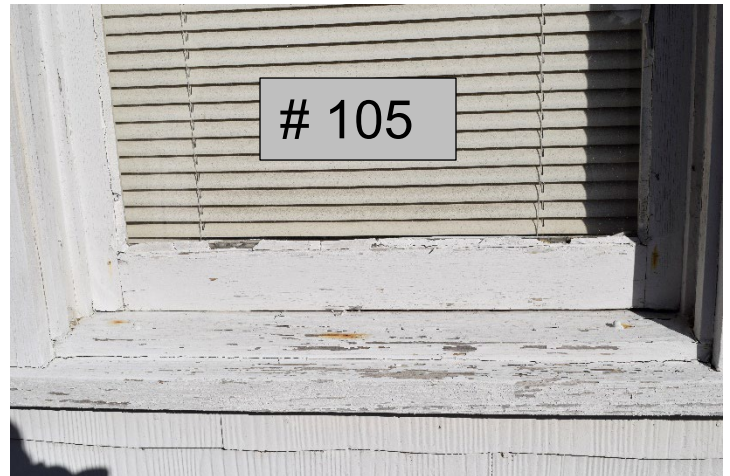
Photos Provided by Staff #s 105 & 106

Windows 105-106 are in  
reparable condition

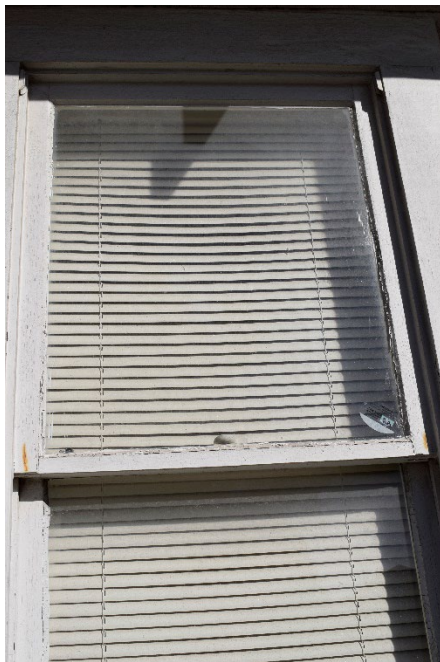
Photos Provided by Staff #s 107 & 108

Windows  
107-108 are  
in repairable  
condition

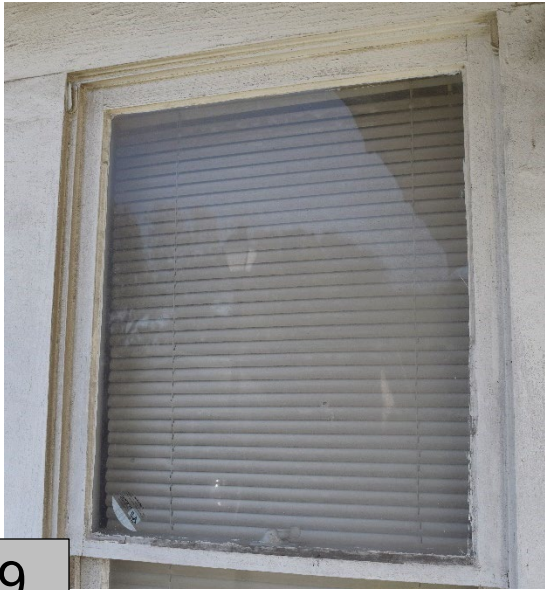
Photos Provided by Staff #s 109 & 110

Windows 109-110 are in repairable condition

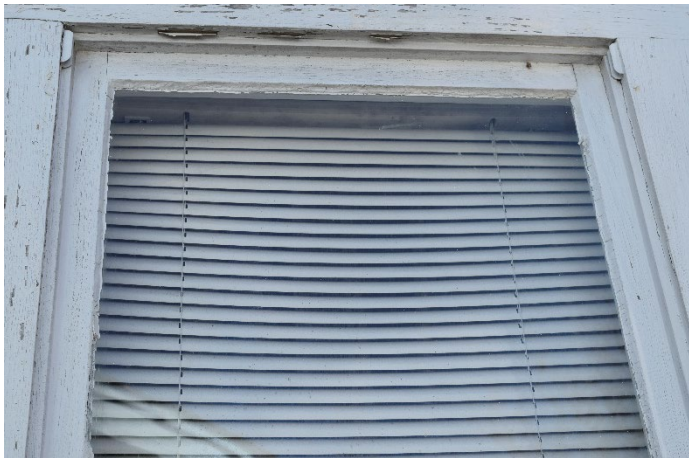
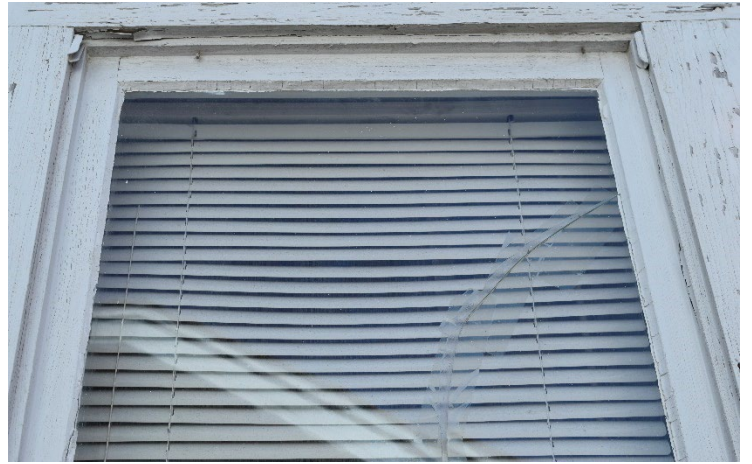
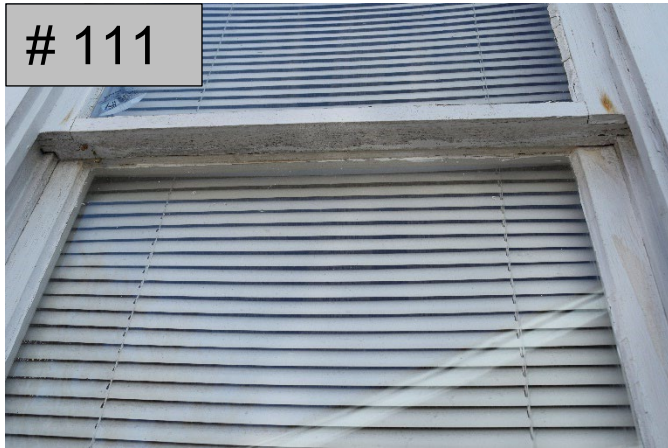
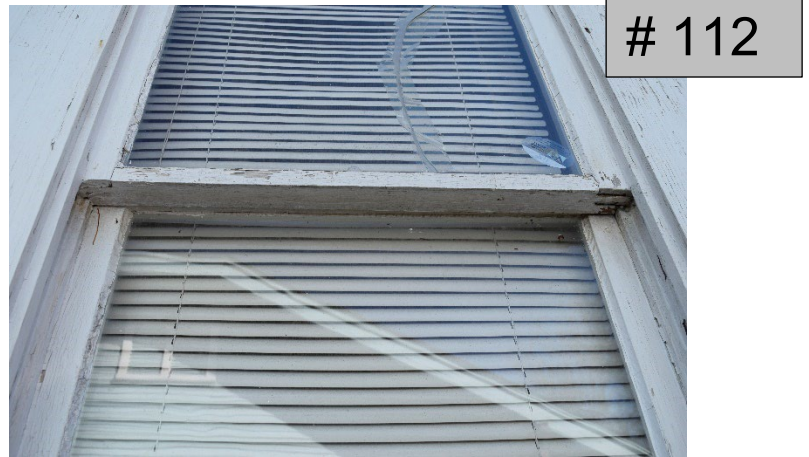
Photos Provided by Staff #s 111 & 112

Windows 111 &  
112 are in  
reparable condition

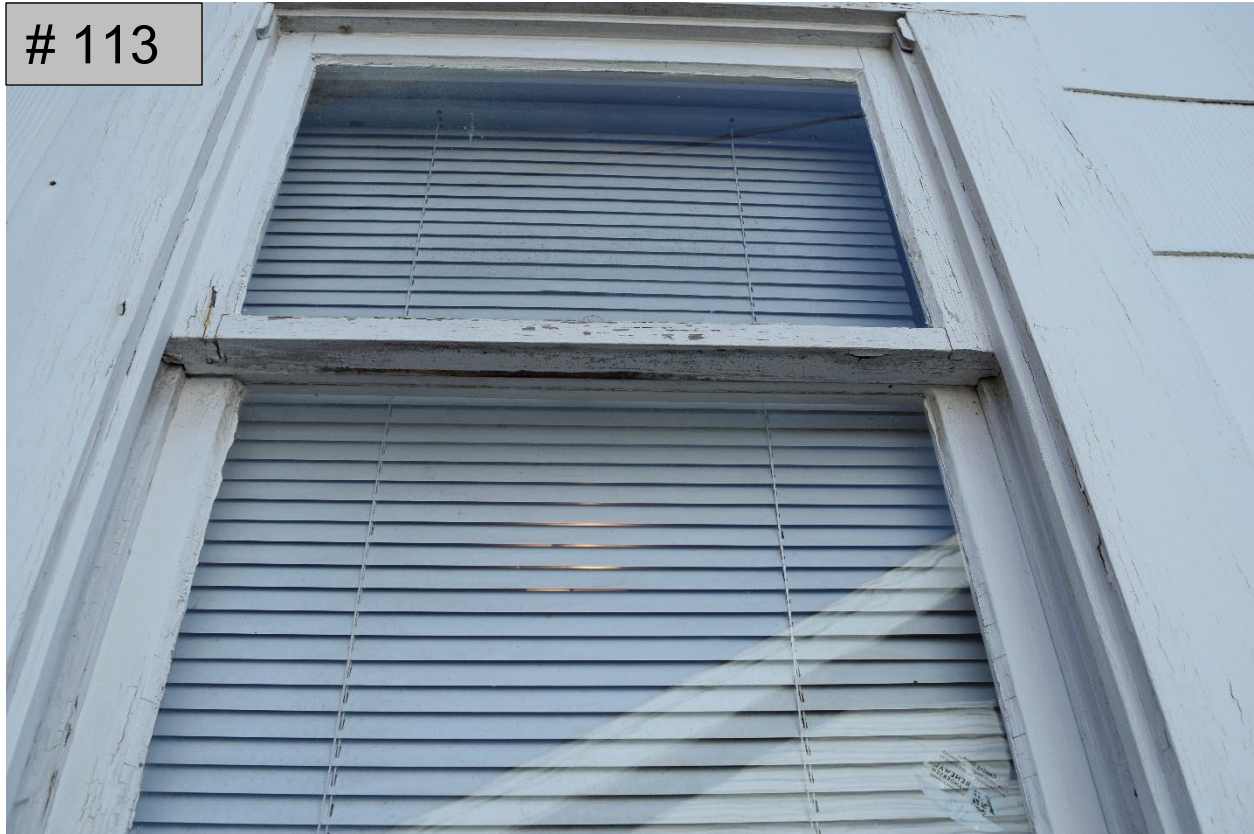
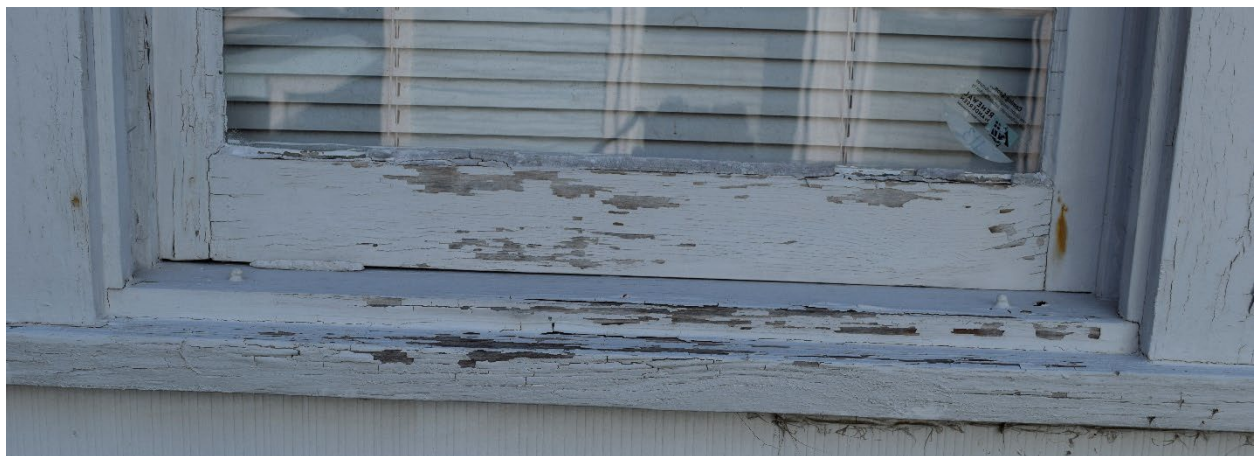
Photos Provided by Staff #113

Window 113 is in  
repairable condition
