CERTIFICATE OF APPROPRIATENESS

Property: 705 W. Main, Lot 11, Block 14, Lockhart Conner & Barziza

Proposal: Alteration – porch deck replacement

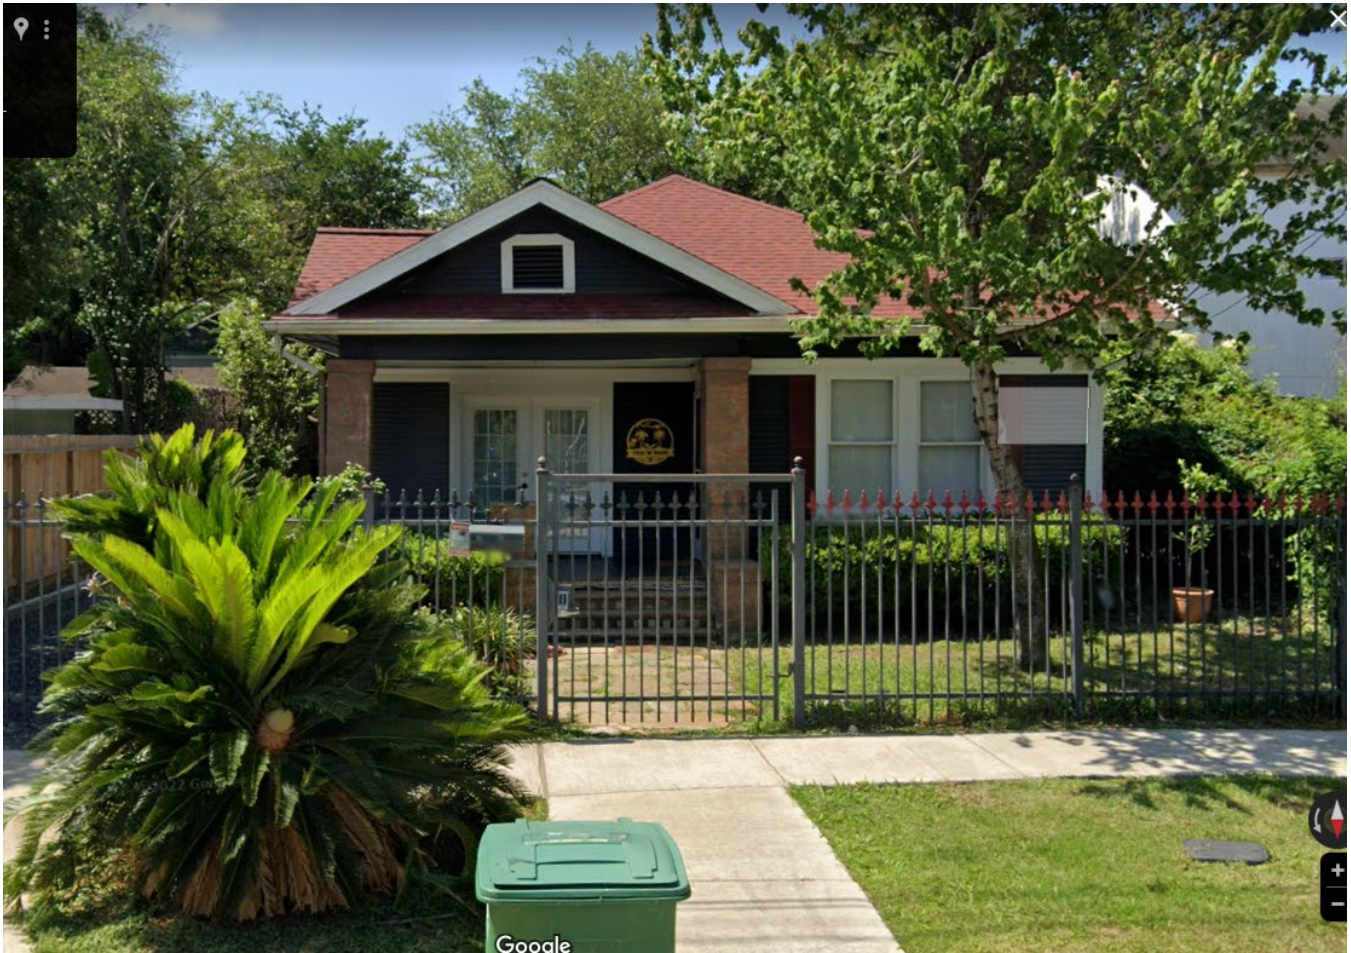
Figure 1 - Current Photo Front Elevation

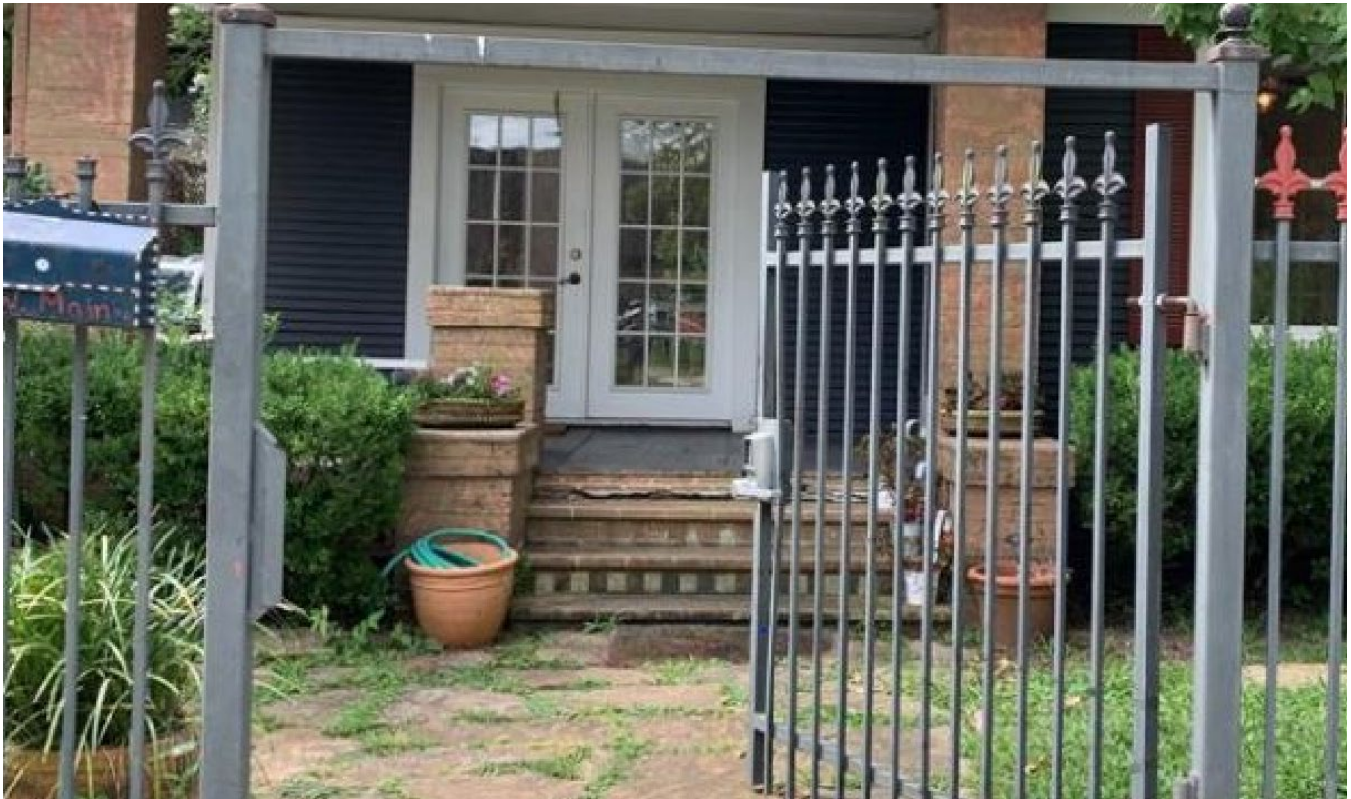
Figure 2 - View of Porch Floor Prior to Alteration from Google Streetview

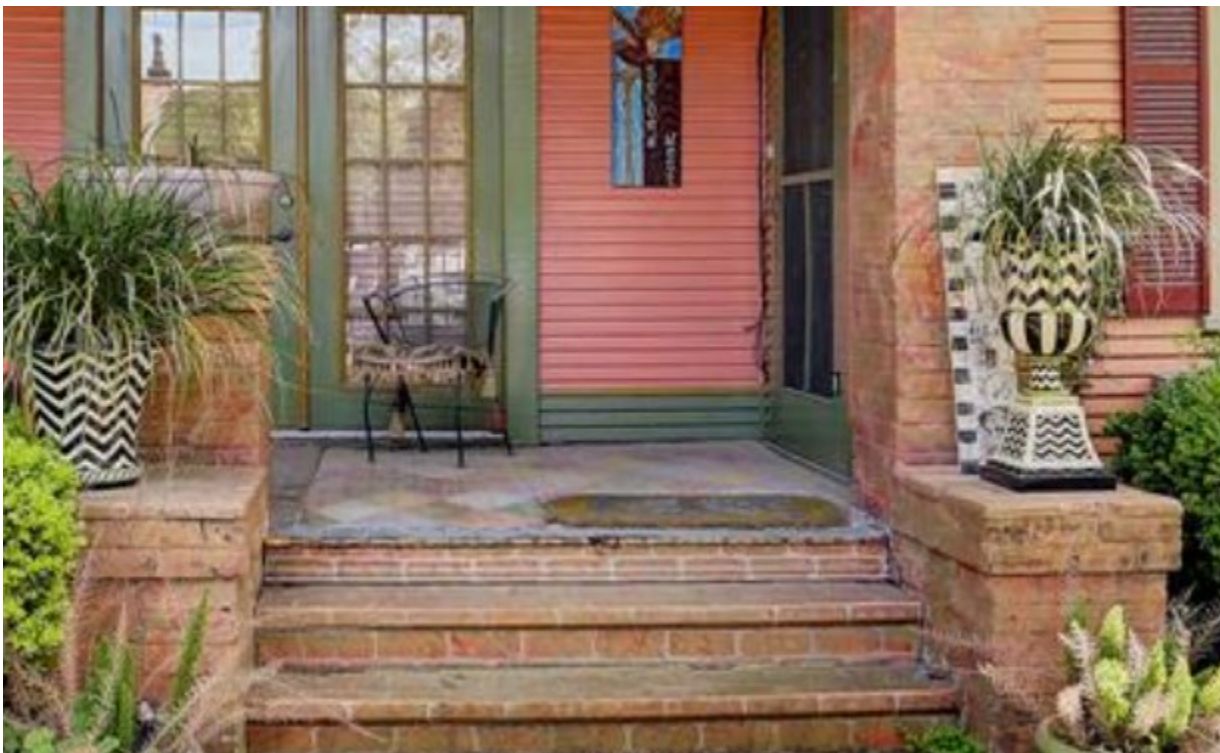
Figure 3 - Image from HAR Listing Porch Floor Prior

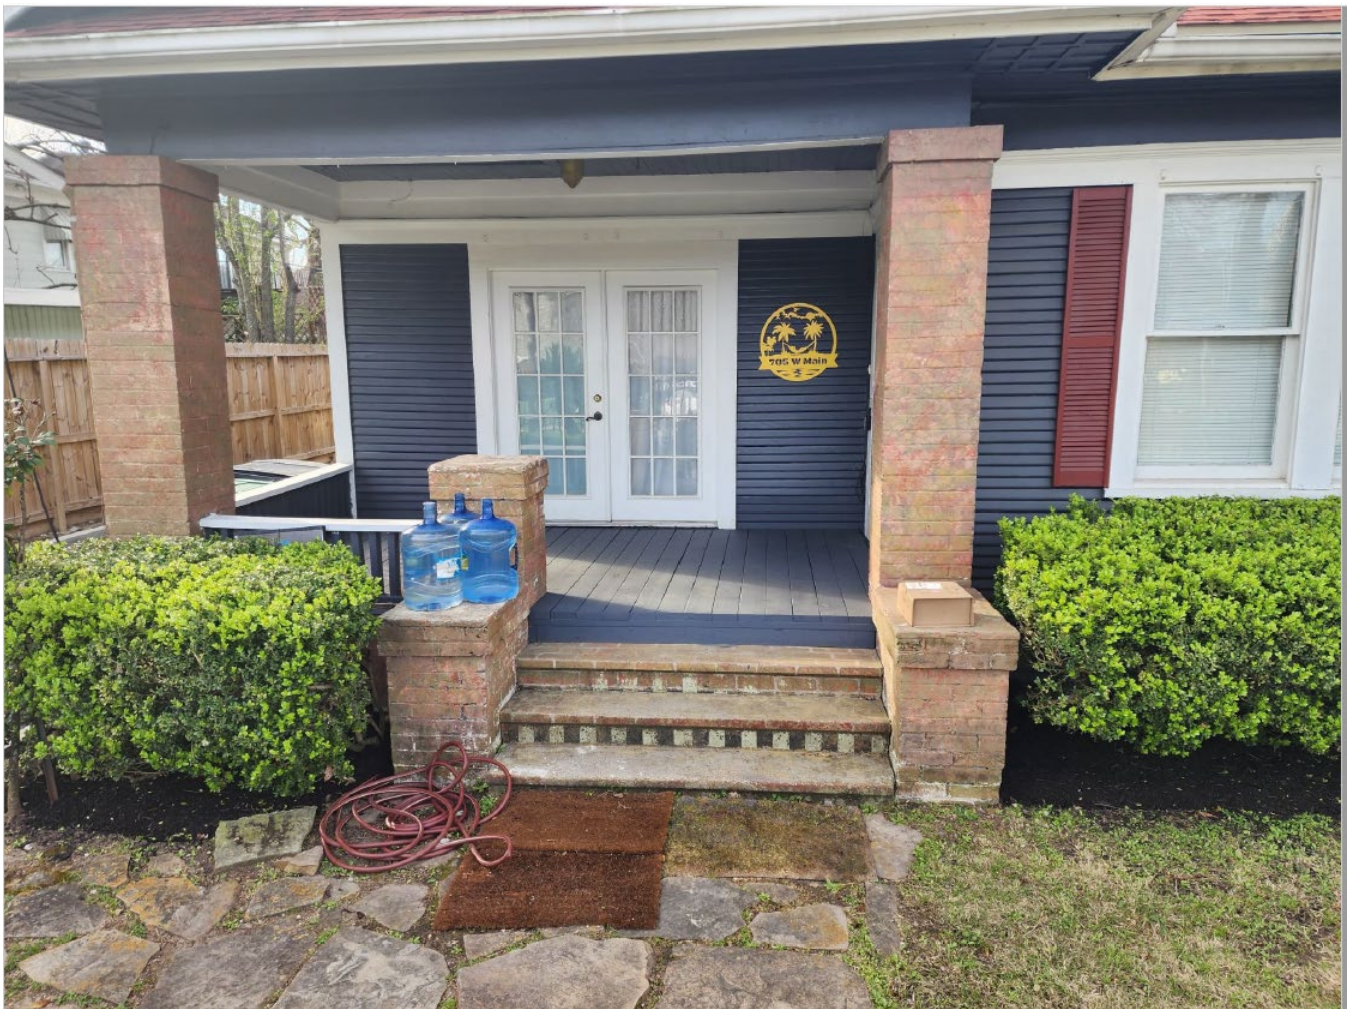
- Applicant worked without a permit and replaced the porch floor decking with 2"x 6" pine wood

<i>Replacing original porch flooring with 2x material does not retain and preserve the character of the front porch. The original material was or would have been nominal 1" x 4' tongue and groove</i> |

Figure 4 - View of porch floor after work completed

Recommendation: Denial - does not satisfy criteria 1, 4, 5, 9 & 10 and issuance of a COR to remove the installed deck floor and replace the porch floor with 1"x4" T&G porch flooring wood perpendicular to the street and with slight slope towards street, as the original would have been

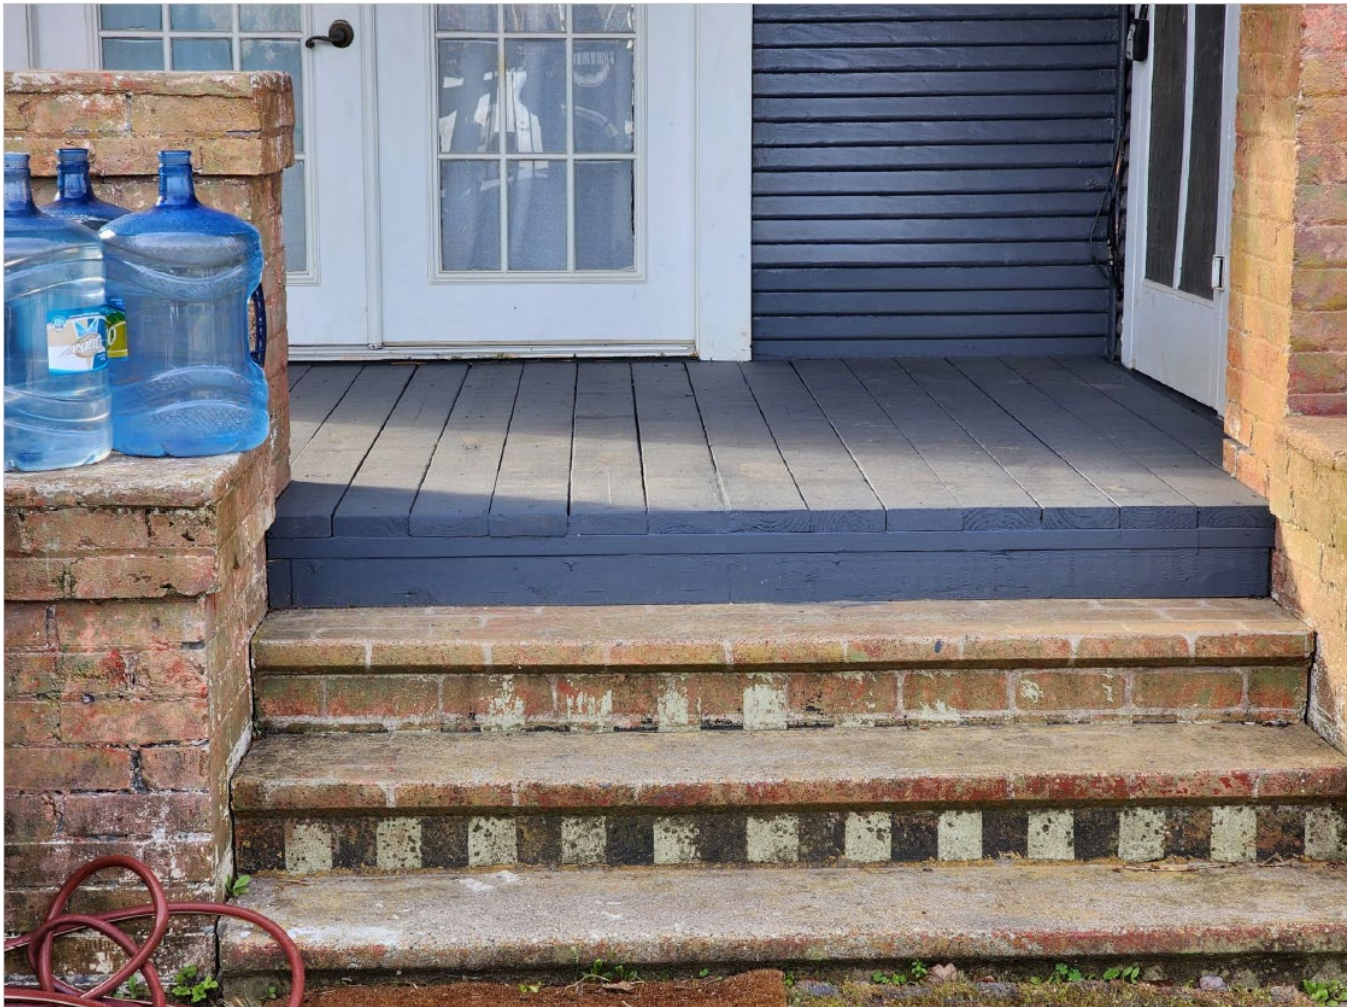
Figure 5 - Close up of new decking

4. The materials he chose ARE NOT of like kind or in keeping with the original historic materials, rather he chose pressure treated 5/4 X 6 deck boards instead of 1X4” pine or cypress tongue and groove porch boards (which are currently available to purchase from multiple hardware stores, such as Lowes or lumber yards).

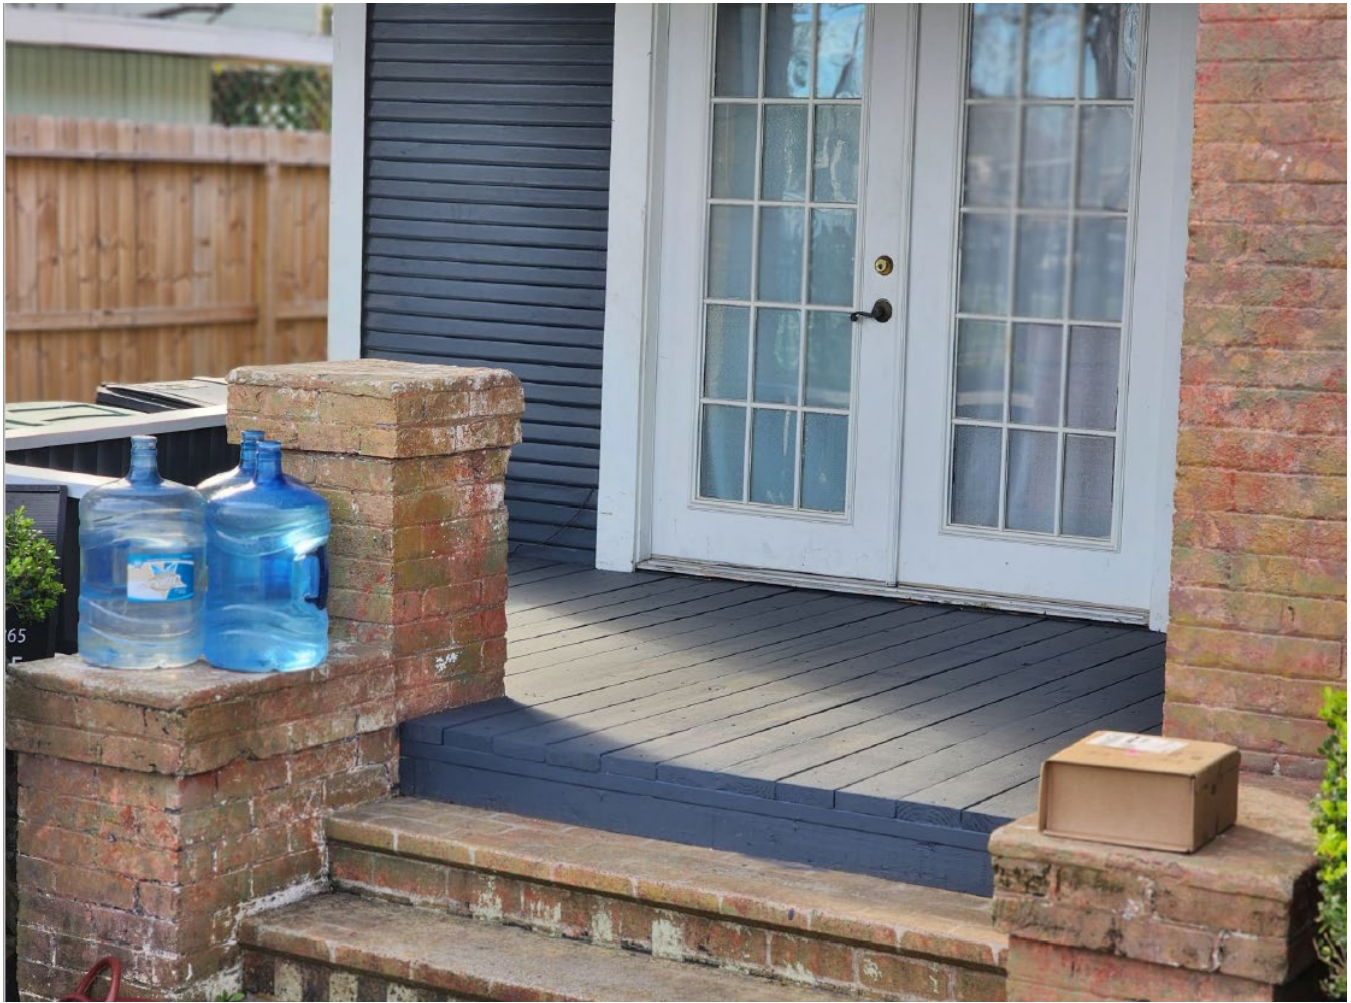
Figure 6 - Additional View Close Up of Deck
