CERTIFICATE OF APPROPRIATENESS

HPO File#: HP2025_0124

Property: 1020 E 16TH St E, 109, Norhill

COR - Certificate of Remediation

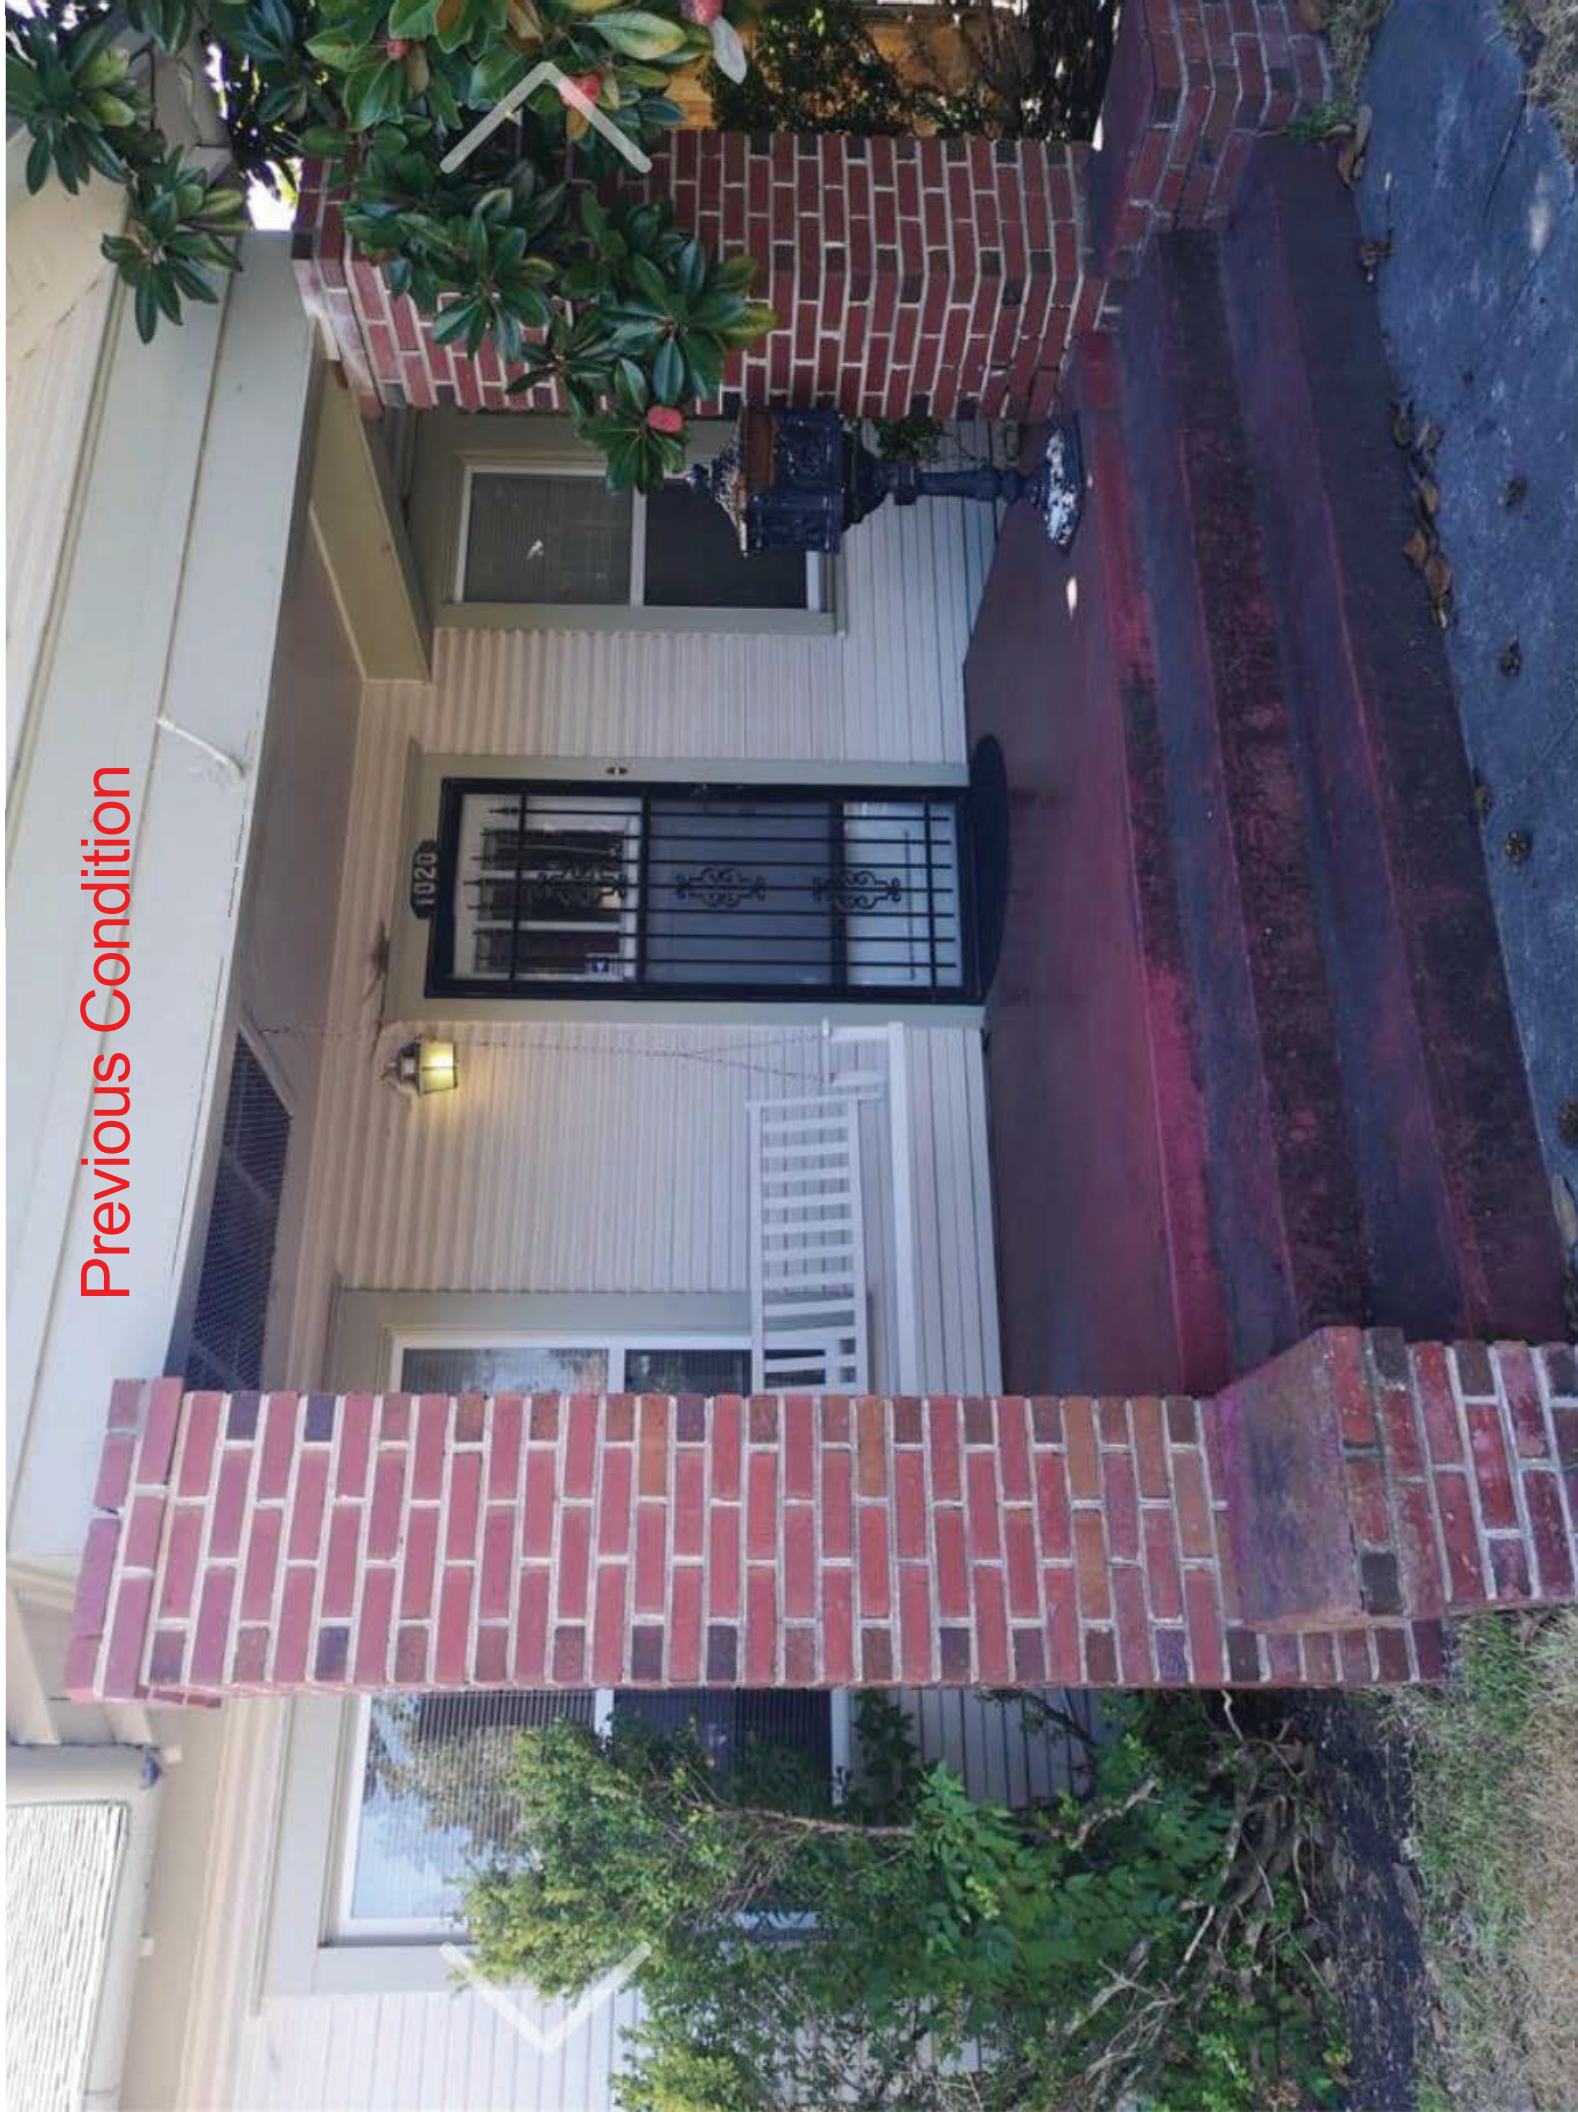
Previous Condition

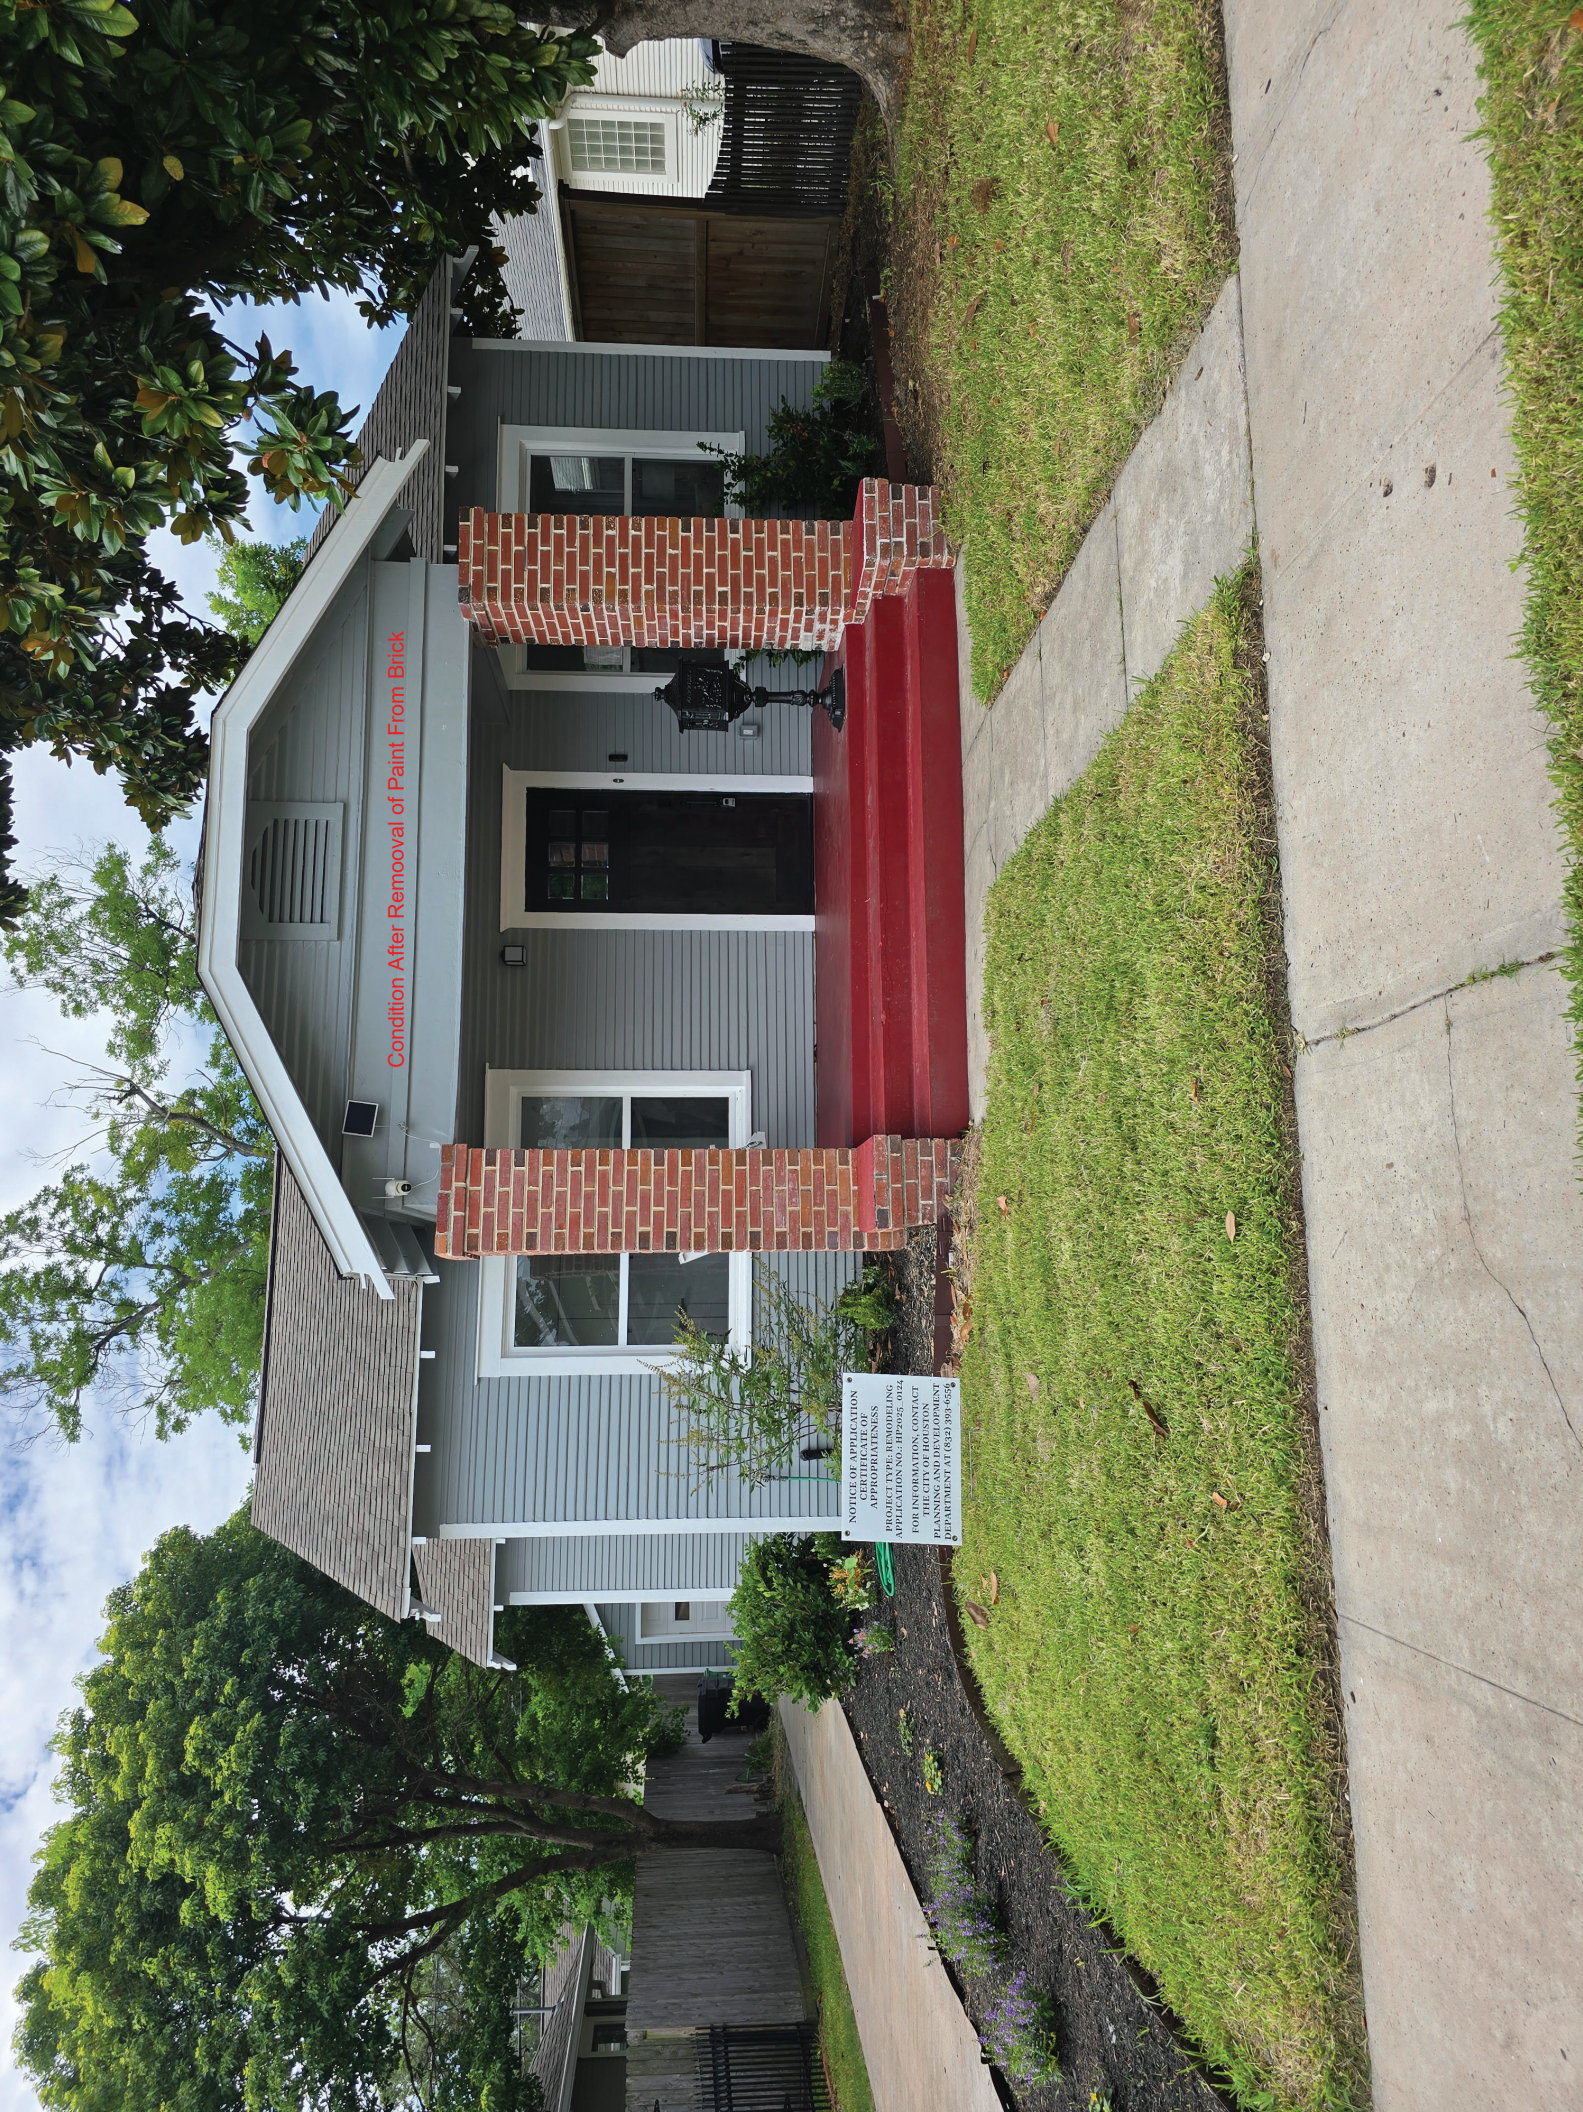
- Non-original Front Door was removed and replaced.
- Front Porch Brick columns were painted.

- Painting unpainted masonry is not allowed under Preservation Ordinance.

Condition After Painting of Brick &
Replacement of Door without COA

- Paint must be Removed from Brick Columns.
