7542 Cayton St Glenbrook Valley

#### CERTIFICATE OF APPROPRIATENESS

**Proposal:** Alteration – replace roofing system

January 27, 2022 HPO File No. 2021\_0372

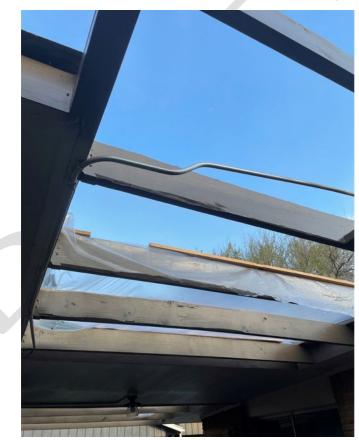
Previously covered roof – open now causes damage to front door and sliding door
