# **CERTIFICATE OF APPROPRIATENESS**

Proposal: Alteration -

HPO File No. HP2022-0291

1204 Studewood Street Norhill

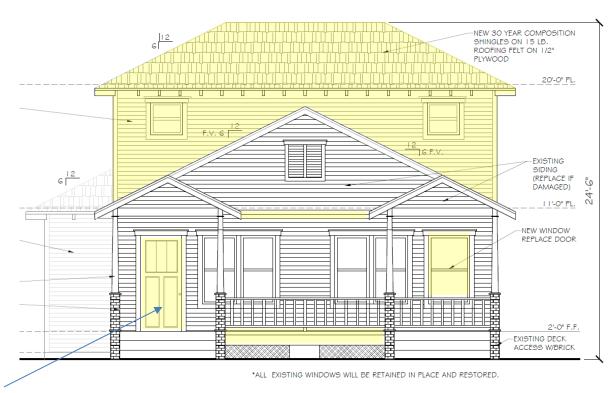
Applicant proposes to replace inappropriate door with a craftsman style door

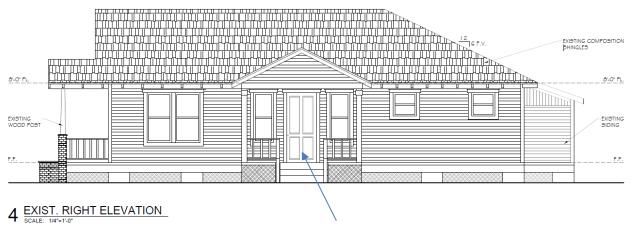
Existing doors and door trim are not original
