1022 Peddie St Norhill

CERTIFICATE OF APPROPRIATENESS

Proposal: Alteration – Windows:

The applicant proposes to replace the original 1/1 wood windows with Renewal by Andersen Fibrex

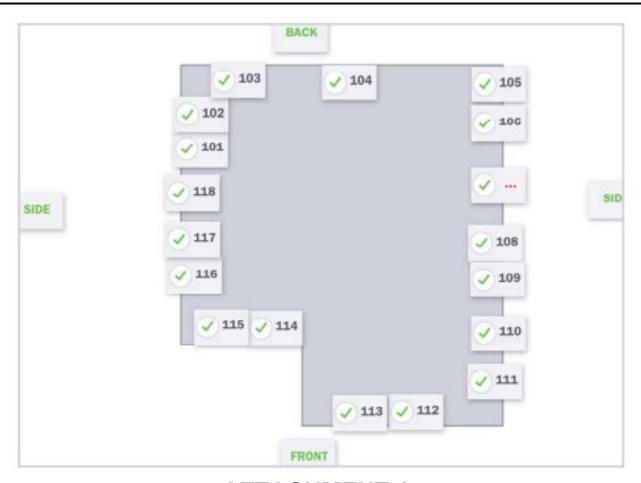
EXISTING WINDOWS

S	D	NA		S - satisfies D - does not satisfy NA - not applicable
			(1)	The proposed activity must retain and preserve the historical character of the property; The existing windows are in need of repair, thus preserving the character of the property.

(4)	The proposed activity must preserve the distinguishing qualities or character of the building, structure, object or site and its environment; By replacing windows that are in good condition, the windows are not being preserved.

(9)	The proposed design for any exterior alterations or addition must not destroy significant historical, architectural, archaeological or cultural material, including but not limited to siding, windows, doors and porch elements; By removing the existing windows, would indeed be destroying significant historic material
\boxtimes			(10)	The proposed alteration or addition must be compatible with the massing, size, scale material and character of the property and the context area; and

Recommendation: Denial

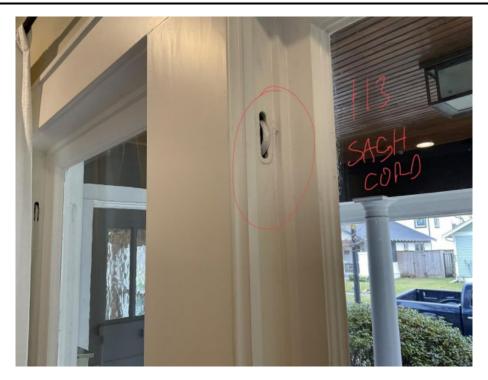
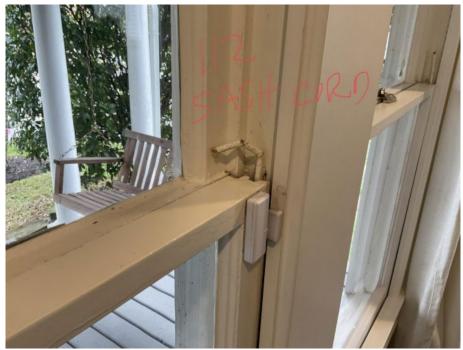
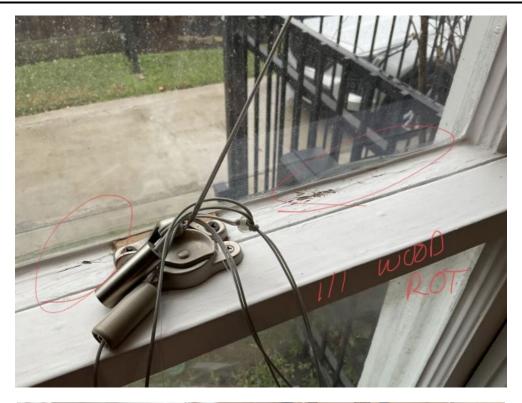
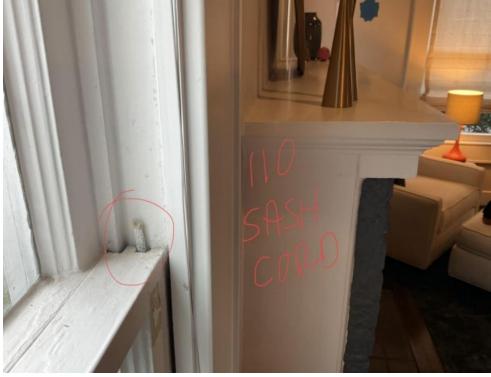
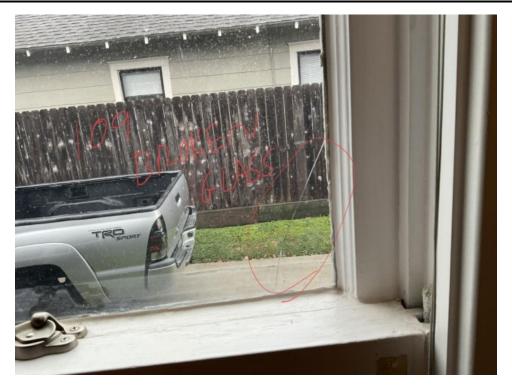
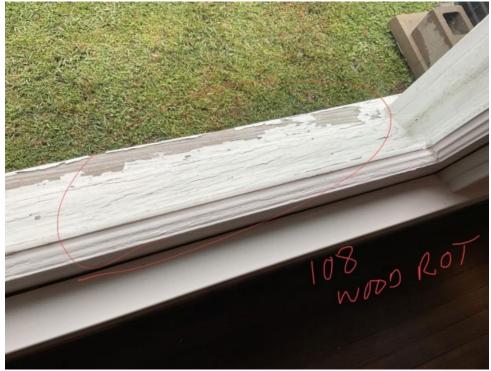
PHOTOS

DAMAGE TO EXISTING WINDOWS
Window	Describe Damage
Ex. A1	Glass is broke, window is inoperable, rail is rotten, and frame is broken
101	Wood Rot
102	Missing sash colds
103	Wood Rot
104	Wood Rot
105	Missing sash cords
106	Missing Hardware / Wood Rot
107	Broken pane (glass), window well not open
108	Wood Rot
109	Broken glass

DAMAGE TO EXISTING WINDOWS							
Window	Describe Damage						
Ex. Al	Glass is broke, window is inoperable, rail is ratten, and frame is broken.	-					
110	Missing sash cords						
111	Wood Rot						
/12	Missing sesh cord						
H3	Missing sash cord						
174	Frame Damaged						
115	Missing sash cord						
116	Broken glass						
117	Wood RET						
118	Wood Damage
