CERTIFICATE OF APPROPRIATENESS

Property: 7523 Rockhill Street, Lot 30, Block 67, Glenbrook Valley Sec. 7 Extn

Proposal: Alteration: Windows

ITEM B08 7523 Rockhill St Glenbrook Valley

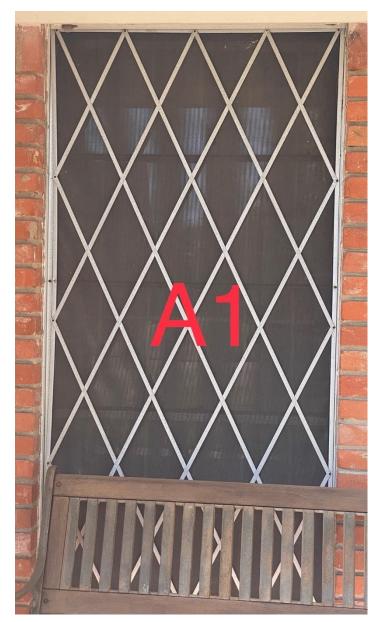
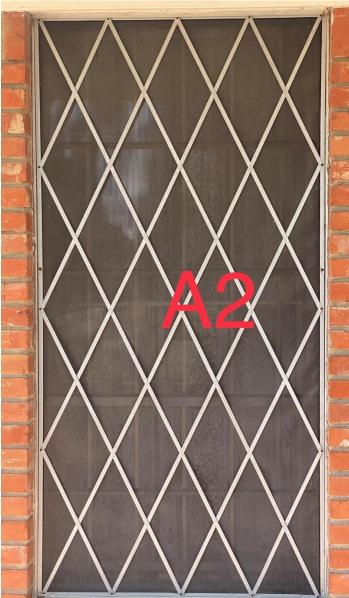
Current Photos Provided By Applicant – Front Elevation

- There is no damage to existing windows per window worksheet
- Reason for replacement: wanting energy efficiency per window
- As of April 10, 2023, vinyl windows have been installed and original, aluminum windows have been removed.

Recommendation: Denial - does not satisfy criteriaDenial of COA. Issuance of COR for work completed and

the condition that surface mounted muntins of same shape be placed on the four windows

on front elevation where the diamond pattern simulated divided lite pattern appears.

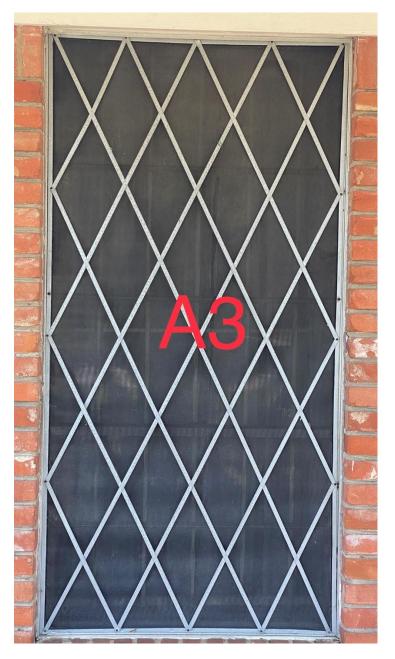
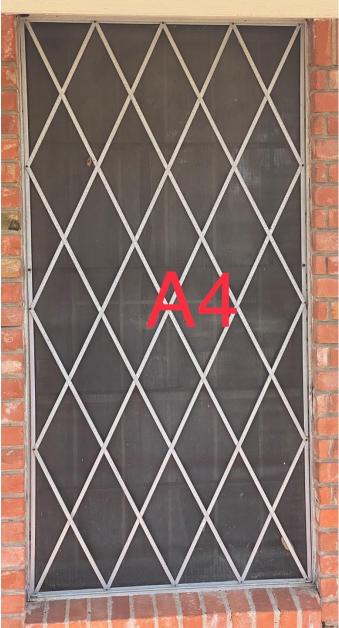
Current Photos Provided By Applicant – Front Elevation

(6)	New materials to be used for any exterior feature excluding what is visible from public alleys must be visually compatible with, but not necessarily the same as, the materials being replaced in form, design, texture, dimension and scale; The simulated divided lite diamond pattern is incompatible with the 2-over-2 lite pattern of the aluminum windows in the context area.
