CERTIFICATE OF APPROPRIATENESS

Property: 1418 Studewood Street, Lot 10, Block 112, North Norhill Neighborhood

Proposal: Alteration: Porch, Siding, Ramp, Windows

August 3, 2023 HPO File No. 2023 0149

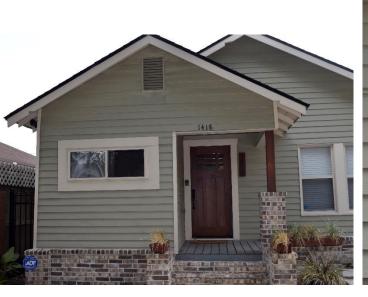
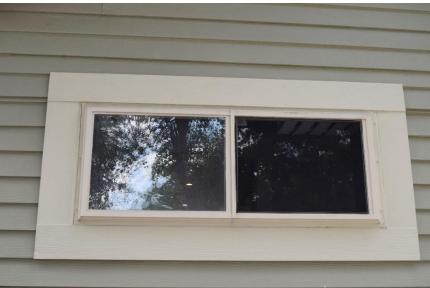
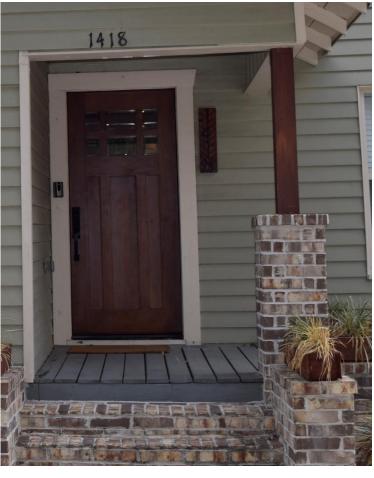
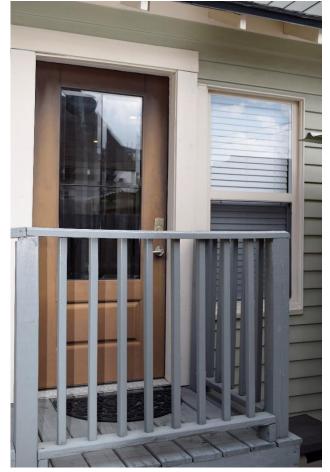
Photos Provided By Staff

- Unpermitted work for the following:
 - Grass removal and concrete pads in place
 - Ramp installed
 - Alteration to porch
 - Alteration to windows on front elevation, left-hand side
 - Deviated from scope of work on right elevation from Oct. 2019 COA (location of door)
- A total of 22 red tag notices between 10-2020 to12-15-2022 with multiple follow-up visits by inspector
 - Most recent inspector follow-up on 7-18-2023

Recommendation: Denial of COA. Issuance of COR to remove brick skirting on front elevation on both sides of the brick porch steps; have slider windows on front elevation on left-hand side be inset and recessed with window trim matching historic windows; replace porch deck boards with 1"x4" tongue-n-groove, laid front to back; convert existing front porch column into a tapered column, and reorient ramp approach from the rear of the lot. Porch pedestals, front door, removal of awning on front elevation, placement of door on right elevation, and garage door to remain as completed.
