CERTIFICATE OF APPROPRIATENESS

Property: 1011 W Gardner Street, Lot 18, Block 119, North Norhill Neighborhood Subdivision.

Proposal: Alteration - Porch or Balcony

ITEM A4 1011 W Gardner St Norhill

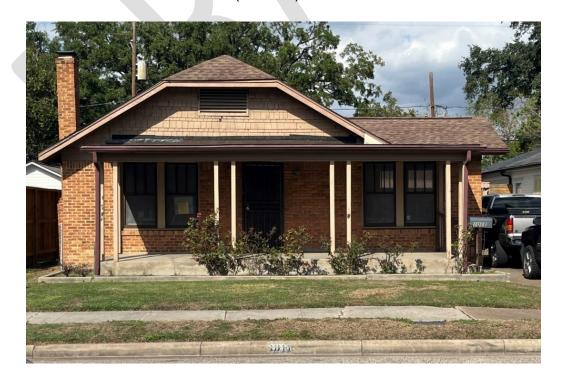
CURRENT PHOTOS
SOUTH (FRONT) ELEVATION

The applicant proposes to alter the existing front porch roof and columns to incorporate a design that is in keeping with the existing house's front gable with hip roof design and other contributing structures in the Norhill Historic District. The existing front porch configuration with a flat roof is non-original. The project details include:

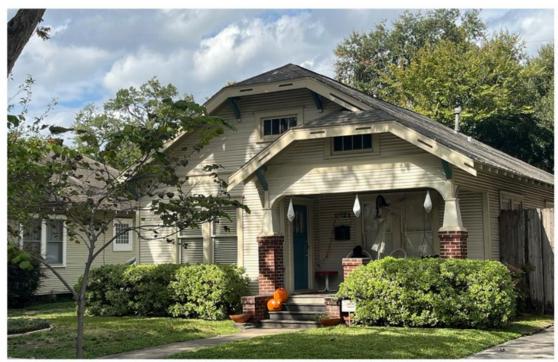
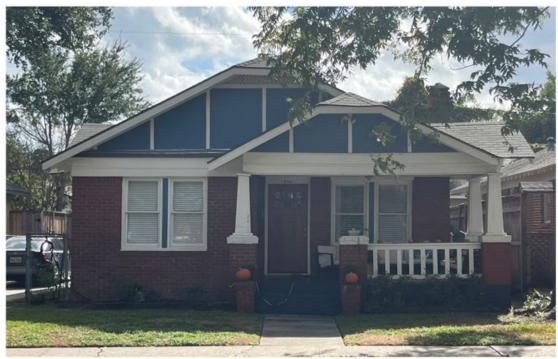
PROPOSED PORCH ROOF EXAMPLES IN NORHILL

- The new hipped gable porch roof will mimic the original existing front gable on the house. Porch soffit will be covered in beadboard.
- Porch Details (26'-3" x 8'-0" x 14'-2")

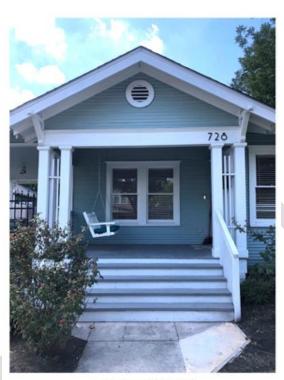
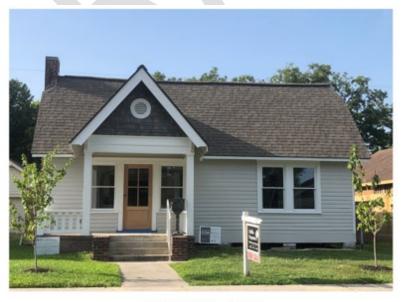
EXAMPLES OF PROPOSED WOOD COLUMNS IN NORHILL

- The existing concrete slab (1'-0" height) will remain in place.
 - o Remove existing porch wood columns (non-original) and replace with two wood 8" square columns to support the new gable porch roof.

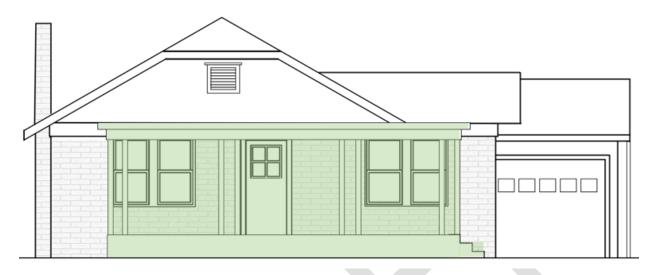
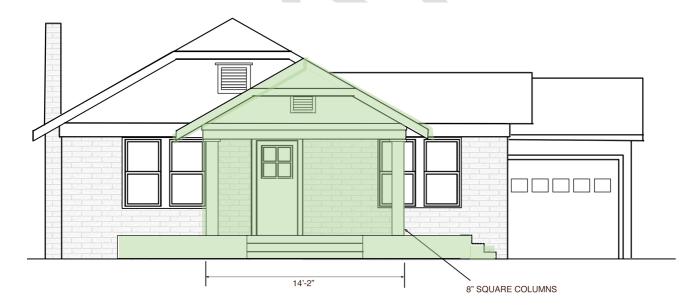
SOUTH (FRONT) ELEVATION

- Porch Roof (18'-0" x 8'-0" x 14'-2")
 - Remove the existing flat porch roof (non-original).
 - Construct a second hipped gable roof to cover a portion of the existing concrete porch slab.
