CERTIFICATE OF APPROPRIATENESS

Property: 3516 Garrott Street, Lot 17, Block 12. Westmoreland Subdivision. The property includes a two-story

Proposal: Alteration- addition, other

February 15, 2024 HPO File No. 2024_0019 3516 Garrott St Westmoreland

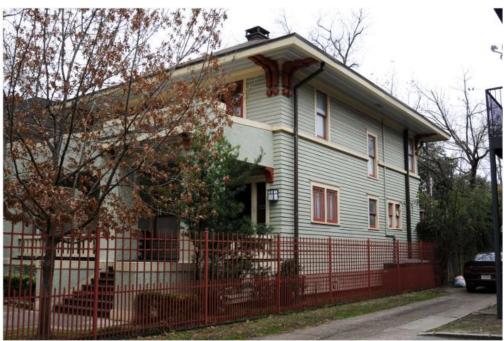
Northwest corner, January 2024

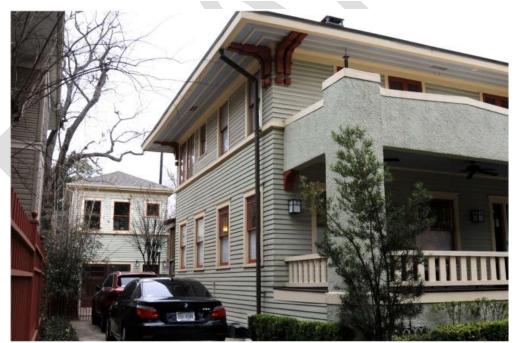
Southeast corner, January 2024

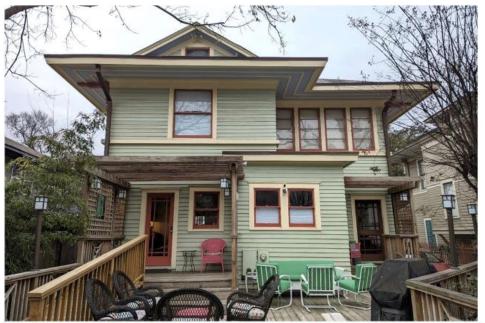
West (rear) elevation, January 2024. Downstairs non-original porch, pergola, and rear door to be removed are visible at far right. Upstairs rear window(s) to be removed (one or two, depending on size of elevator equipment) are visible at far right.

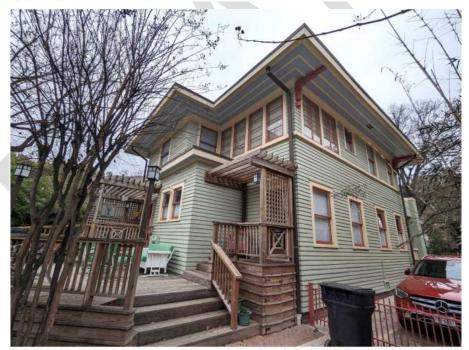
Southwest corner, January 2024. Downstairs non-original porch and pergola to be removed are visible at center. Upstairs rear window(s) to be removed (one or two, depending on size of elevator equipment) are visible above.

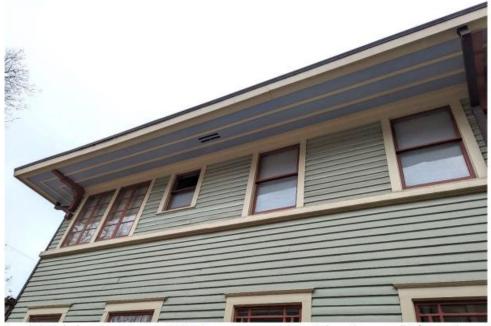
South (side) elevation, January 2024. Two center upstairs windows (one small 1/1, one larger 1/1) will be preserved and relocated to the east (front) and west (rear) walls of the bathroom addition.
