CERTIFICATE OF APPROPRIATENESS

Property: (Main building) 201 E 9th Street, Lot 8 & 9, Block 229, Houston Heights Subdivision. (Secondary Building) 211 E9th street lots 13-16 & tracts 10A, 11A & 12A. Situated on a 30,292 square foot corner lot.

Proposal: Alteration/ Addition

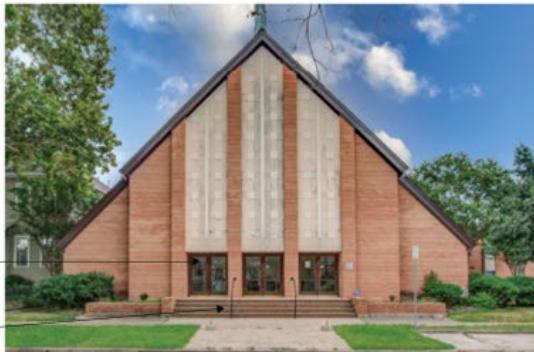
BUILDING 1 - (WEST ELEVATION) REHABILITATION

REPLACE DOORS WITH NEW ARCHITECTURALLY APPROPRIATE OPENINGS

REPLACE HANDRAILS WITH NEW ARCHITECTURALLY APPROPRIATE AND CODE COMPLIANT

Doors-Sanctuary Main Entry (West) – Non-Original /Non-Appropriate Aluminum Egress Door at main Entrance to be replaced with historically appropriate.

- Replace Handrails with New Architecturally and Code Compliant

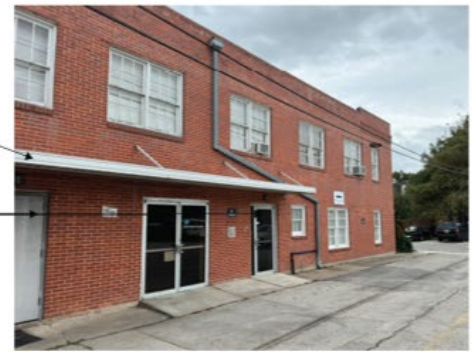
BUILDING 2 - (WEST ELEVATION) REHABILITATION

REMOVE/REPLACE CANOPY

REPLACE EXISTING STOREFRONT WITH NEW ARCHITECTURALLY APPROPRIATE OPENINGS

- Doors- Side Entry (West)– Non-Original Aluminum Store Front door to be replaced with storefront Aluminum Thermal Framing System (Kawneer TRIFAB VG (Versa Glaze)

- Replace Existing Metal Canopy with Architecturally Compliant Metal Canopy

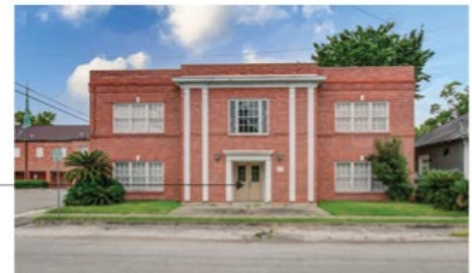
BUILDING 2 - (SOUTH ELEVATION) REHABILITATION

REPLACE EXISTING DOOR WITH ARCHITECTURALLY APPROPRIATE NEW

- Main Entry (South) – Non-Original /Non-Appropriate Aluminum Egress Door at main entrance to be replaced with historically appropriate Aluminum (Kawneer)

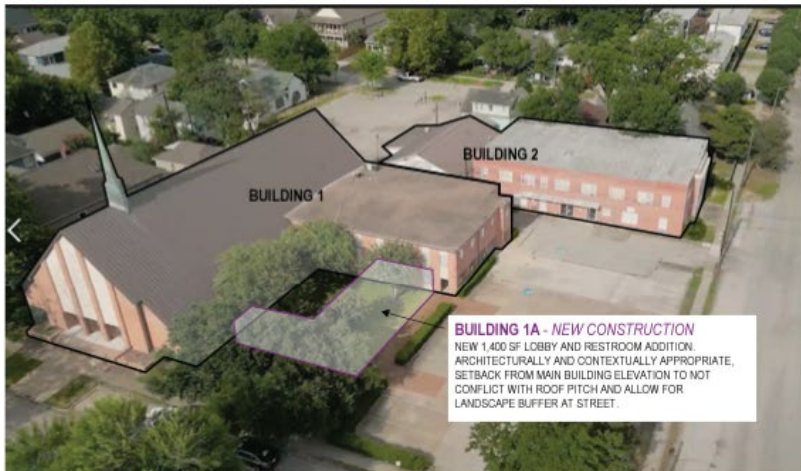
BUILDING 1A - NEW CONSTRUCTION
NEW 1,400 SF LOBBY AND RESTROOM ADDITION. ARCHITECTURALLY AND CONTEXTUALLY APPROPRIATE. SETBACK FROM MAIN BUILDING ELEVATION TO NOT CONFLICT WITH ROOF PITCH AND ALLOW FOR LANDSCAPE BUFFER AT STREET.

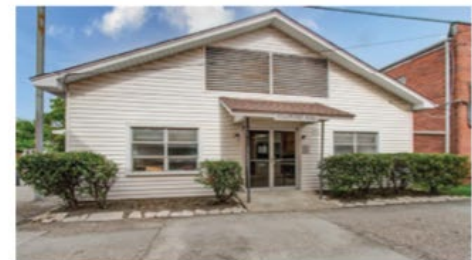
BUILDING 2 - DEMOLITION

BUILDINGS 2&3 TO BE DEMOLISHED

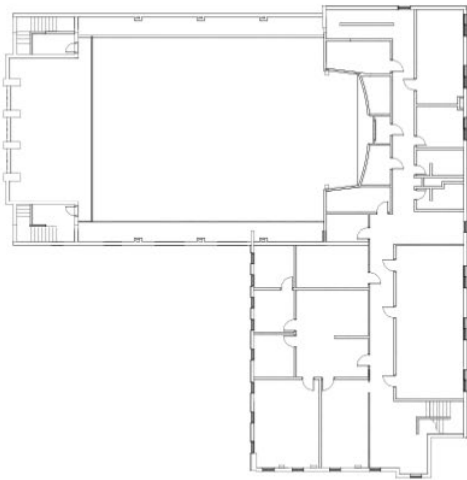
Existing Floor Plan - Level 2

Floor Plans - Building 1 - Level 2 - Existing vs Proposed

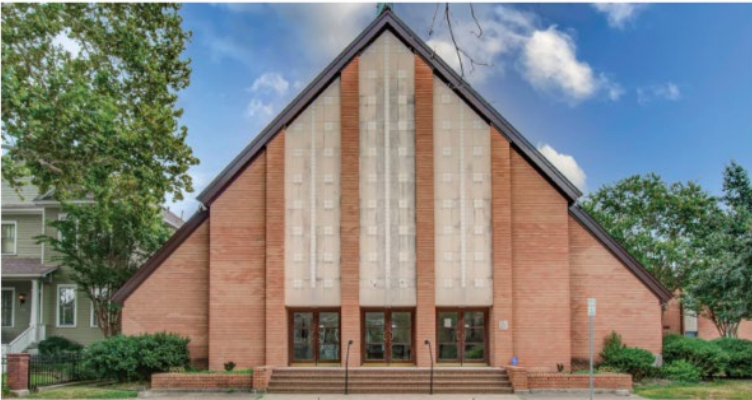
Existing Elevation

Elevations - Building 1 - Existing vs Proposed - West

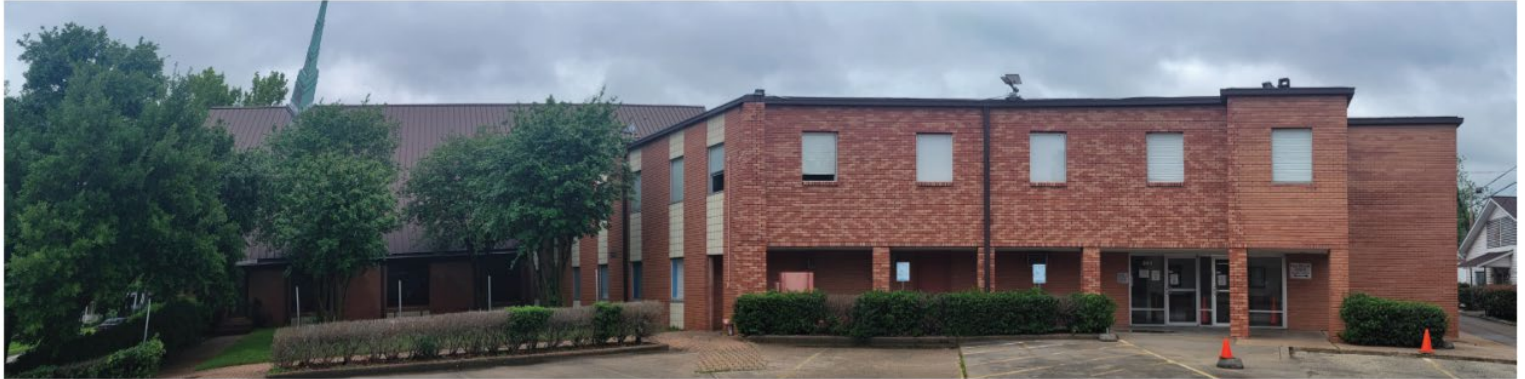
Existing Elevation

Elevations - Building 2 - Existing vs Proposed - South

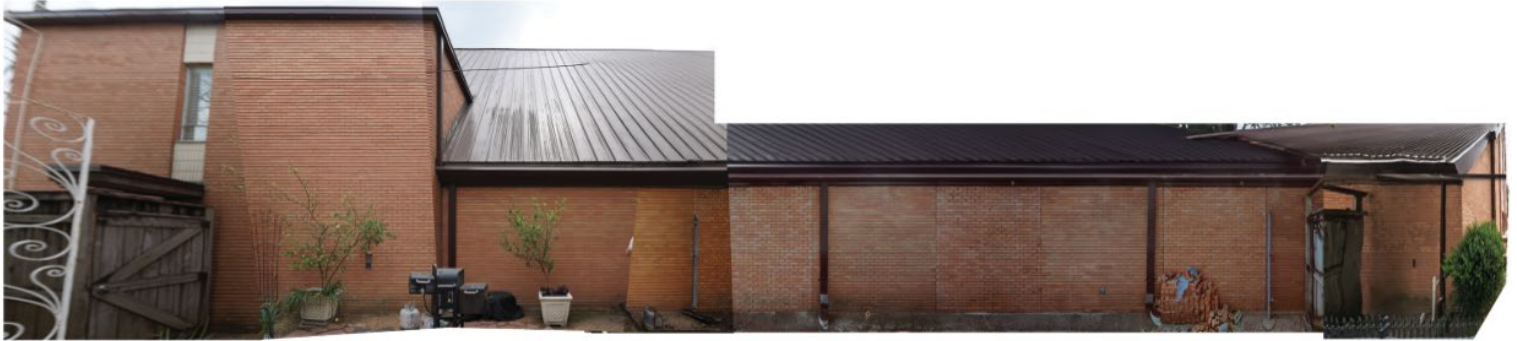
Existing Elevation

Elevations - Building 2 - Existing vs Proposed - North
