CERTIFICATE OF APPROPRIATENESS

Property: 705 W. Main, Lot 11, Block 14, Lockhart Conner & Barziza

Proposal: Alteration – porch deck replacement

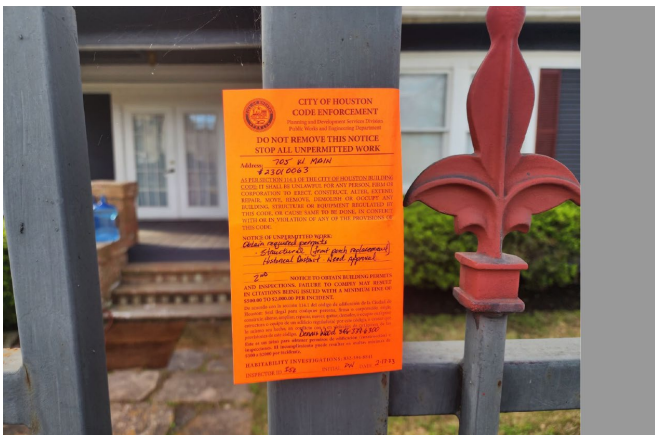
Figure 1 - Current Photo Front Elevation

- Applicant worked without a permit and replaced the porch floor decking with 2"x 6" pine wood

5. The replacement of the street- facing front porch with historically inappropriate material without the authorization of HAHC and in an amount greater than 100 sq Ft was deliberate and designed to circumvent the requirements of the Historic Preservation Ordinance.

6. Further, the owner then sought to conceal this violation by painting over the new deck boards to give them the appearance of having been there before the City’s Inspector could inspect the work.

Recommendation: Denial - does not satisfy criteria 1, 4, 5, 9 & 10 and issuance of a COR to remove the installed deck floor and replace the porch floor with 1"x4" T&G porch flooring wood perpendicular to the street and with slight slope towards street, as the original would have been
