**CERTIFICATE OF APPROPRIATENESS**

**Applicant:** Sarah Hannah, Four Square Design Studio, for Matt and Ashlea Sheridan, owners

**Property:** 803 W Melwood St, Lot 18, Block 205, North Norhill Subdivision. The property includes a historic 911square foot, one-story wood frame single-family residence and a situated on a 6,157 square foot (59.2' x 104') corner lot.

**Proposal:** Demolition – of the existing detached garage

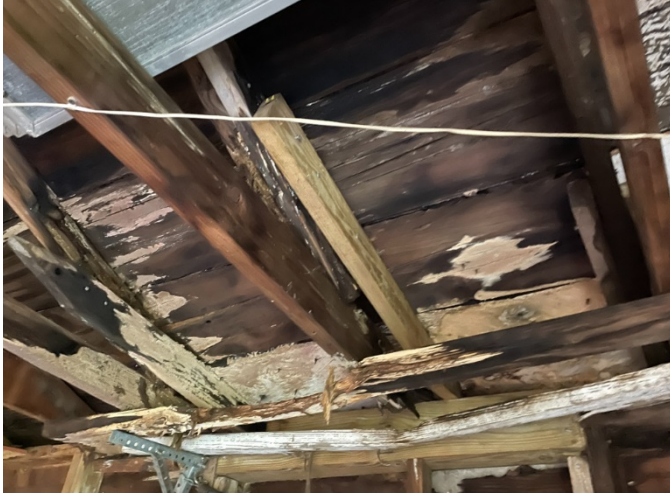
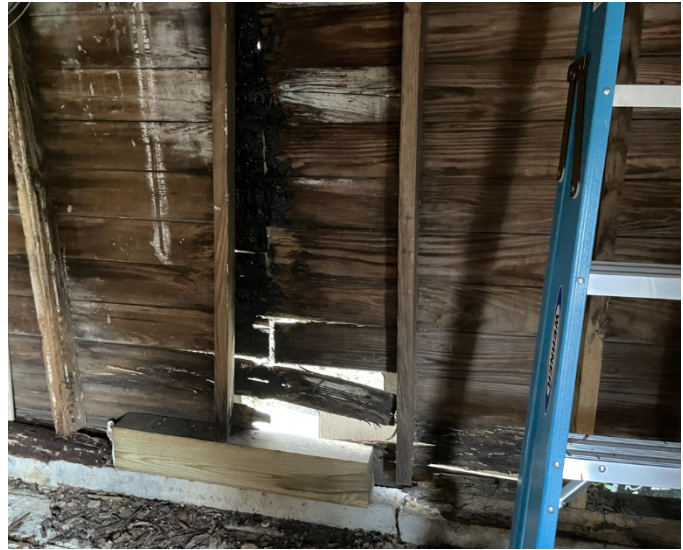
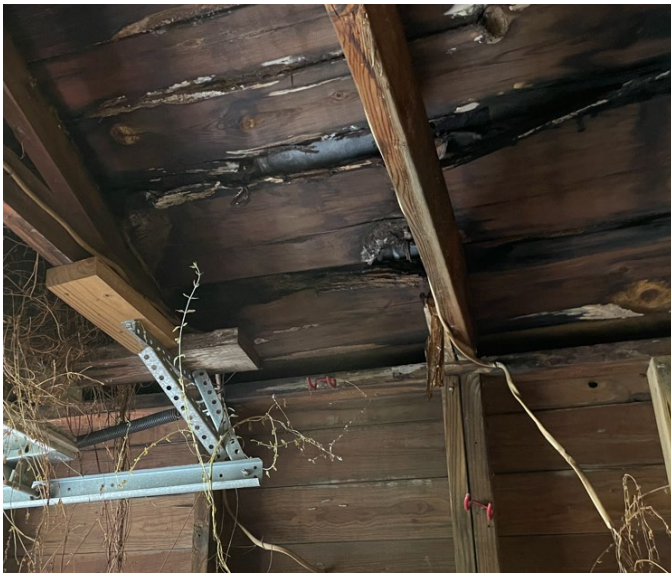
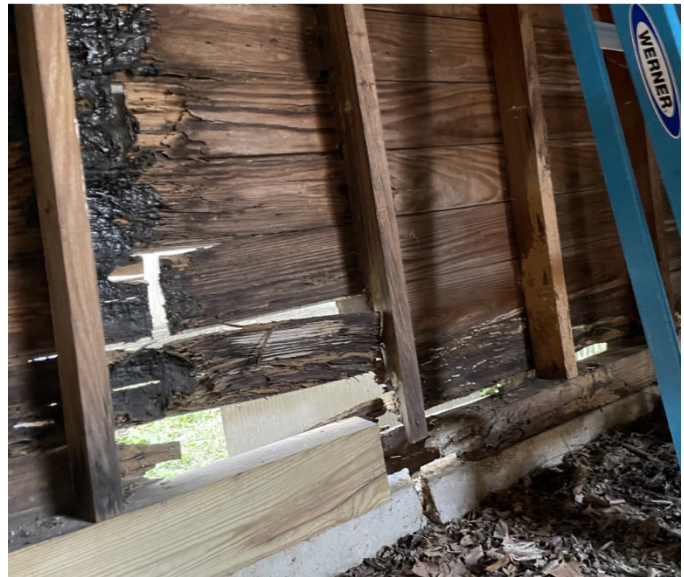
**CURRENT PHOTOS OF GARAGE  
INTERIOR**

In addition, the garage as shown on Sanborn and in Tax records isn't original and therefore is noncontributing and has no historic value. In addition to that it's in bad condition and isn't functioning as a garage. Please see mechanical report attached in support of that and supporting pictures.

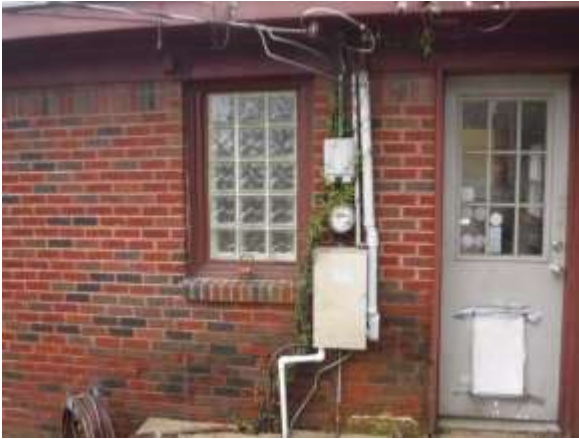
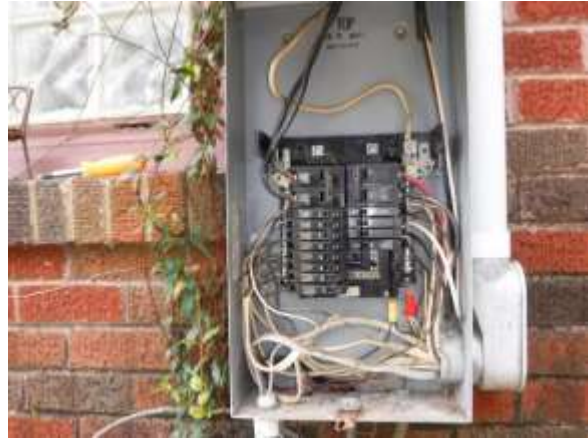
Due to the age and condition of the house and electrical system, further investigation with the seller and a licensed electrician is recommended to determine if any active knob-and-tube wiring is present in the home. We observed remnants of the knob-and-tube wiring at the rear of the home which had voltage present at the time of the inspection.

**Obtain Cost Estimate**

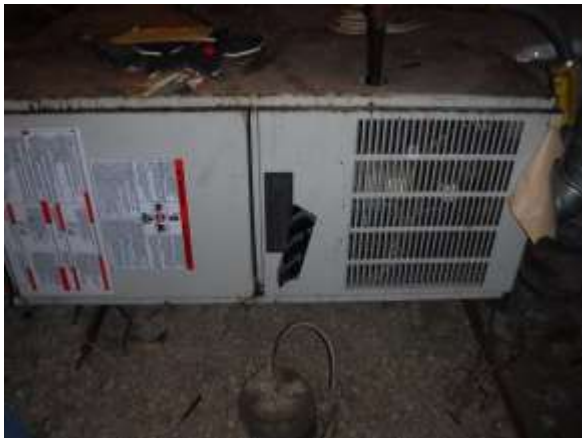
The heating for the house was provided by a natural gas-fired horizontal furnace located in the attic. The equipment was as follows:

Manufacturer	Size	Date	Location
Kenmore	75,000-BTU	1999	Attic

The gas was not on at the time of the inspection, and the furnaces were not operationally checked. It is recommended that all components of the furnaces be checked by a service company when the gas is turned on.

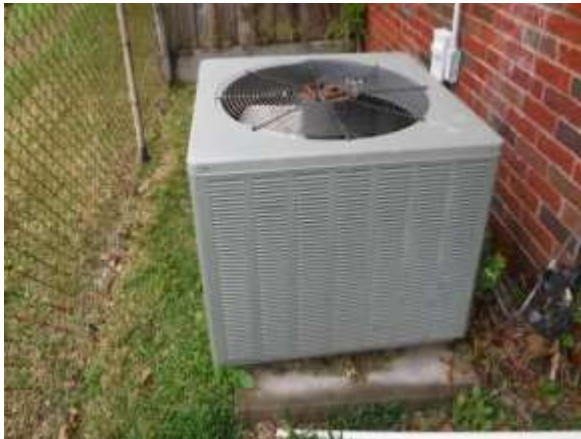
The air conditioning for the house was provided by one forced air split system. The equipment included the following:

<u>Zone</u>	<u>Condensing Unit</u>	<u>Date</u>	<u>Evap. Coil</u>	<u>Date</u>	<u>ΔT(degrees)</u>
House	3-ton WeatherKing	2009	NOT VISIBLE		15

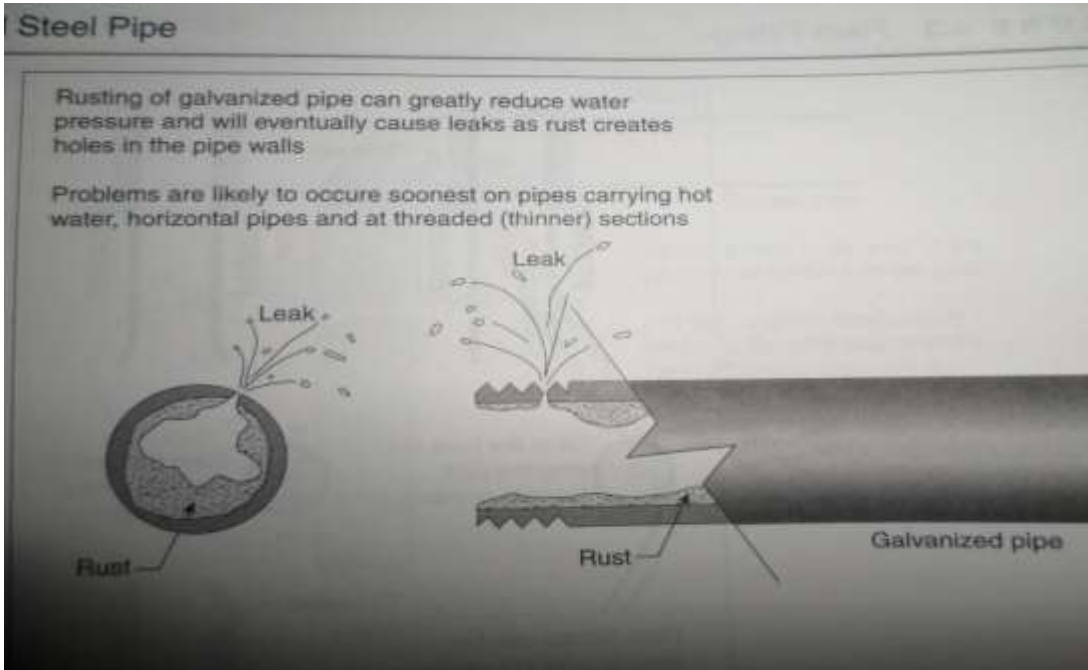
The water pressure reduced noticeably when a second faucet was turned on. With the galvanized water piping, the cause could be related to a buildup of rust or scale on the interior of the water piping. If the condition is unacceptable to you, then it is recommended that you check with a plumbing contractor.

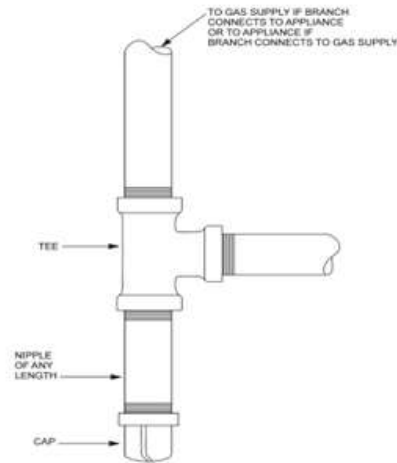
Clip art showing a sediment trap in gas line

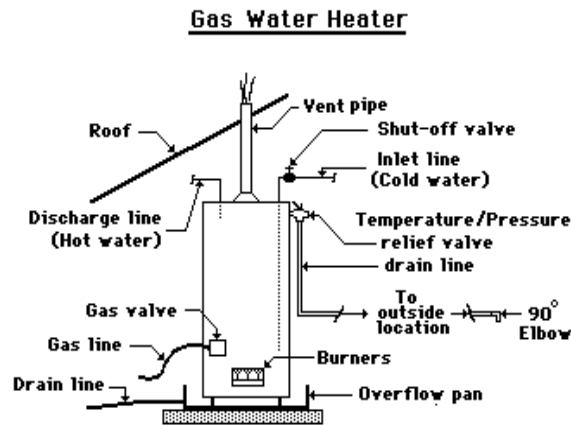
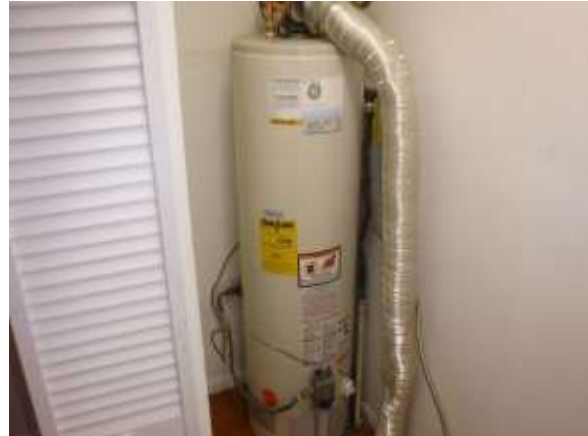
<u>Manufacturer</u>	<u>Size</u>	<u>Date</u>	<u>Piping Type</u>	<u>Location</u>
General Electric	40 Gallon -Gas	2010	Galvanized	Utility Room

The gas was off to the house at the time of the inspection, so the temperature of the water could not be checked. Normally, 120 degrees is the recommended maximum temperature of hot water to prevent accidental scalding. It takes approximately 1/2 second of exposure to 160 degree water to cause a second or third degree burn. See the link below for more information about hot water burns and a scalding graph.  
[http://www.accuratebuilding.com/services/legal/charts/hot\\_water\\_burn\\_scalding\\_graph.html](http://www.accuratebuilding.com/services/legal/charts/hot_water_burn_scalding_graph.html)

Due to the age and/or condition of the equipment, it is the opinion of the inspector that it has only a limited amount of life remaining. Normal life expectancy of a water heater in the Houston area is approximately 7 to 10 years.
