**CERTIFICATE OF APPROPRIATENESS**

**Property:** 1113 Tulane St, Lots 11 & 12, Block 205, Houston Heights Subdivision. The property includes a 1,024 SF one-story wood single family residence with a later two-story addition in the rear on a 8,800 sqft interior lot.

**Proposal:** Demolition –The applicant is proposing to demolish the contributing structure and the later additions due to its deteriorated condition, termite damage and water damage.

## STRUCTURAL REPORT

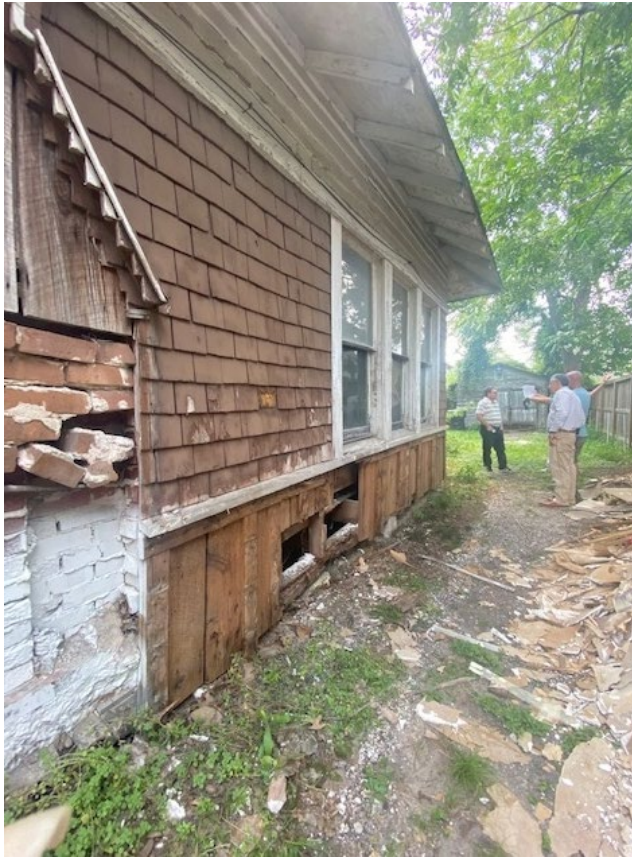
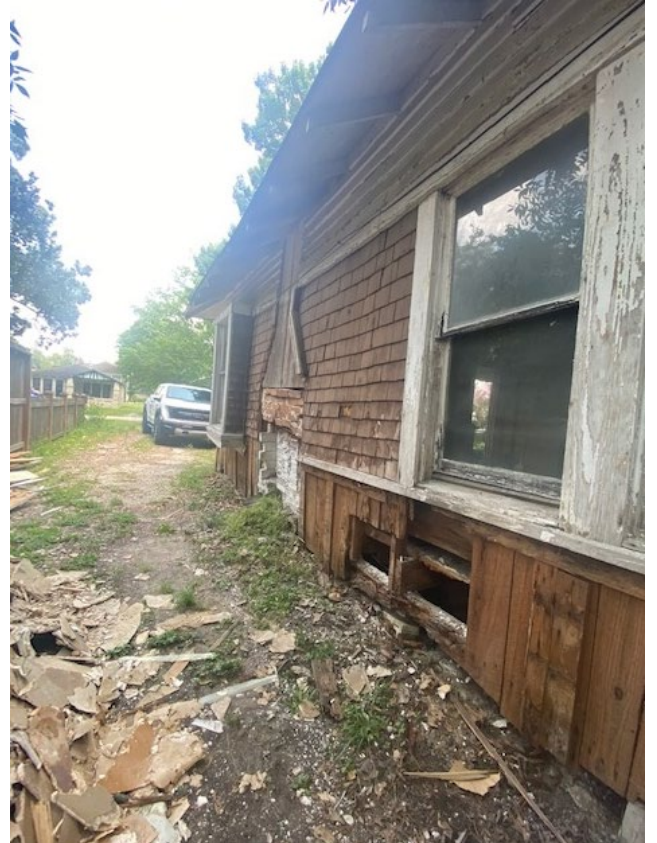
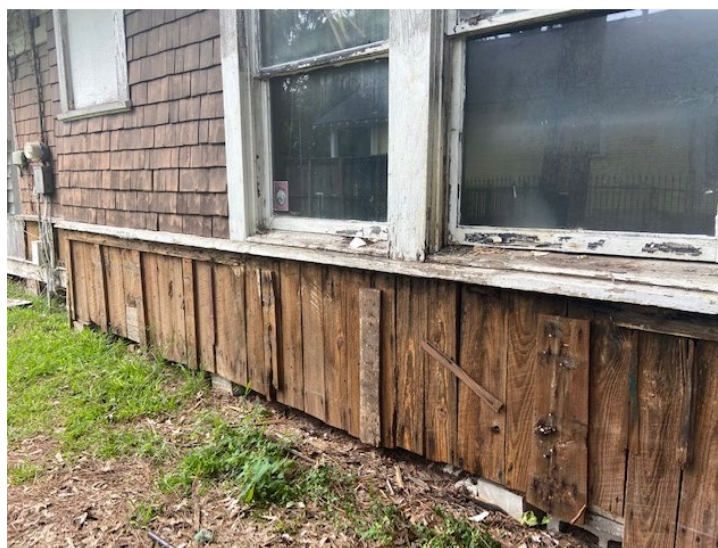
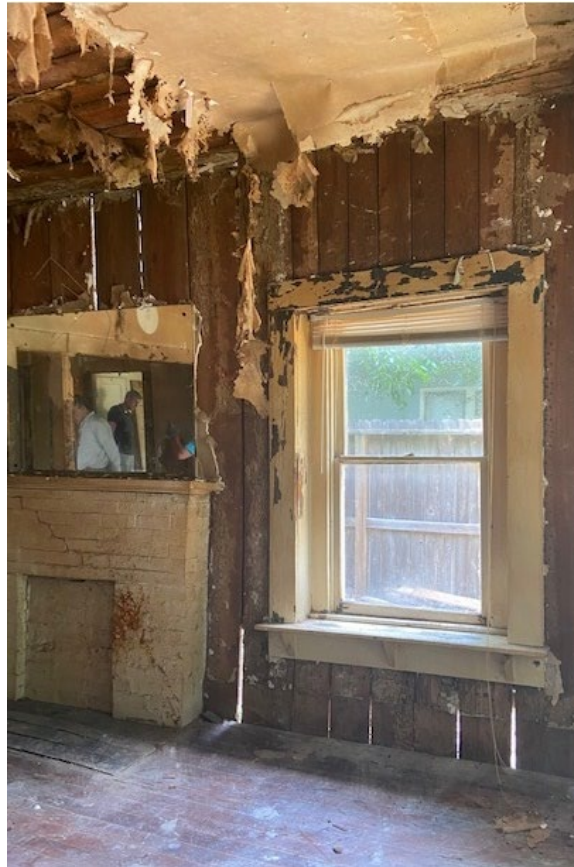
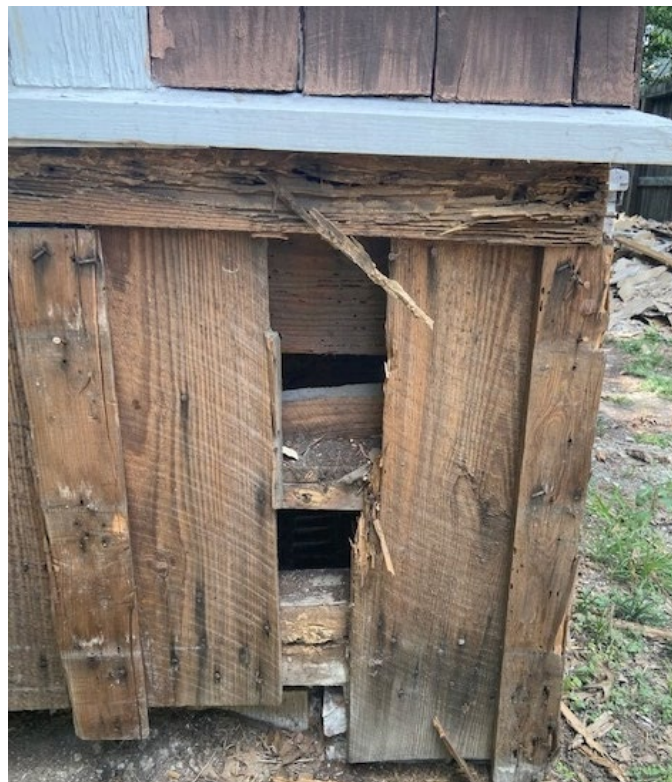
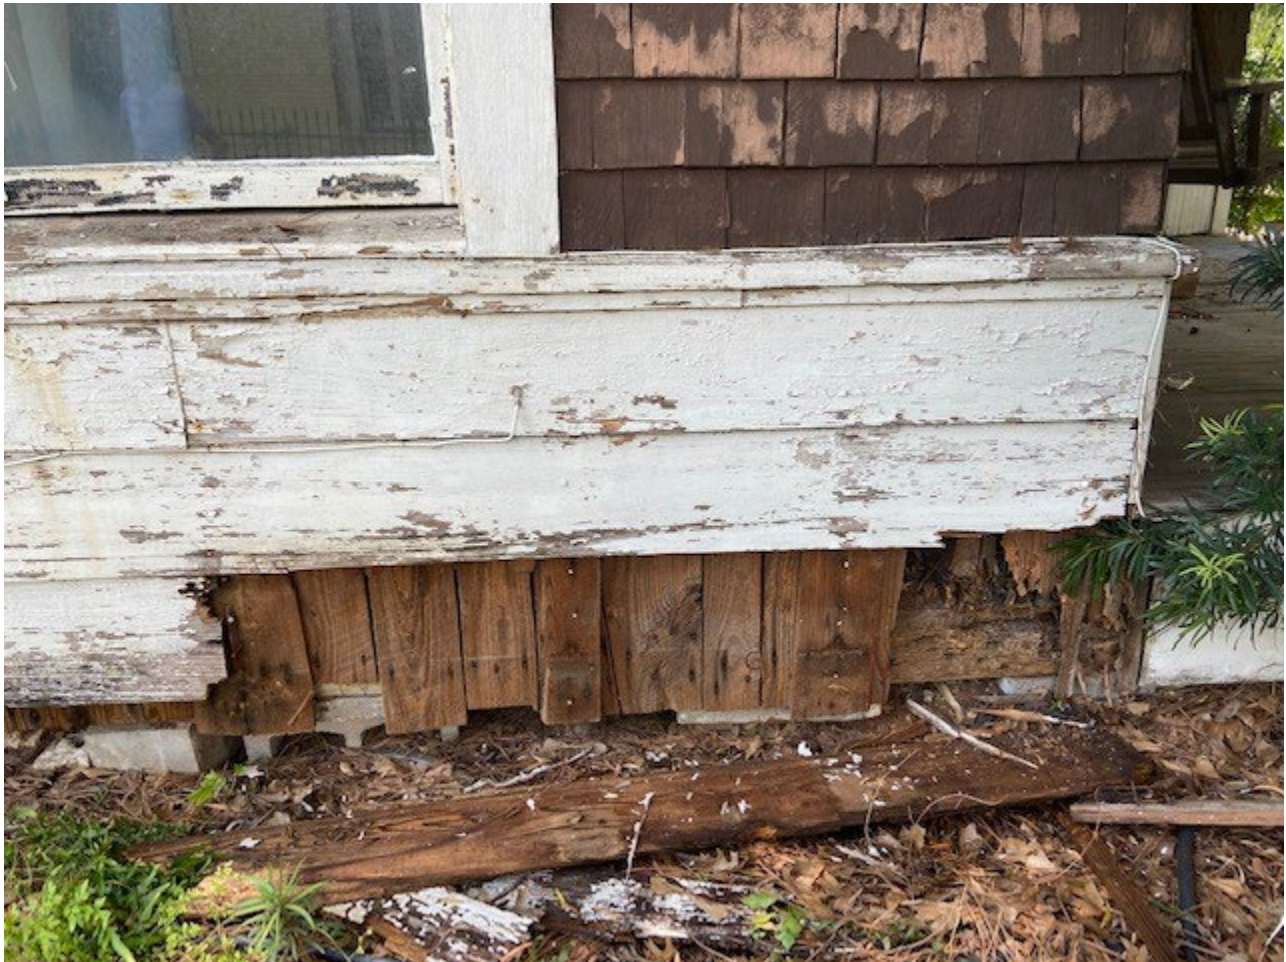
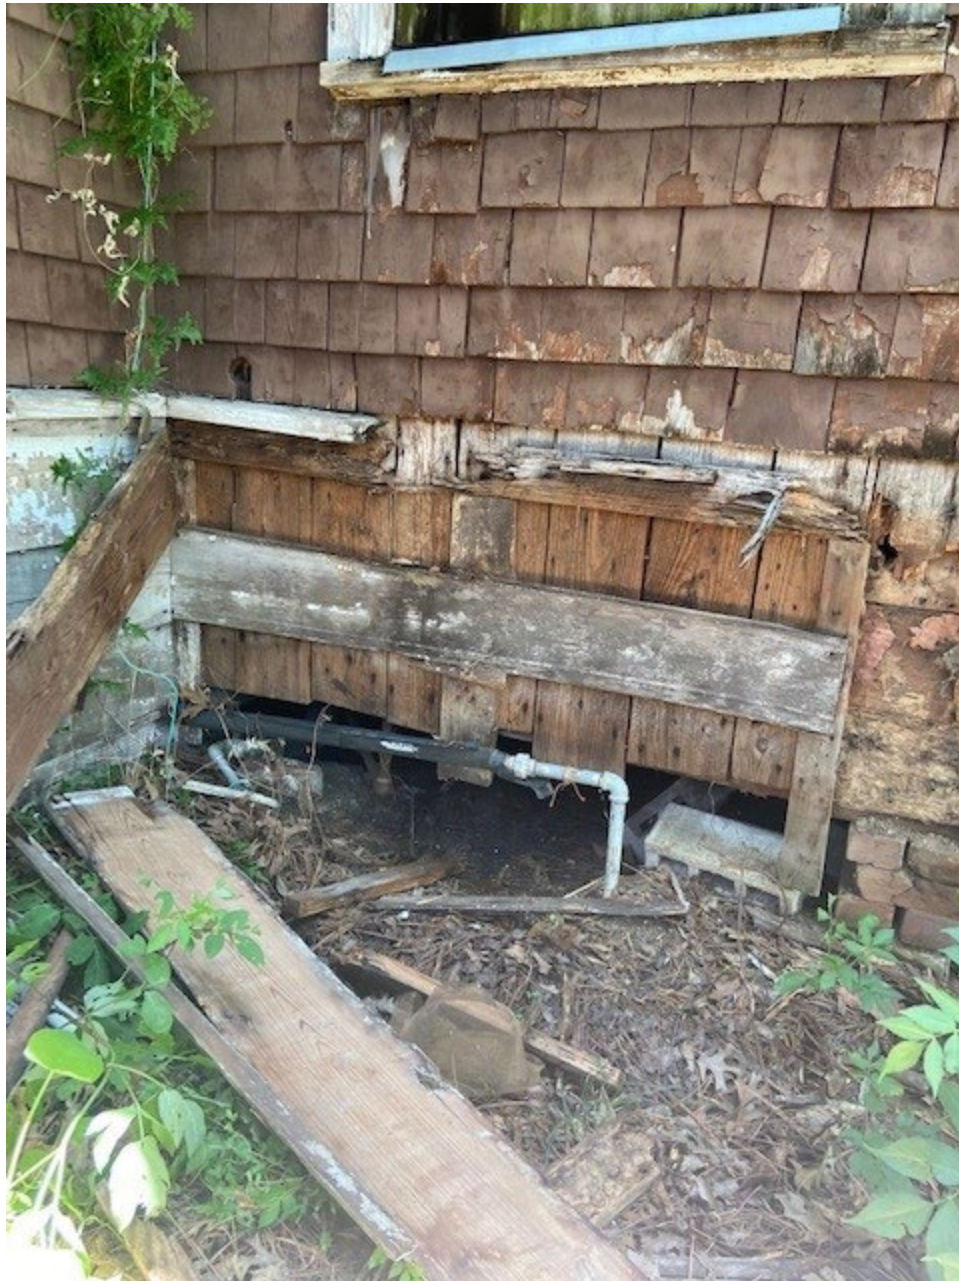
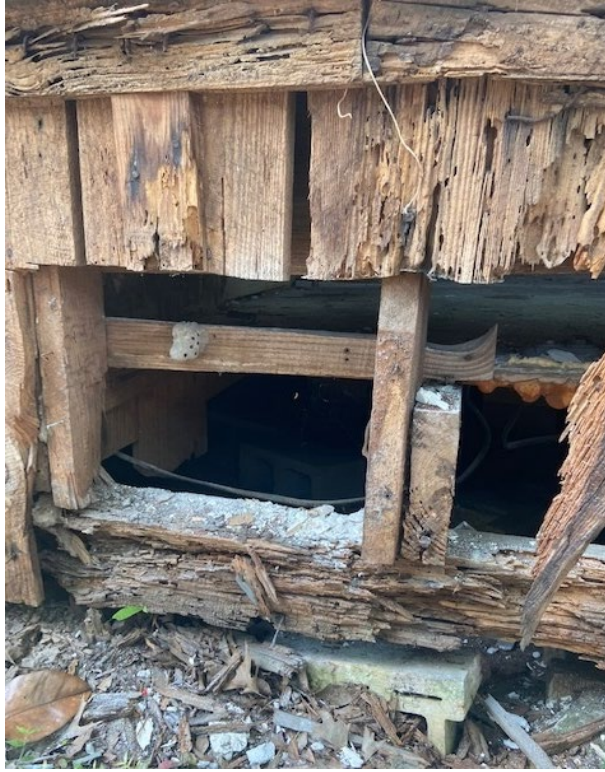
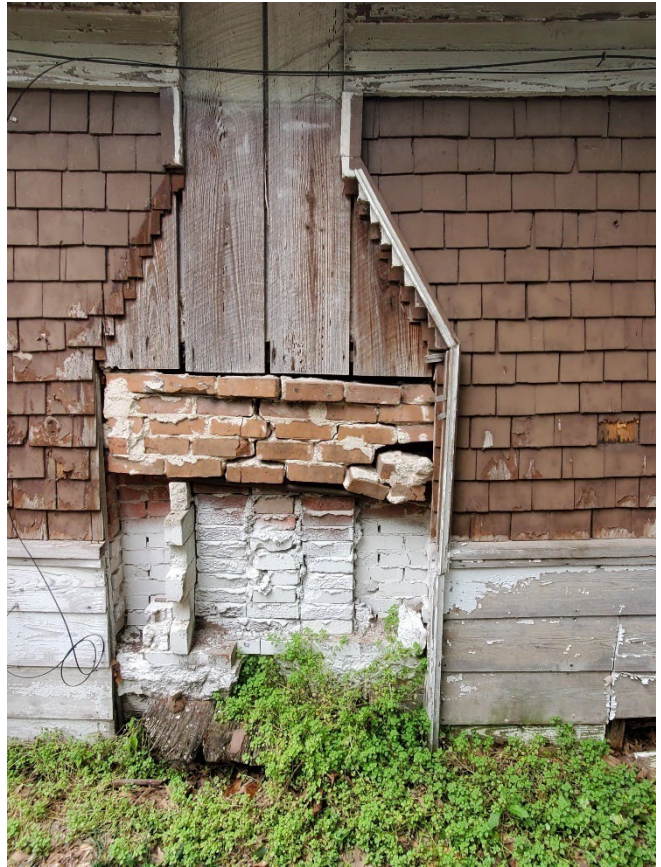
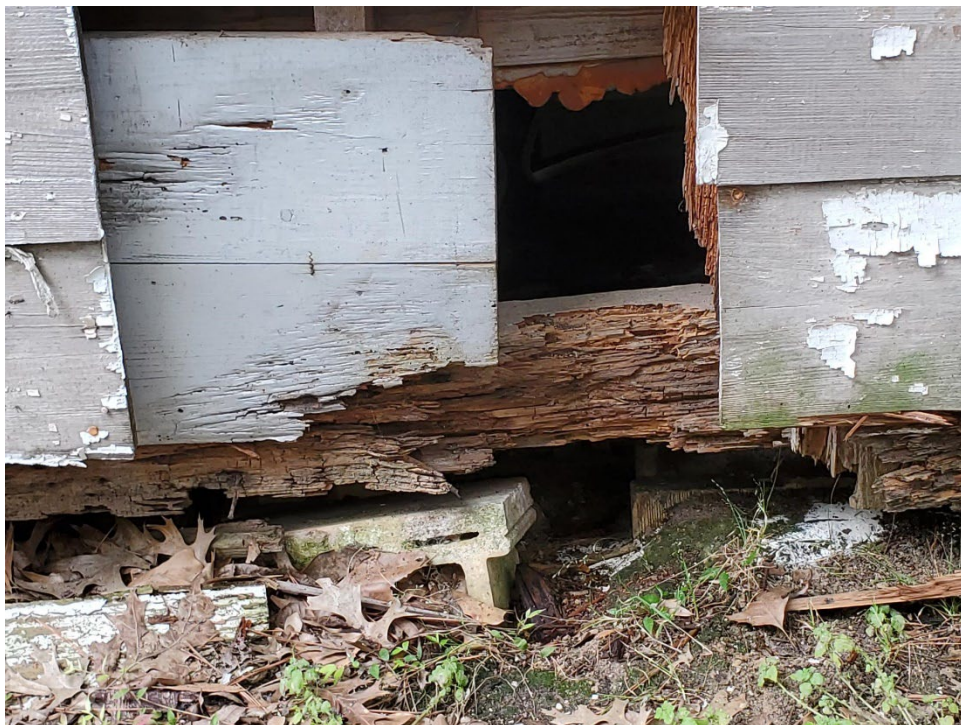
**EXISTING PHOTOS**

(AFTER APPLICANT REMOVE SOME BOARDS FOR FURTHER INSPECTION)

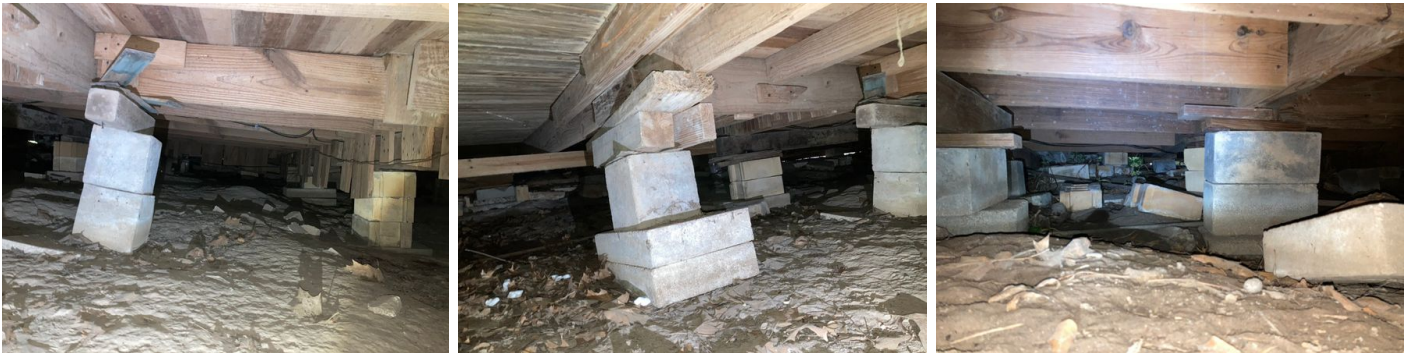
#### Description: Block and Beam

The foundation of the house was a block and beam type foundation, with individual support piers (blocks) and wood beams spanning between the piers at the crawlspace under the house.

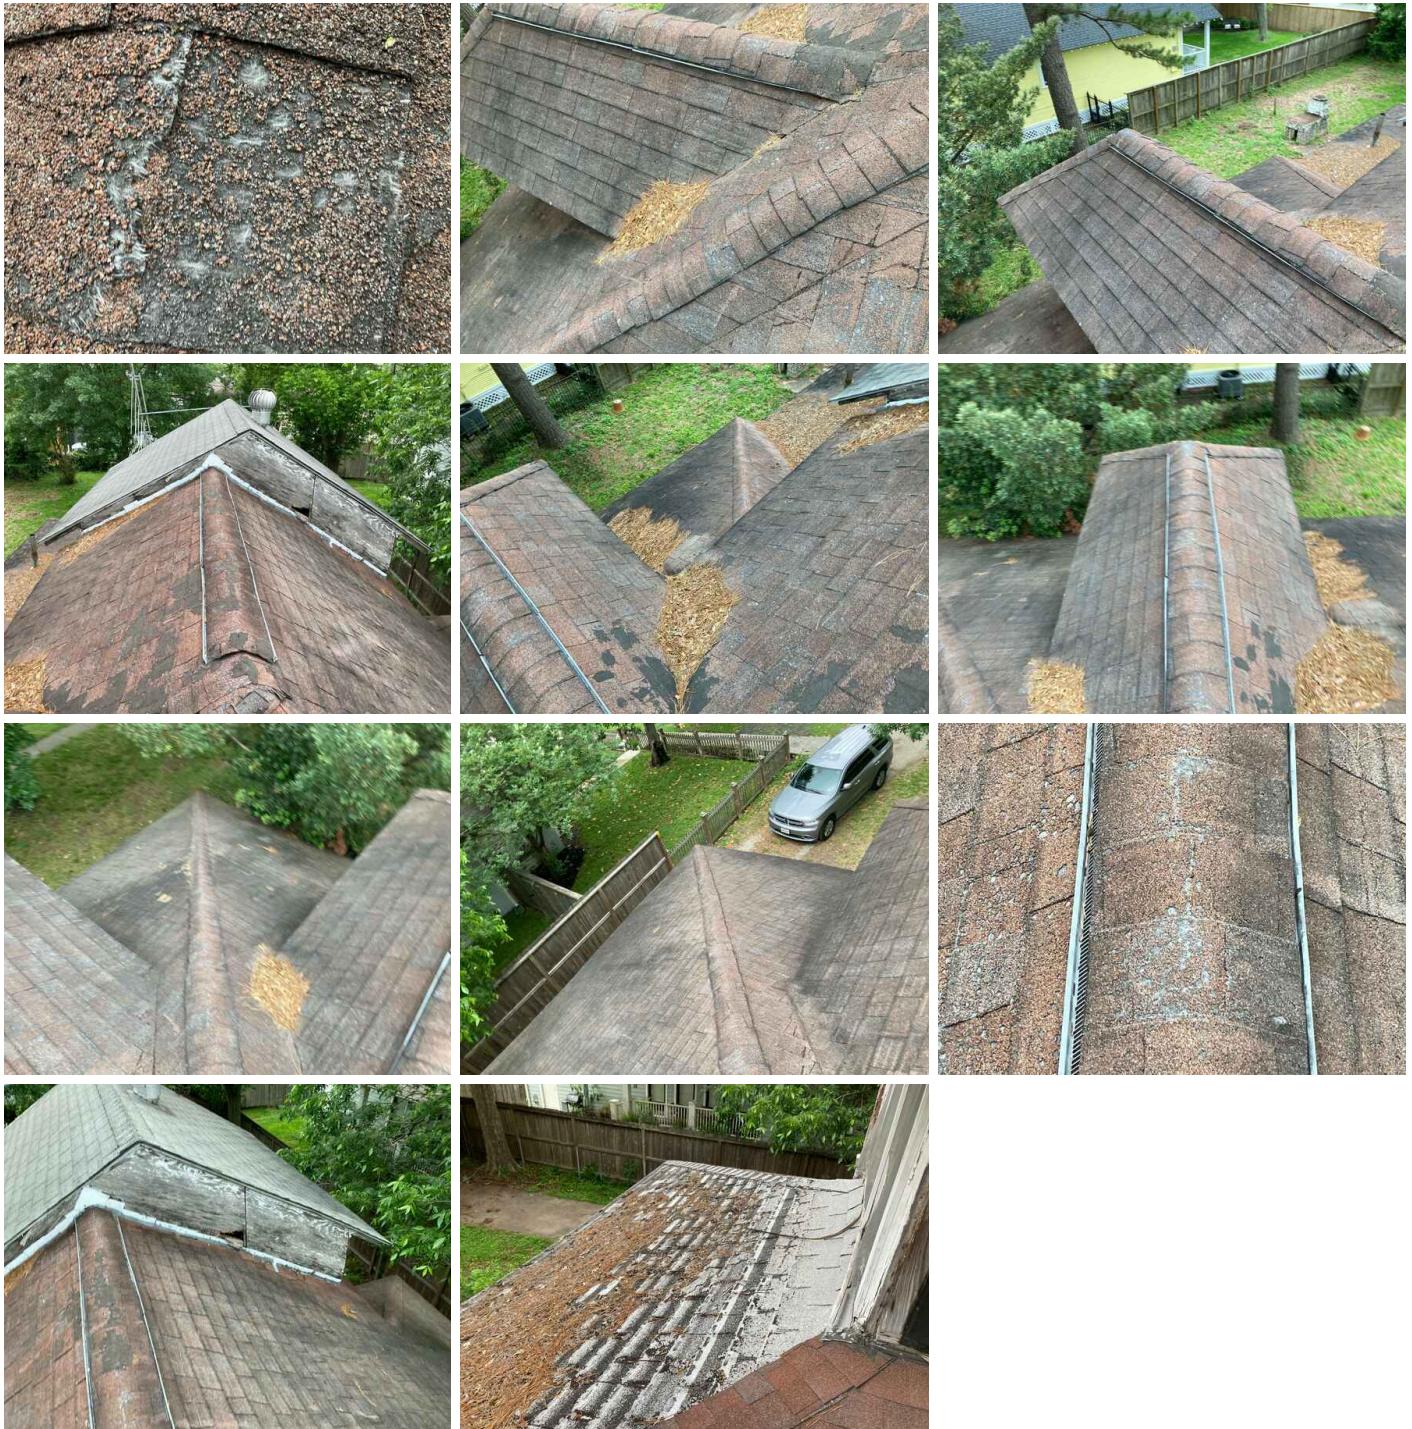
### Roof Description: Composition Shingles

The pitched roof surface was constructed of composition shingles. The life expectancy of a composition shingle roof has been observed to vary from 15 to 20 years, with most requiring replacement at about 17-20 years.

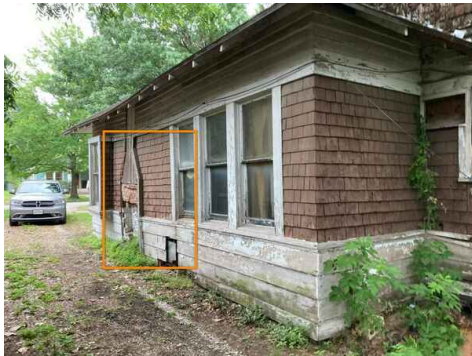
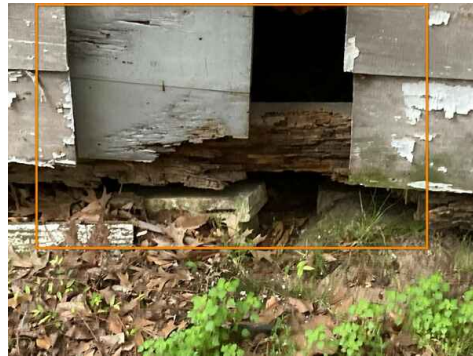
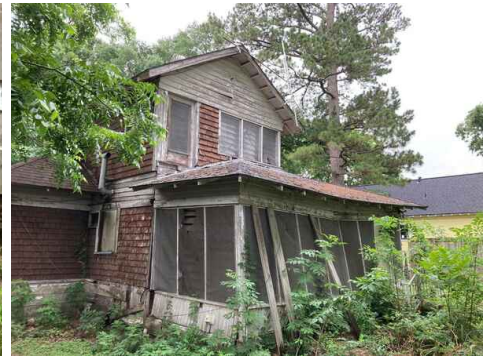
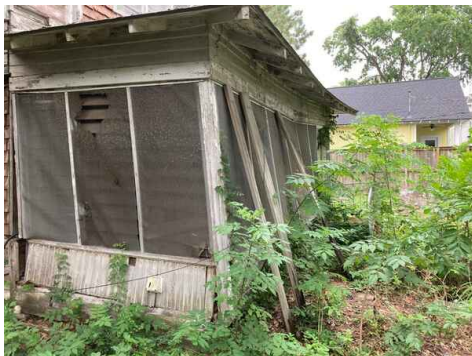
**REAR PORCH WALL AND THE HOUSE NORTH WALL**

The wall framing at the back porch and the north wall of the house were severely compromised.

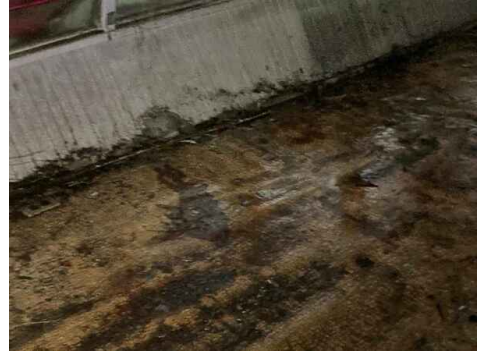
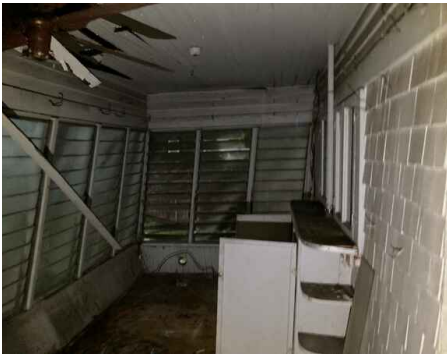
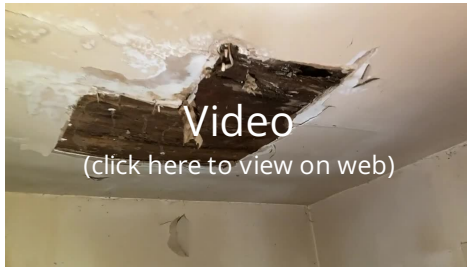
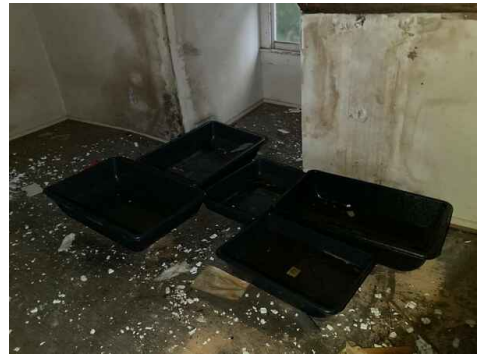
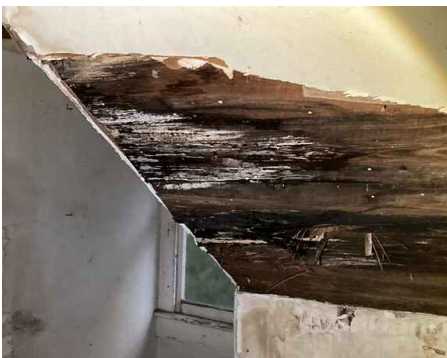
The house was in very poor condition, and, in our opinion, was in essentially tear down condition, with severe damage on beams under the house, water damage due to severe roof leaks, the walls being racked out of plumb, sagging framing members, rotted framing members, damage from wood destroying insects, and rotted roof deck. It is pointed out that the house it is not safe to inhabit in its current condition.

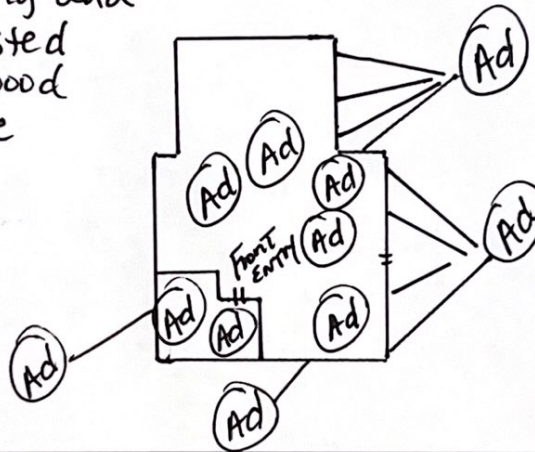
In my professional opinion,  
 Framing, subFlooring and  
 Siding is too infested  
 with active drywood  
 termites to achieve  
 control.
