# CERTIFICATE OF APPROPRIATENESS

ITEM XXX  
HPO File #: HP2026\_0206

914 Main St  
Landmark:

RE: North Elevation Façade Repair Program – Supplemental Letter (Completed Stabilization Inspections)  
Commerce Towers  
914 Main Street  
Houston, Texas 77002  
K&H Project No. 11393.5001R

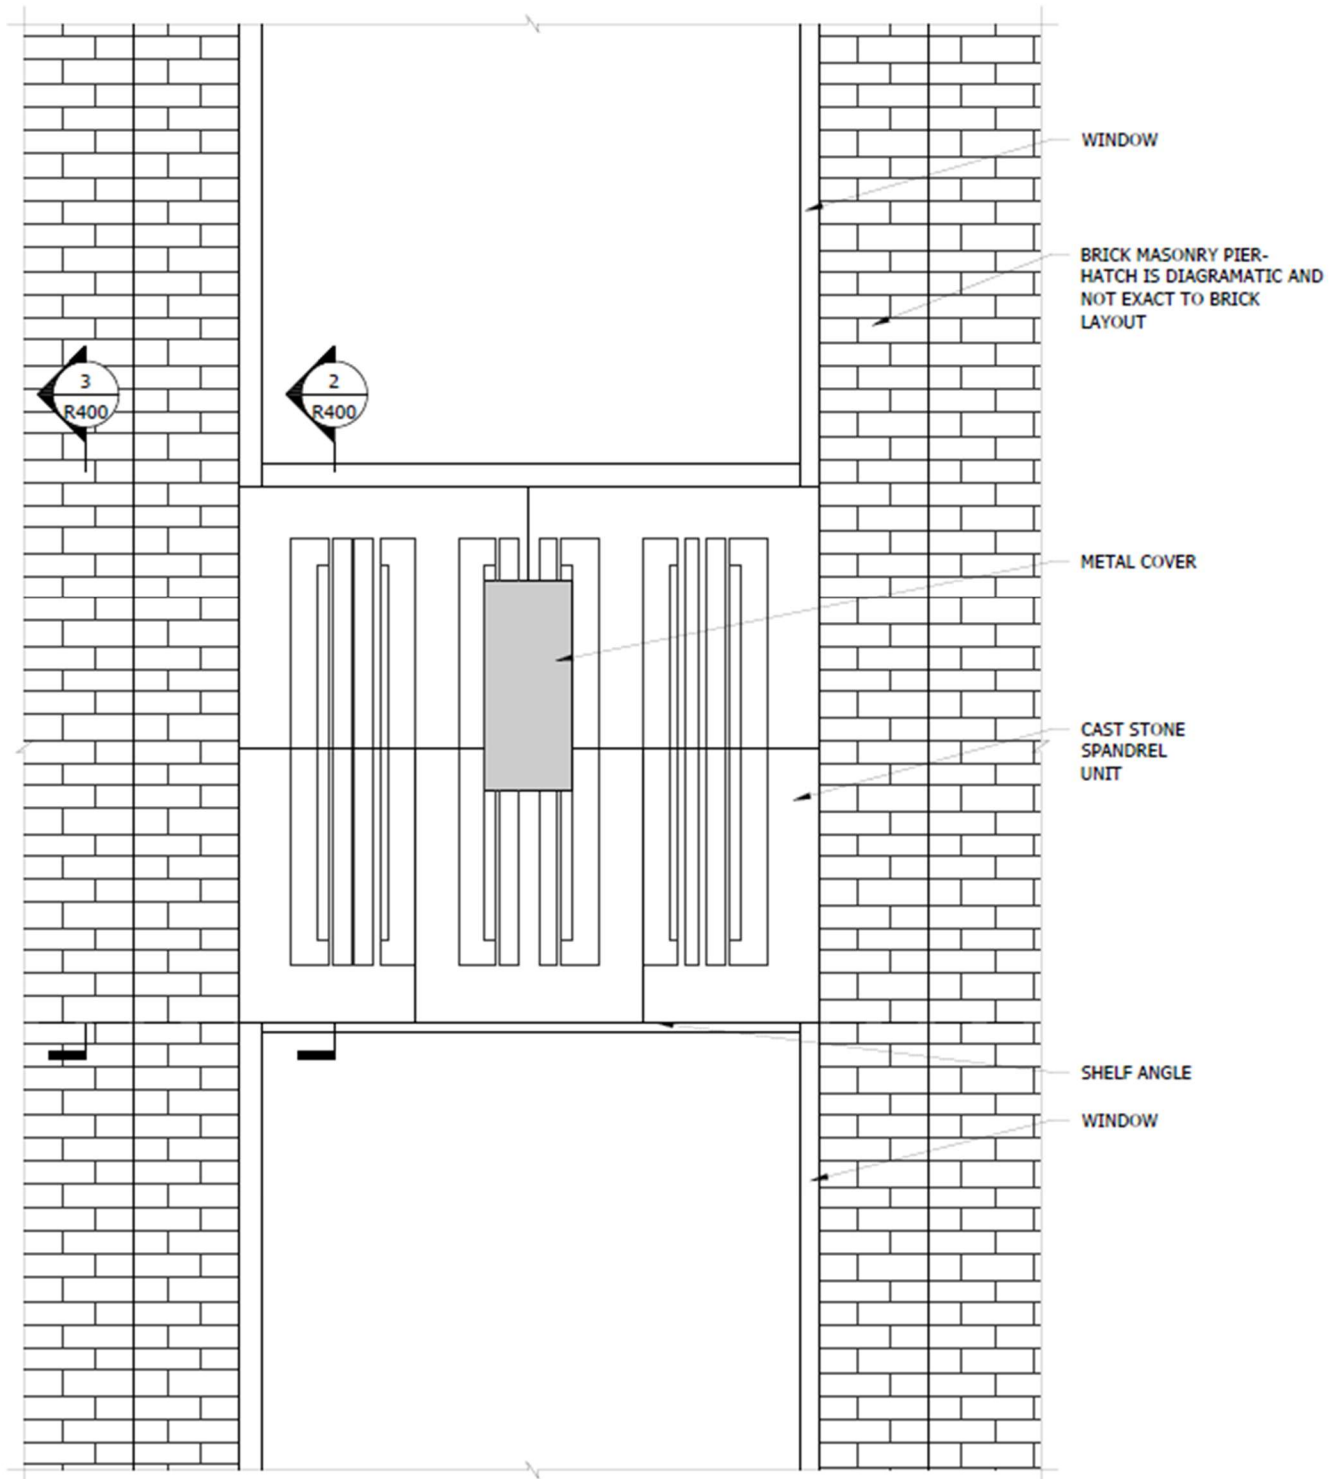
## TYPICAL CAST STONE SPANDREL

- Repoint deteriorated mortar joints, replacing cracked brick masonry units, rehabilitating steel shelf angles, and replacing cracked or spalled cast stone spandrel units. The spandrel units will be replaced with either GFRC or cast stone to match the existing color, texture, and profile of the existing units.

- Rebuild 100% of the cast stone spandrels from the 12th floor to the 25th floor.
- Repair/replace the cast stone spandrels at shelf angles utilizing the diagram depicted on the next page. This repair includes pinning the upper cast stone units in place to remove the lower three units resting on the steel shelf angles.

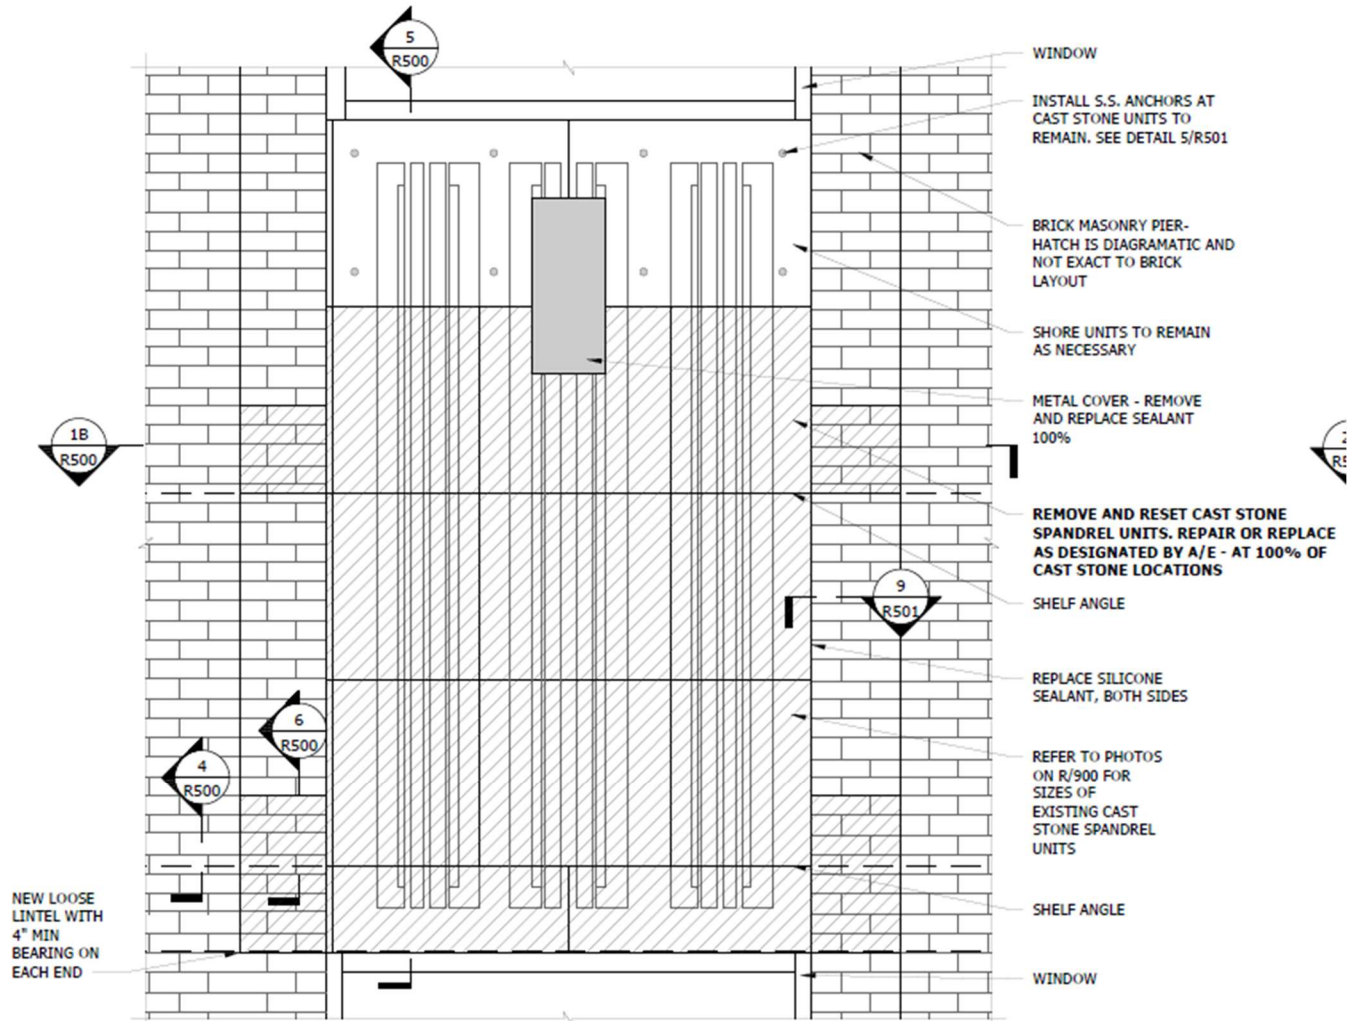
## 12<sup>TH</sup> FLOOR ENLARGED SPANDREL

- a. Consistent with prior findings, the 12<sup>th</sup> floor spandrels contained significant deterioration at both the north and east elevations at nearly every spandrel location.

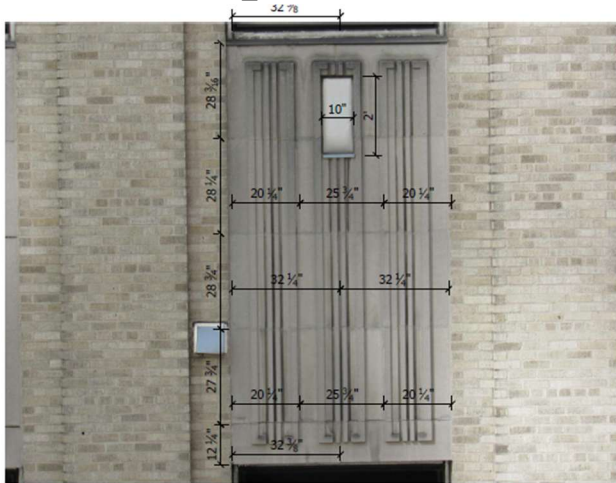
5 12TH FLOOR SPANDREL  
SCALE: NTS

NOTE: SPANDREL CONTAINS 11 UNITS

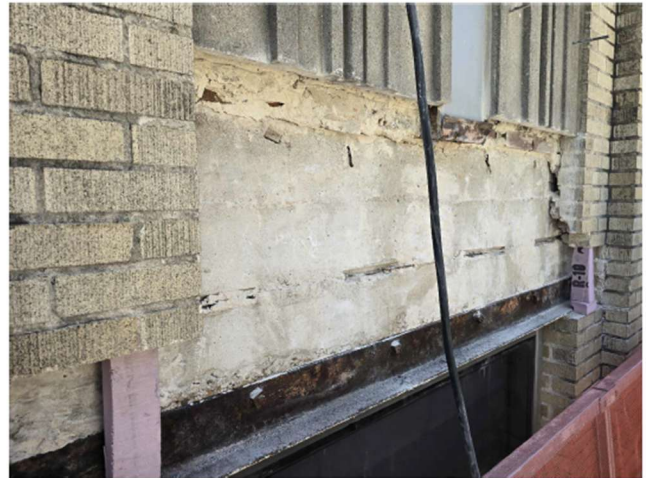
8 SHELF ANGLE (EXPOSED) AT SPANDREL  
SCALE: NTS

1. Isolated spalls primarily located at the lower/first course of cast stone units, the units which bear on the steel shelf angle, were observed (Photo Nos. 1 – 2). This is consistent with the findings from the prior reports. The lower/first course of cast stones contain significantly more deterioration compared to the second course because of the corrosion at the shelf angle and lateral ties.

4. Given that our structural analysis found the existing shelf angles to be adequate, our recommendation is to leave as many in place as possible, unless there is substantial deflection or section loss. Because the shelf angles will remain in place, the goal will be to provide substantial protection to the existing steel to minimize the potential for future corrosion.

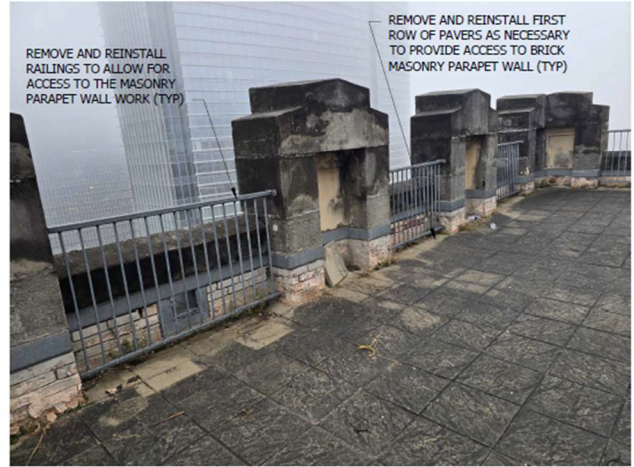
10 PARAPET BACKSIDE/ELEVATION  
SCALE: NTS

1. The parapet wall across the north facade of the building contained significant deterioration to the inboard/roof-facing masonry wythe, with extensively washed-out mortar joints (Photo Nos. 5 – 6). The outboard/street-facing limestone copings and piers of the parapet wall appeared to be in better condition comparatively, but did have weathered and open mortar joints as well as isolated outwardly displaced limestone units.
2. One (1) inspection opening was performed at the inboard masonry wythe to better understand the condition of the masonry wythes behind the outer wythe. We found that the inboard/roof-facing brick masonry wythe is the only brick wythe before the limestone units. Additionally, although the mortar joints are heavily eroded, the remaining mortar was solid and well bonded.

9. Remove and reset displaced limestone units at the parapet wall.
10. Repoint the inboard side of the masonry parapet wall. Isolated rebuilding of the outer wythe of brick masonry may be necessary.
11. Replace window perimeter sealant 100%.
