**CERTIFICATE OF APPROPRIATENESS**

**Property:** 4019 Inverness Drive, Track 10 and 11A, Block 90, Tall Timbers section of River Oaks. The property includes a historic 5,900 square foot single-family residence and attached 1,040 square foot garage situated on a 43,200 square foot corner lot.

**Significance:** The Tone-Howe House is a protected landmark residence built in the Southern Colonial style. This country house type of residence was designed by Architect Birdsall Briscoe and constructed circa 1957.

**Proposal:** Alteration –

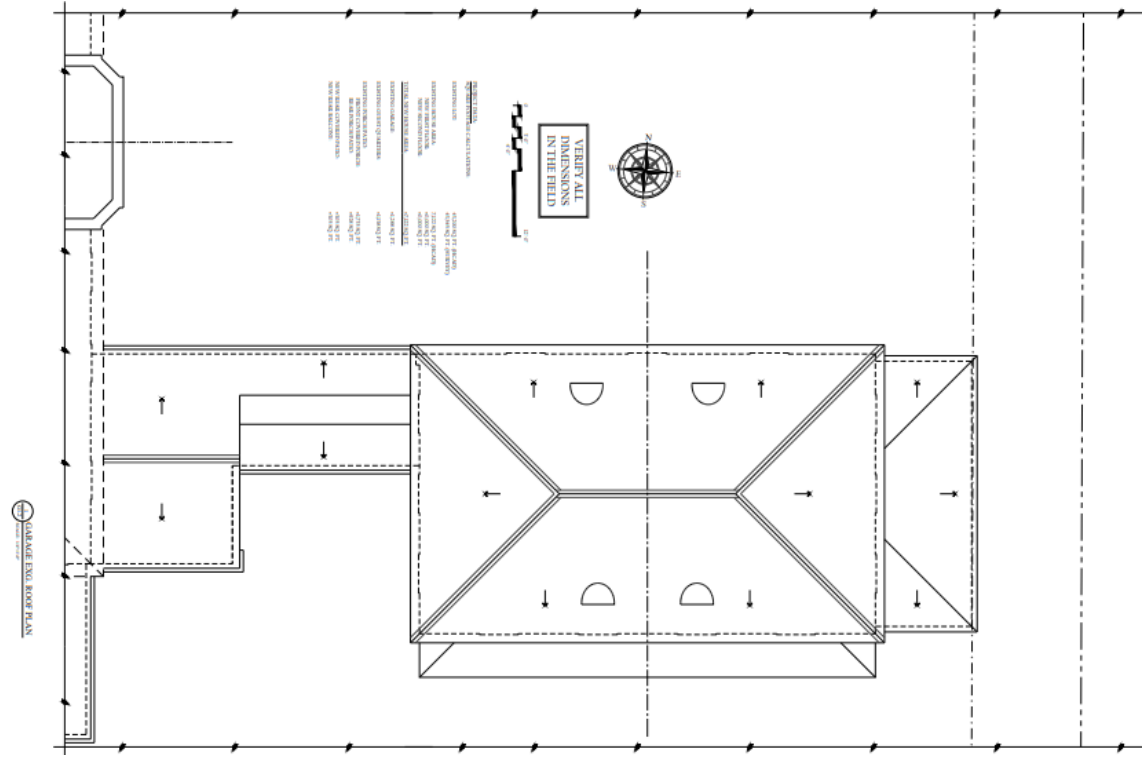
**ROOF PLAN – ATTACHED GARAGE**  
**EXISTING**

- **Roof:** The existing is cedar shingle roof covered by a composition shingle will be removed. The main house and Garage roof will be replaced by the proposed *Vermont semi-weathering slate roof*. The breezeway roof to the Garage will be replaced by a *copper standing seam roof*. A new balcony roof on the rear of the Garage will be a copper standing seam roof.

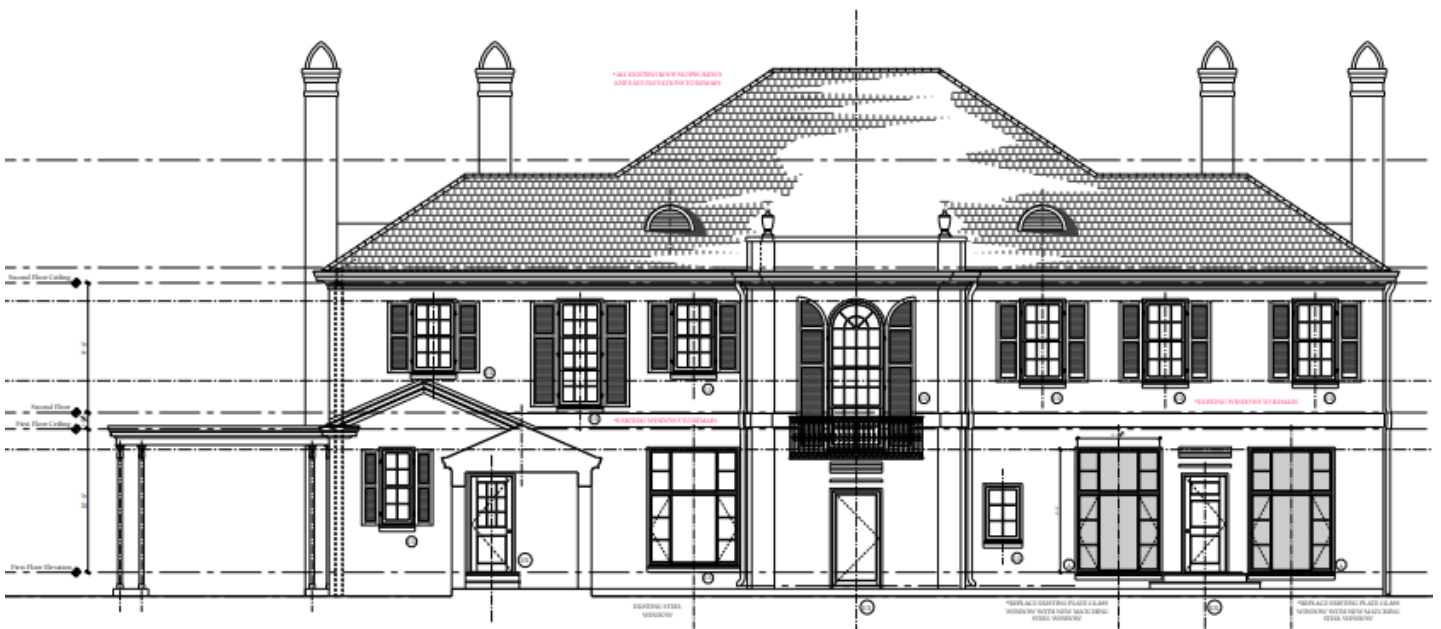
**EAST ELEVATION – (REAR)**  
EXISTING/PROPOSED

- **Main House:** two broken plate glass units on the rear/east elevation to steel units matching the existing steel unit on the same elevation.
- **Main House:** no eaves or ridge heights are being altered. No changes to square footage.

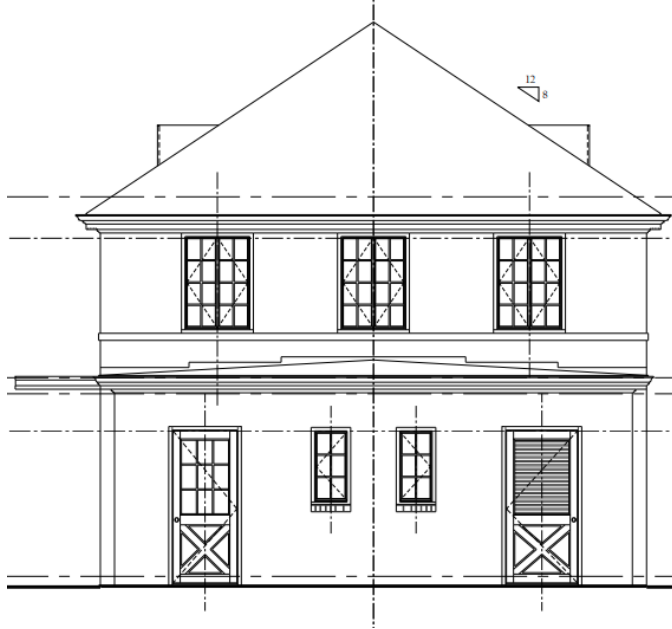
EXISTING

**EAST ELEVATION –(REAR SIDE OF GARAGE)**

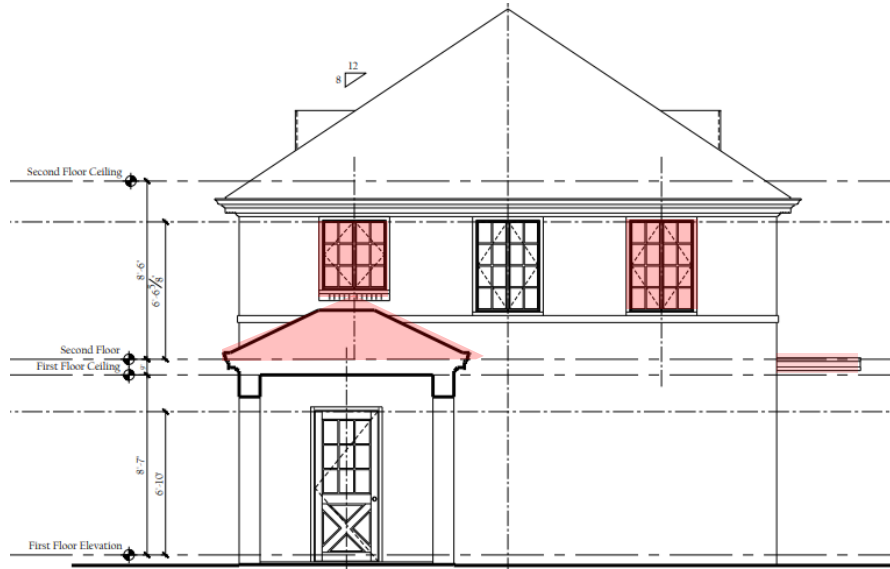
EXISTING

**EAST ELEVATION –(FACING REAR OF PRIMARY RESIDENCE– GARAGE)**

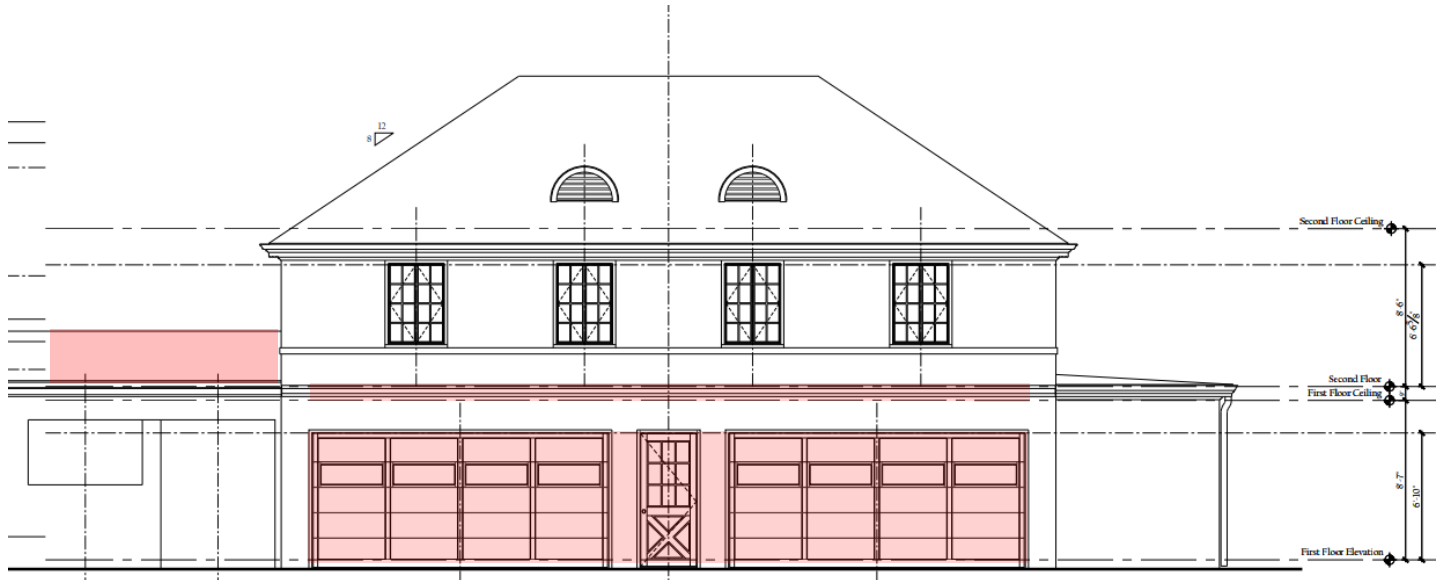
EXISTING

**SOUTH ELEVATION – FRONT FACING DEL MONTE DRIVE (GARAGE)**

- **Garage Door:** The existing Garage has two wooden garage doors with glass panes. There is a man swing door in the center between the garage doors. Applicant proposes the doors openings to be altered and doors replaced by three wood garage doors with glass panes, similar in design to the existing garage doors. The scroll work detail will be replicated on the new doors. The existing two Garage Doors are 7'6" high x 16' wide. The three new Garage Doors are 7'6" high x 10' wide. The existing doors are wood and glass; the new doors to match.

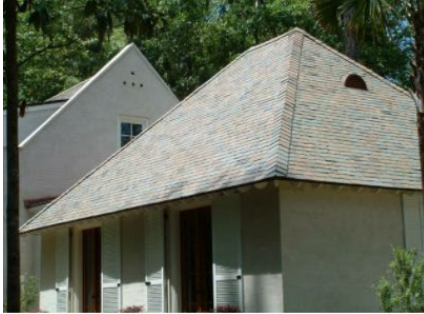
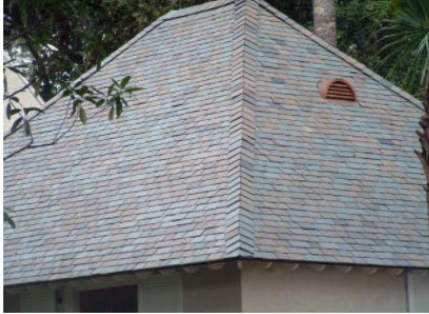
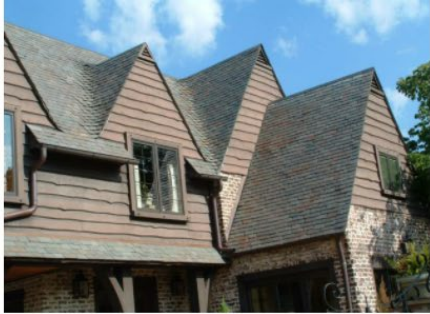
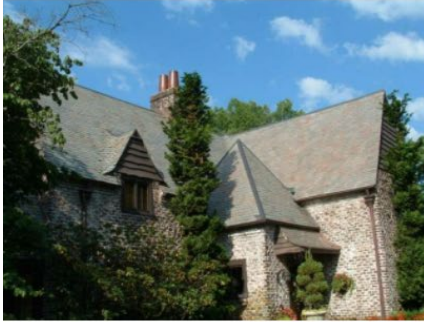
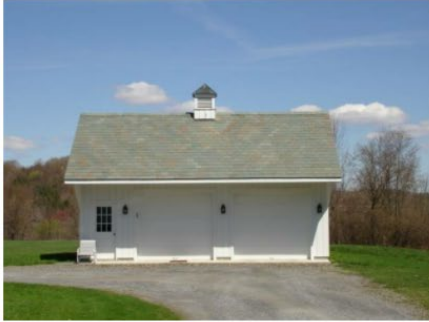
Reference for new roof material:

Vermont Semi Weathering Green and semi weathering Gray Slate

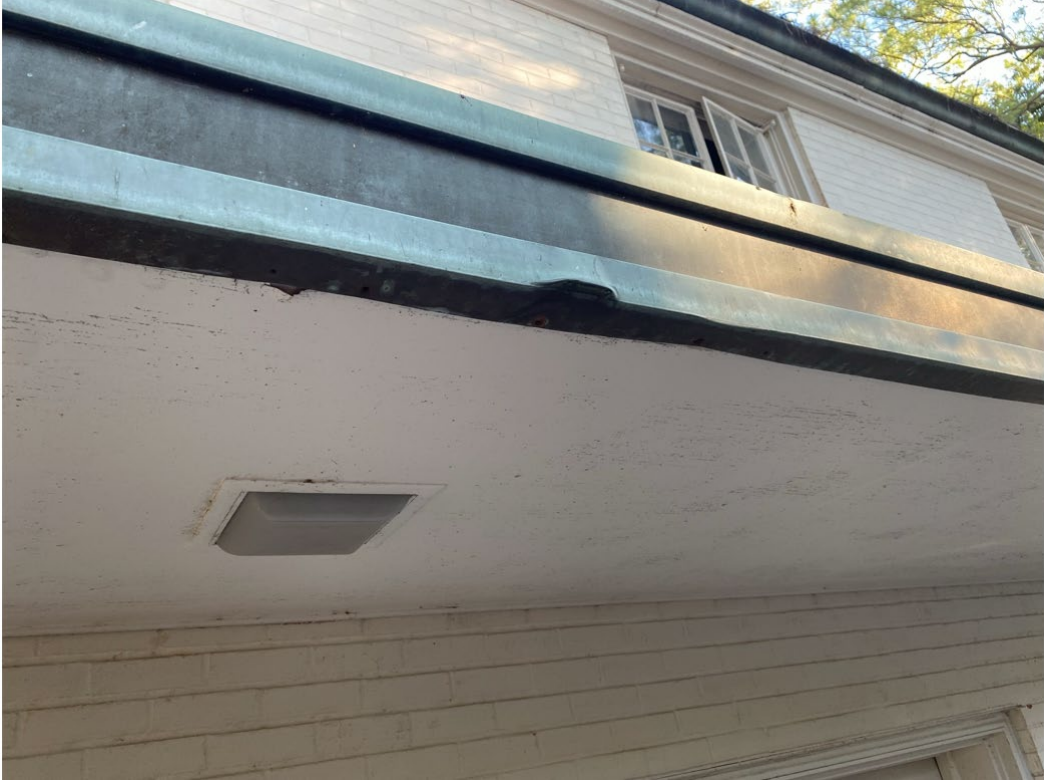
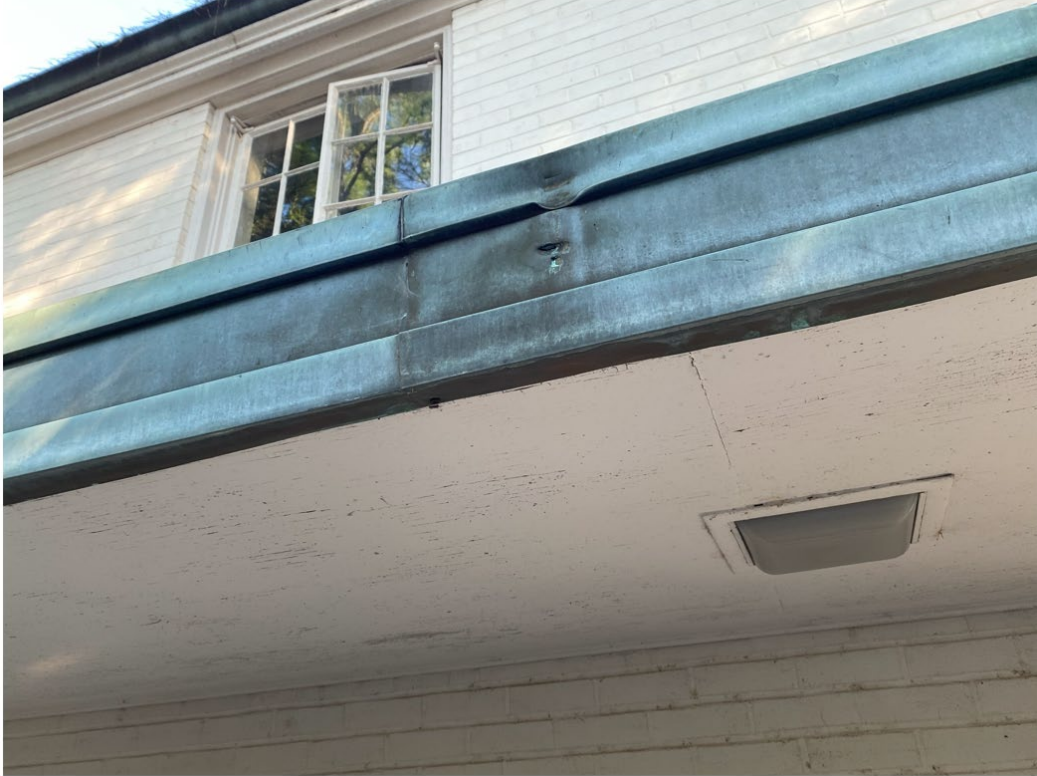
Condition of Copper Clad Awning

Hard to see in these photos but the copper cladding wrapping the front and top of the awning has multiple areas where it needs to be removed, repaired, and/or replaced.

Additionally, the plywood on the underside of the awning is starting to delaminate and needs to be replaced.

Possibly some repair to the structure but that's to be determined.
