CERTIFICATE OF APPROPRIATENESS

- **Property:** 1029 Arlington Street, Lot 4, Block 219, Houston Heights Subdivision. The property includes a historic 1,500 square foot, one-story wood frame single-family residence situated on a 6,600 square foot (50' x 132') interior lot.
- Significance: Contributing Queen Anne residence, constructed circa 1920, located in the Houston Heights Historic District South. Previous alterations include a COA in April of 2013 for the northwest rear corner.

Proposal: Alteration – Addition, Revision to COA approved by HAHC 5/22 HPO2022_0110

November 17, 2022 HPO 2022_0254

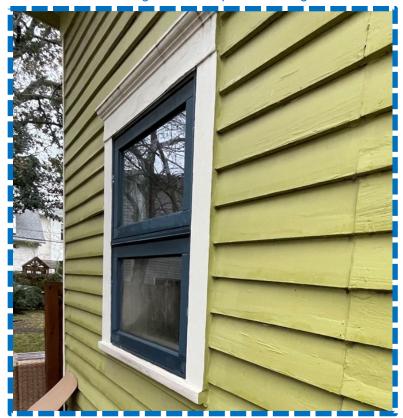
CURRENT PHOTOS – REAR ELEVATION (WEST) ADDITION C. 2013

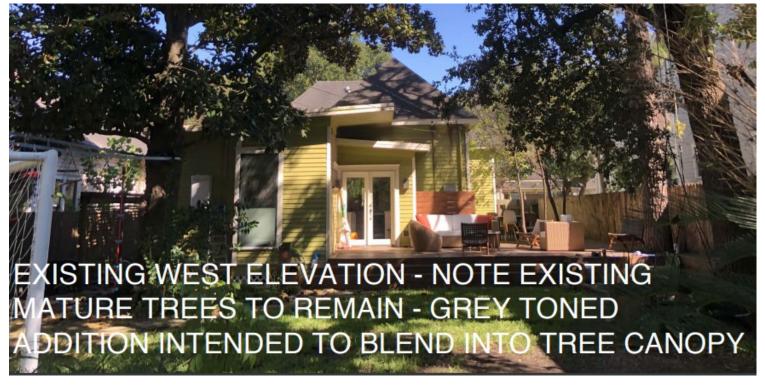
CURRENT PHOTOS - REAR ADDITION (SHOWING SOUTH SIDE) C. 2013

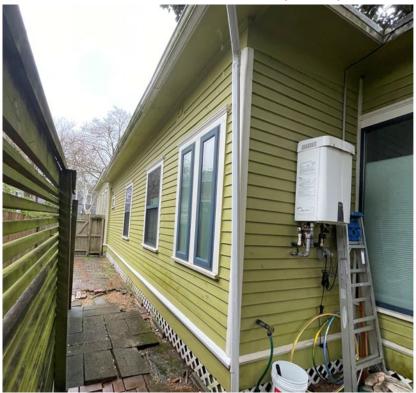
CURRENT PHOTOS - NORTH SIDE ELEVATION (RIGHT) LOOKING TOWARDS BACKYARD

Non-original, REPLACEMENT windows

(9)	The proposed design for any exterior alterations or addition must not destroy significant historical, architectural, archaeological or cultural material, including but not limited to siding, windows, doors and porch elements; <i>Window alterations on historic portion are not original openings and contain replacement windows.</i>

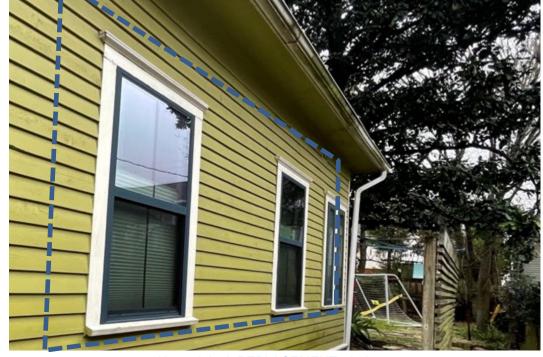
Non-original, REPLACEMENT windows VIEW FROM STREET – NORTH SIDE

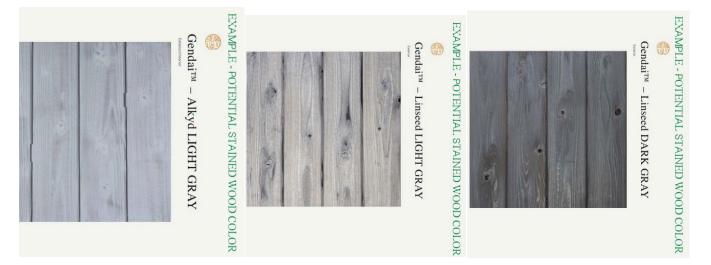
While the exact exterior cladding has not yet been determined, the attached represent the general design intent being pursued, and the likely material supplier, Nakamoto Forestry: light to medium grey stained, or weathered wood, which is most likely to be a Shou Sugi Ban traditional Japanese siding, otherwise commonly known as "burnt cedar" siding, which has a protective char layer on the exterior that is stained / sealed & then left to weather naturally.

It is proposed to be installed in a tight vertical pattern with minimal trim conditions to focus visual attention to the simple geometric form of the new addition.

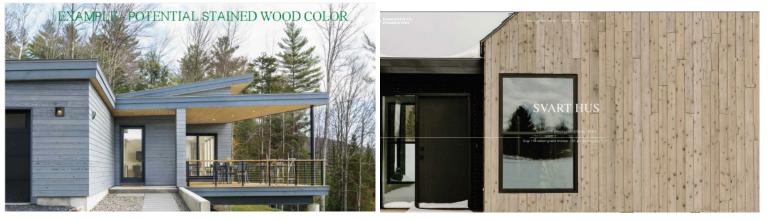
STANDING SEAM METAL ROOF

- Small c.1970 15 sq ft rear addition to be removed.
- Addition materials will differentiate from historic: cladding to be vertical "burnt cedar" wood with 4" reveal or equivalent and roof will be grey architectural standing seam metal, both are intended to blend into tree canopy.

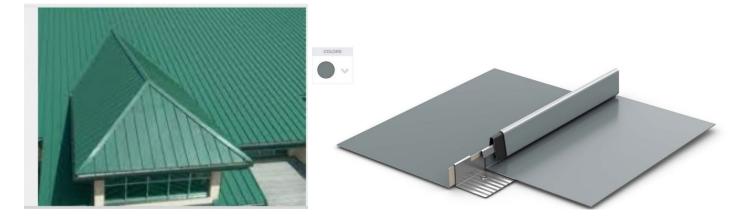
CONFIRMATION THAT THERE ARE NO EAVES FROM ARCHITECT

Yes, - indeed that's exactly what we thinking: the wall to roof transition on the proposed addition is more like a New England salt-box type effect, where there isn't an overhang, and isn't a soffit condition. Instead there is a simple eave board that kicks the roof edge out a couple of inches so it directs the water run slightly away from the wall, - but only slightly away....

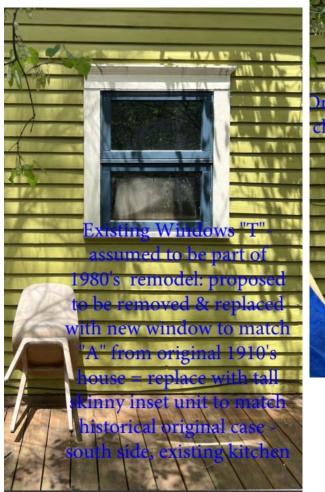
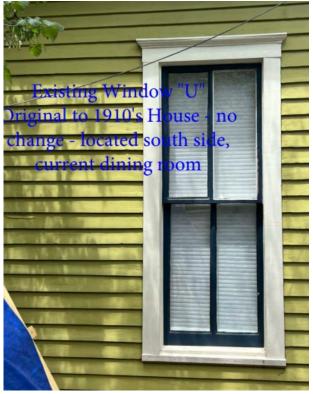
inset and recessed - see attachment

* RESTORE ORIGINAL OPENINGS TO MATCH EXISTING- SEE NEXT PAGE FOR EMAIL CONFIRMATION

On the south, where the current kitchen is located, the Owner's intent is to literally custom fabricate wood windows to match the other original 1910's house windows in that same wall = make them all identical, both in terms of materials, sizes, method of construction, color, etc. = intent is those units would be exact replicas of the original windows adjacent. The 1980's remodel window in the kitchen there would be replaced by one of the two new proposed built-to-match units....
