7806 Santa Elena St Glenbrook Valley

#### CERTIFICATE OF APPROPRIATENESS

**Proposal:** Alteration - Installation and removal of front door and side lites without a COA due to rot and damage.

July 29, 2021 HPO File No. 2021\_0157 7806 Santa Elena St Glenbrook Valley

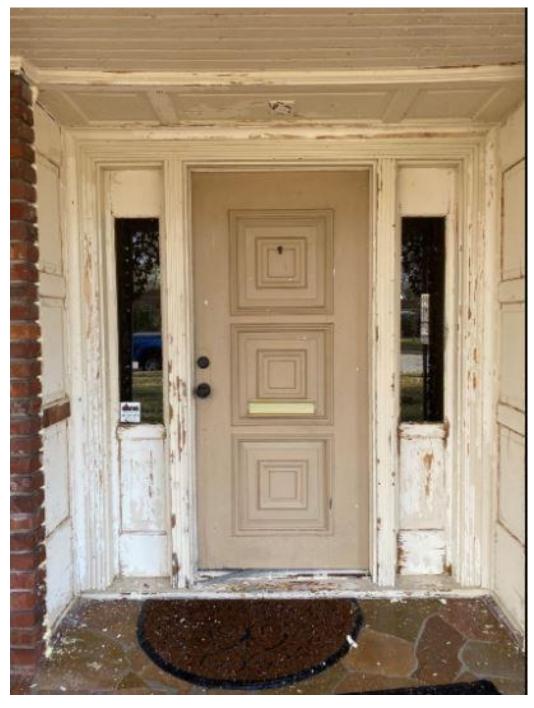
## **Door Before Replacement**

- Removed original single-door with double metal doors.
- Removed two original side lites.

Recommendation: Denial - does not satisfy criteria; Issuance of a COR to replace door for a more appropriate

style and to reinstall two side lites.

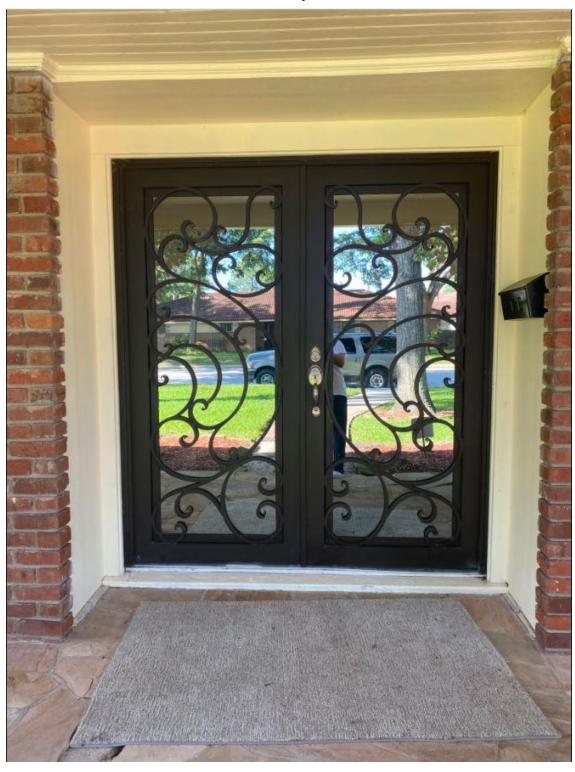
### **Door After Replacement**

(3)	The proposed activity must recognize the building, structure, object or site as a product of its own time and avoid alterations that seek to create an earlier or later appearance; Replacement Door does not match the materials or character of traditional ranch style home. Removal of original side lites does not match the architectural features.
