CERTIFICATE OF APPROPRIATENESS

Property: 804 Hawthorne Street, lot 9, block 24, Montrose Subdivision. The property includes a contributing two-story

Significance: Contributing two-story Craftsman style single-family residence, constructed circa 1917, located in

November 17, 2022 HPO File No. HP2022 0215 804 Hawthorne Street
Audubon Place

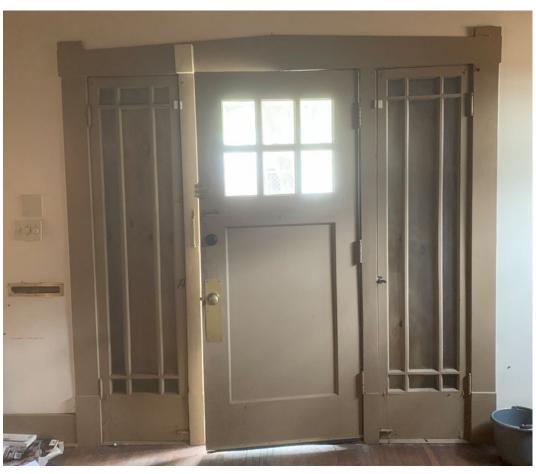
CURRENT PHOTO -INTERIOR FRONT DOOR AND SIDE LITES

- Front Façade: First Floor Front porch railings and balusters to be added for safety reasons (for potential commercial event space use). Existing windows, door and side lites to be restored. All existing cladding to be restored, replaced in kind where necessary.

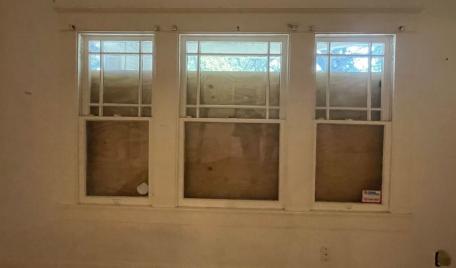
CURRRENT PHOTO - FIRST FLOOR INTERIOR CENTER/SIDE FRONT WINDOWS (TO REMAIN)

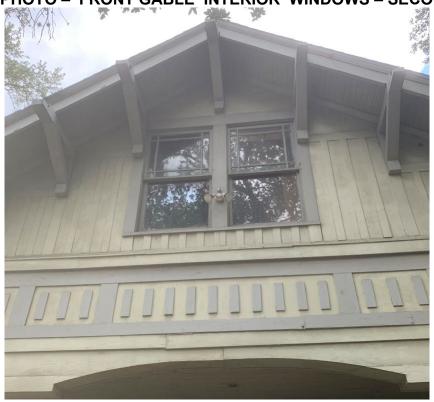
CURRENT PHOTO - FRONT GABLE INTERIOR WINDOWS - SECOND FLOOR

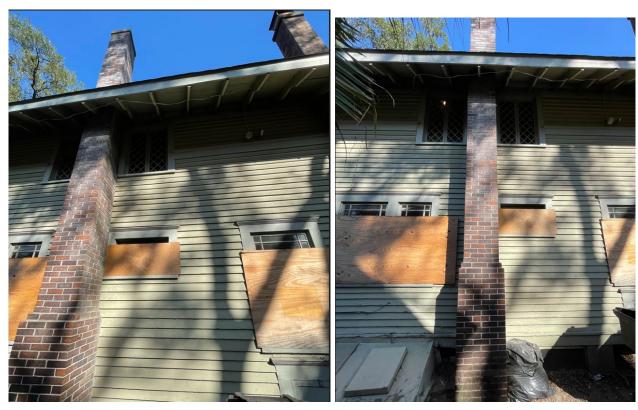
CURRENT PHOTOS-LEFT SIDE ELEVATION WINDOWS TO BE RESTORED

- Front Porch decking, exterior trim and all original windows are to be repaired on front and side elevations.
- One window opening with inset, recessed wood window to be added at rear of left elevation second floor with diamond pattern to match others.

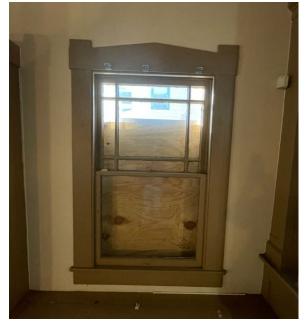
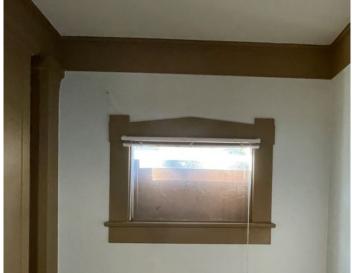
CURRENT INTERIOR VIEW OF WINDOWS TO BE RESTORED

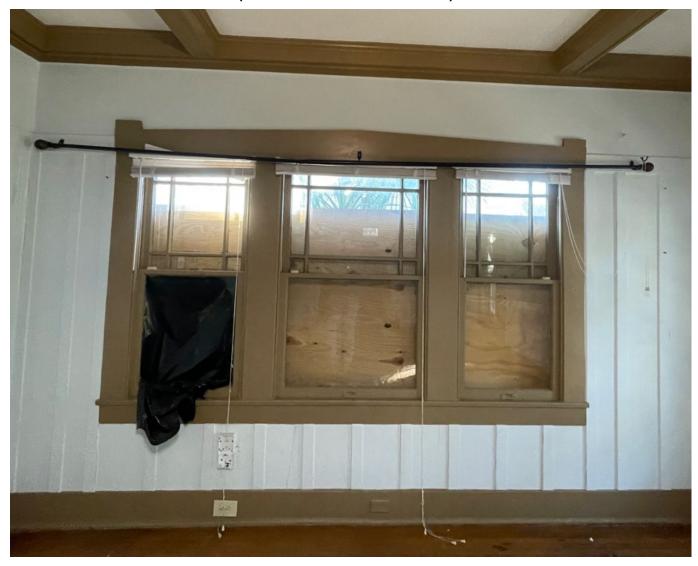
CURRENT PHOTOS- LEFT SIDE ELEVATION WINDOWS TO BE RESTORED (TOWARDS REAR CORNER)

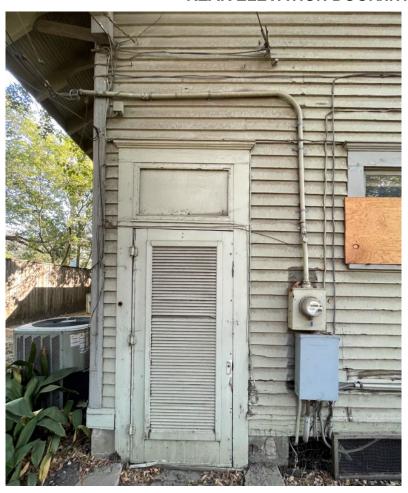
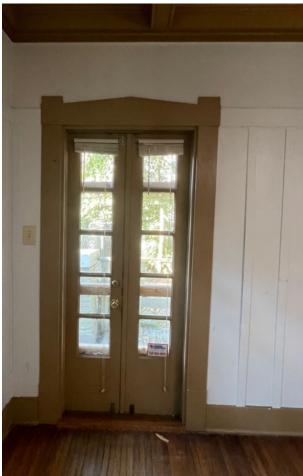
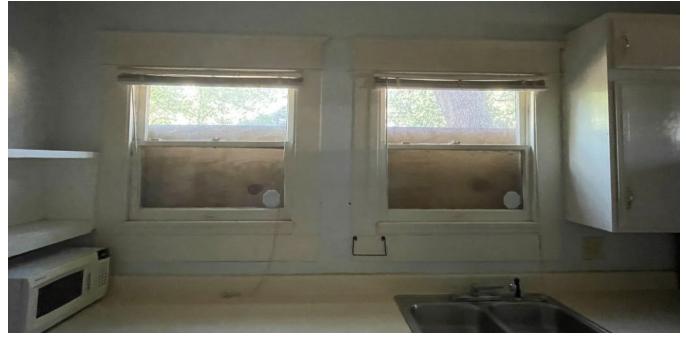
REAR ELEVATION DOOR/INTERIOR OPENINGS

- Rear elevation: two original French doors to be restored, two kitchen windows to be removed and replaced with inset, recessed wood single window. Non-functional existing louvered door to be removed.

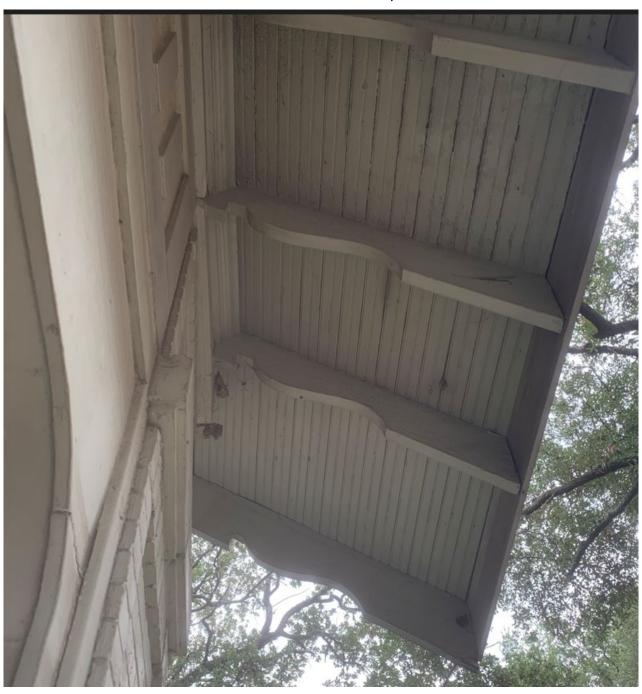
EXPOSED RAFTER TAIL DETAIL, DEEP EAVES

- Remove screened-in side porch alterations. Restore pergola and side entry with original doors and windows.
- 4" x 6" ornamental brackets on the front elevation and rafter tails to be repaired at all sides.

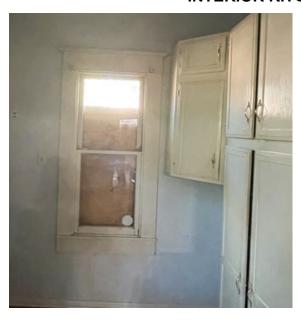
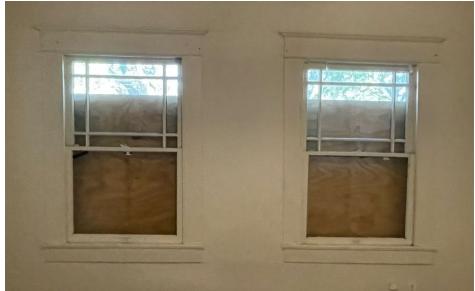
INTERIOR KITCHEN/ SIDE WINDOWS TO BE RESTORED

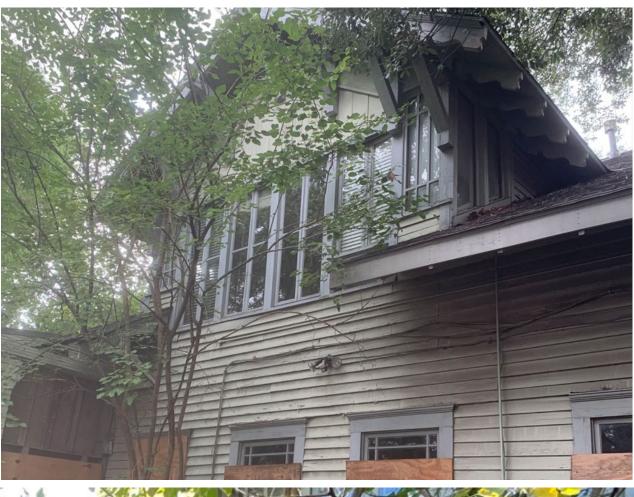
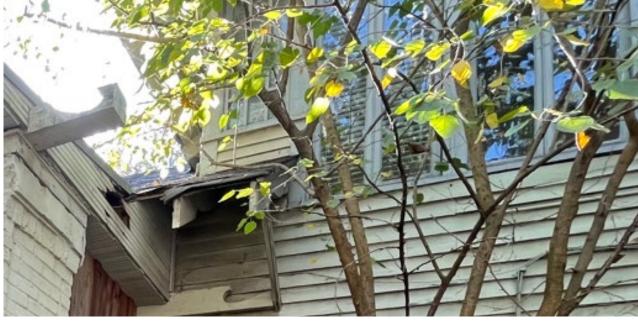
CURRENT PHOTO – RIGHT SIDE FACING STREET 2ND FLOOR WINDOWS

- On right elevation, window to be restored but grill to be applied to match historic window pattern.

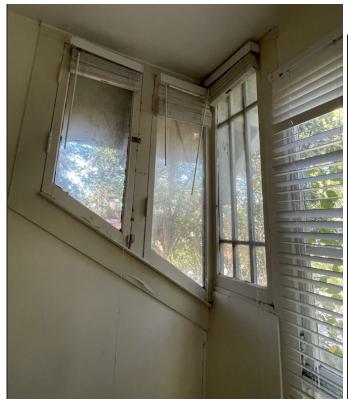
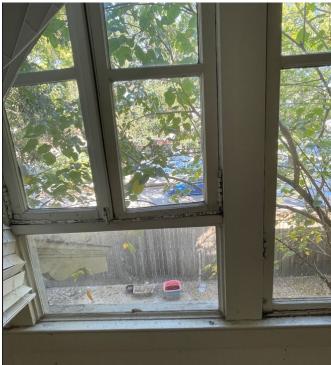
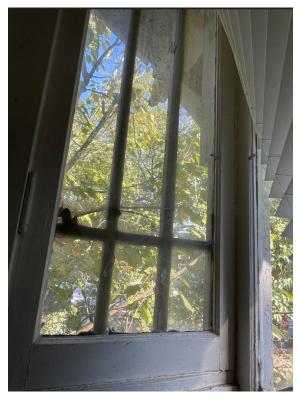
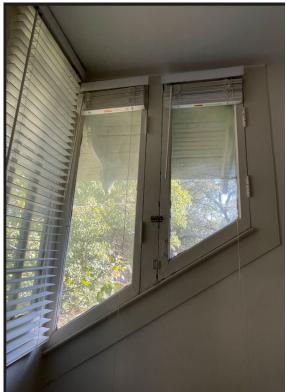
CURRENT PHOTO – RIGHT SIDE FACING STREET 2ND FLOOR WINDOWS INTERIOR VIEW TO BE RESTORED, ANGLED WINDOWS TO BE REMOVED (NOT ORIGINAL)

to the second floor of the right-side elevation facing Stanford St.

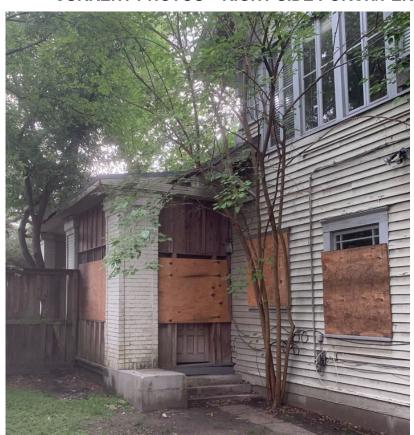
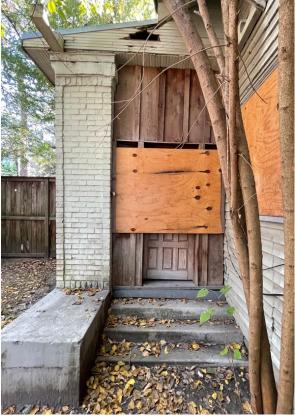
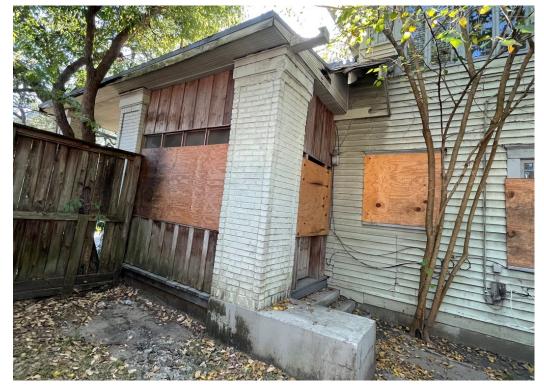
CURRENT PHOTOS – RIGHT SIDE PORCH/PERGOLA (ENCLOSED C. 1950)

the Audubon Place Historic District. Existing alterations were probably done c. 1950 or after which enclosed the right side of wrap around porch or pergola and could have included window alterations

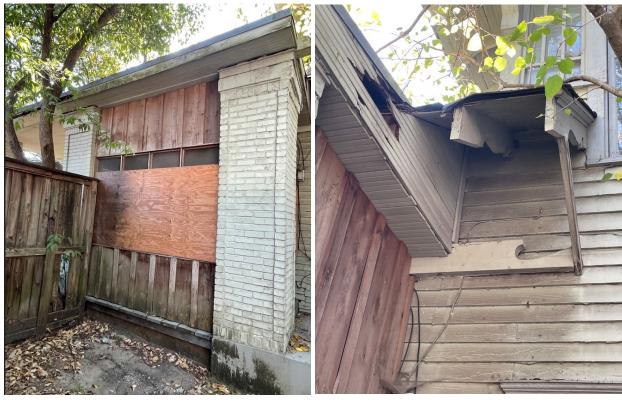
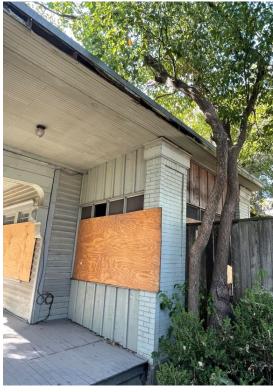
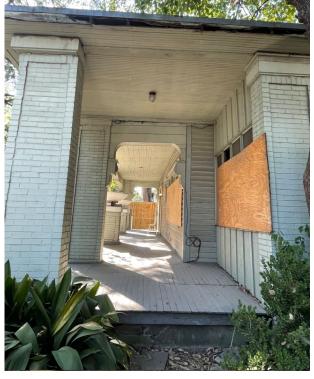
CURRENT PHOTOS – RIGHT SIDE PORCH/PERGOLA (ENCLOSED C. 1950)

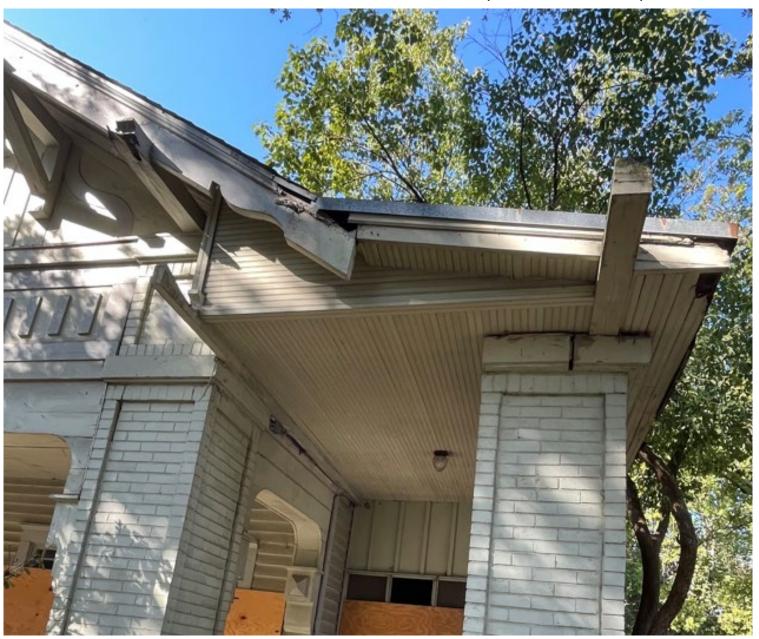
CURRENT PHOTOS – RIGHT SIDE PORCH/PERGOLA (ENCLOSED C. 1950)

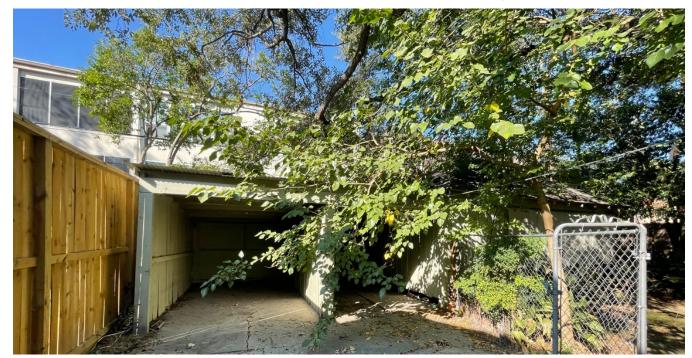
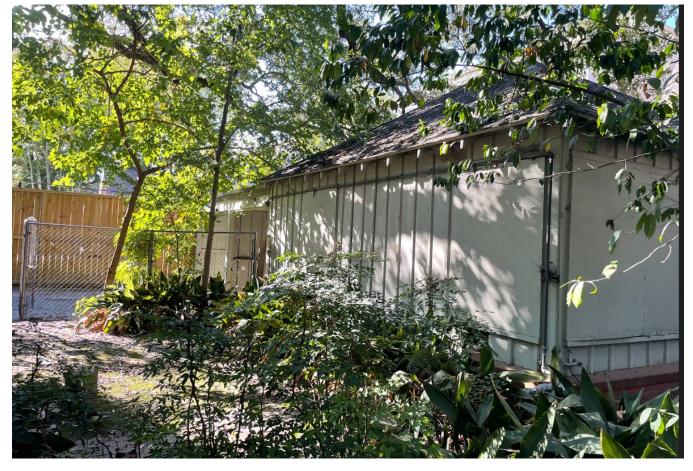
REAR CARPORT AND ACESSORY STRUCTURE - TO BE RESORED, NEW ROOF/ALTERATIONS

Alteration of original garage turned carport and accessory structure: re-roof in kind and slight alteration of roof plan and foundation repair are included. Existing windows and doors will be restored, as well as existing cladding.

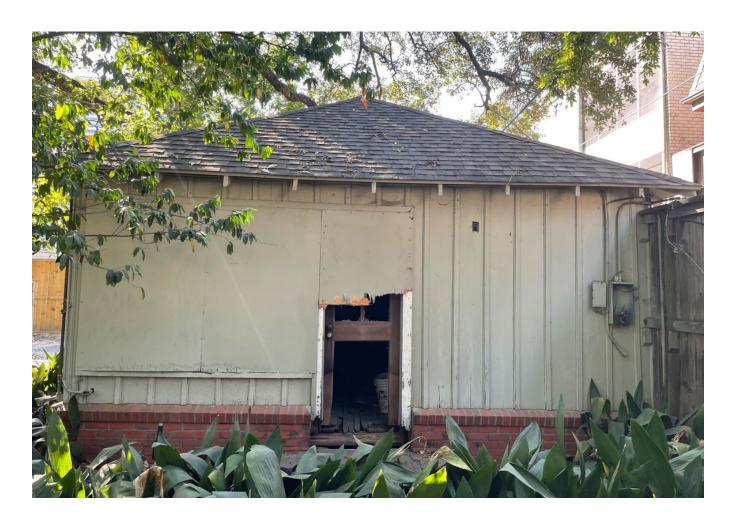
REAR CARPORT AND ACESSORY STRUCTURE TO BE RESORED, NEW ROOF/ALTERATIONS

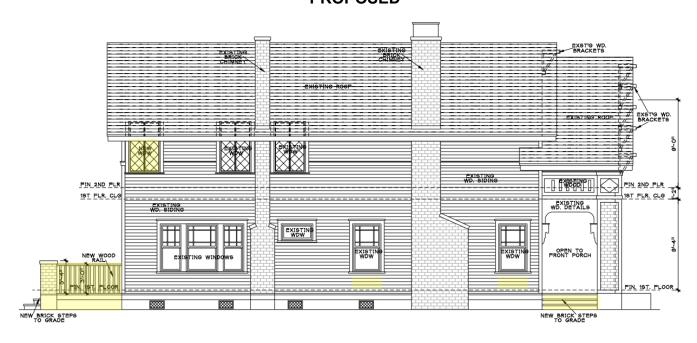
PROPOSED

Firewood window boxes to remain** in yellow below first and second windows (see photographs)
